Markland L/D Ohio River Louisville District

Board of Investigation Briefing, Downstream Miter Gate Failure

USACE Brief - 7 December

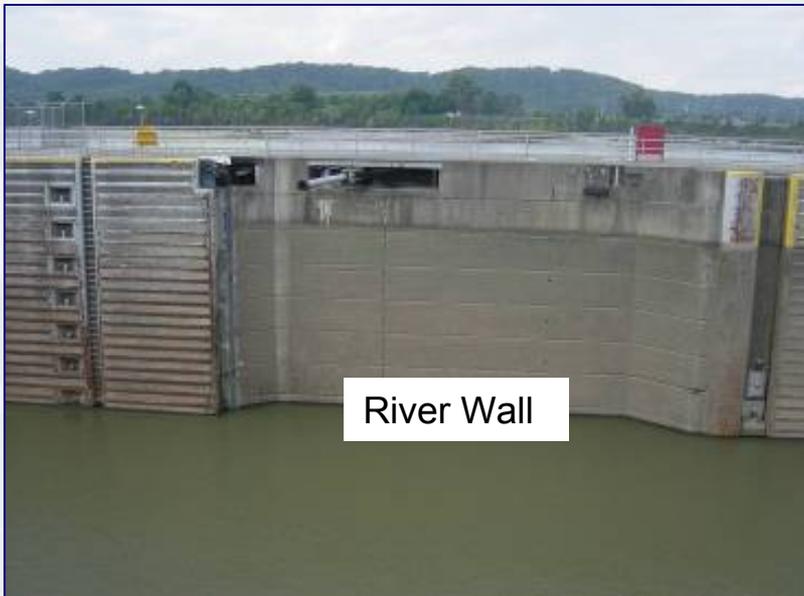
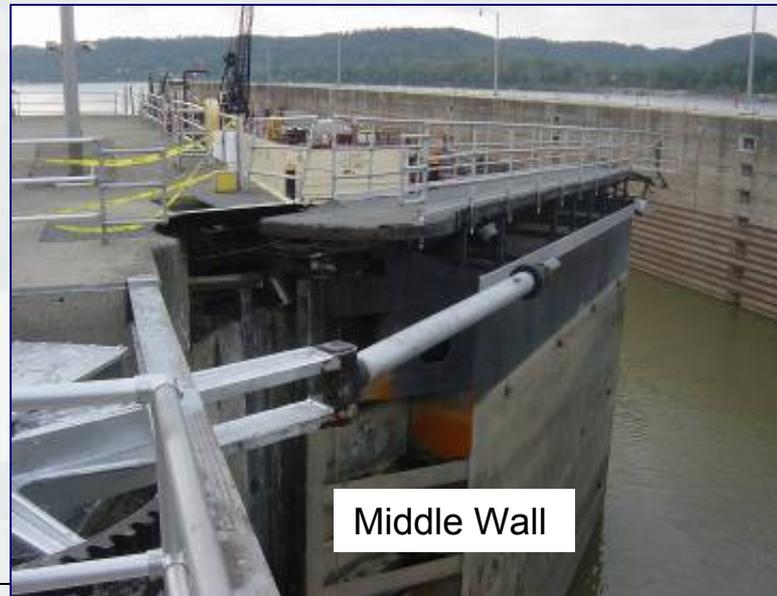
- Downstream Miter Failure - \$9,000,000
 - Final Estimate Still Pending
- Loss of Lower River Wall Gate Leaf with Anchorage and Strut Arm Damage
- A partial loss of the Lower Middle Wall Miter Gate with Anchorage and Strut Arm Damage
- The loss of the River Wall Filling Valve pilot valve assembly.
- Damage to the Private Vessel, CQ Princess – (\$1,200 claim)

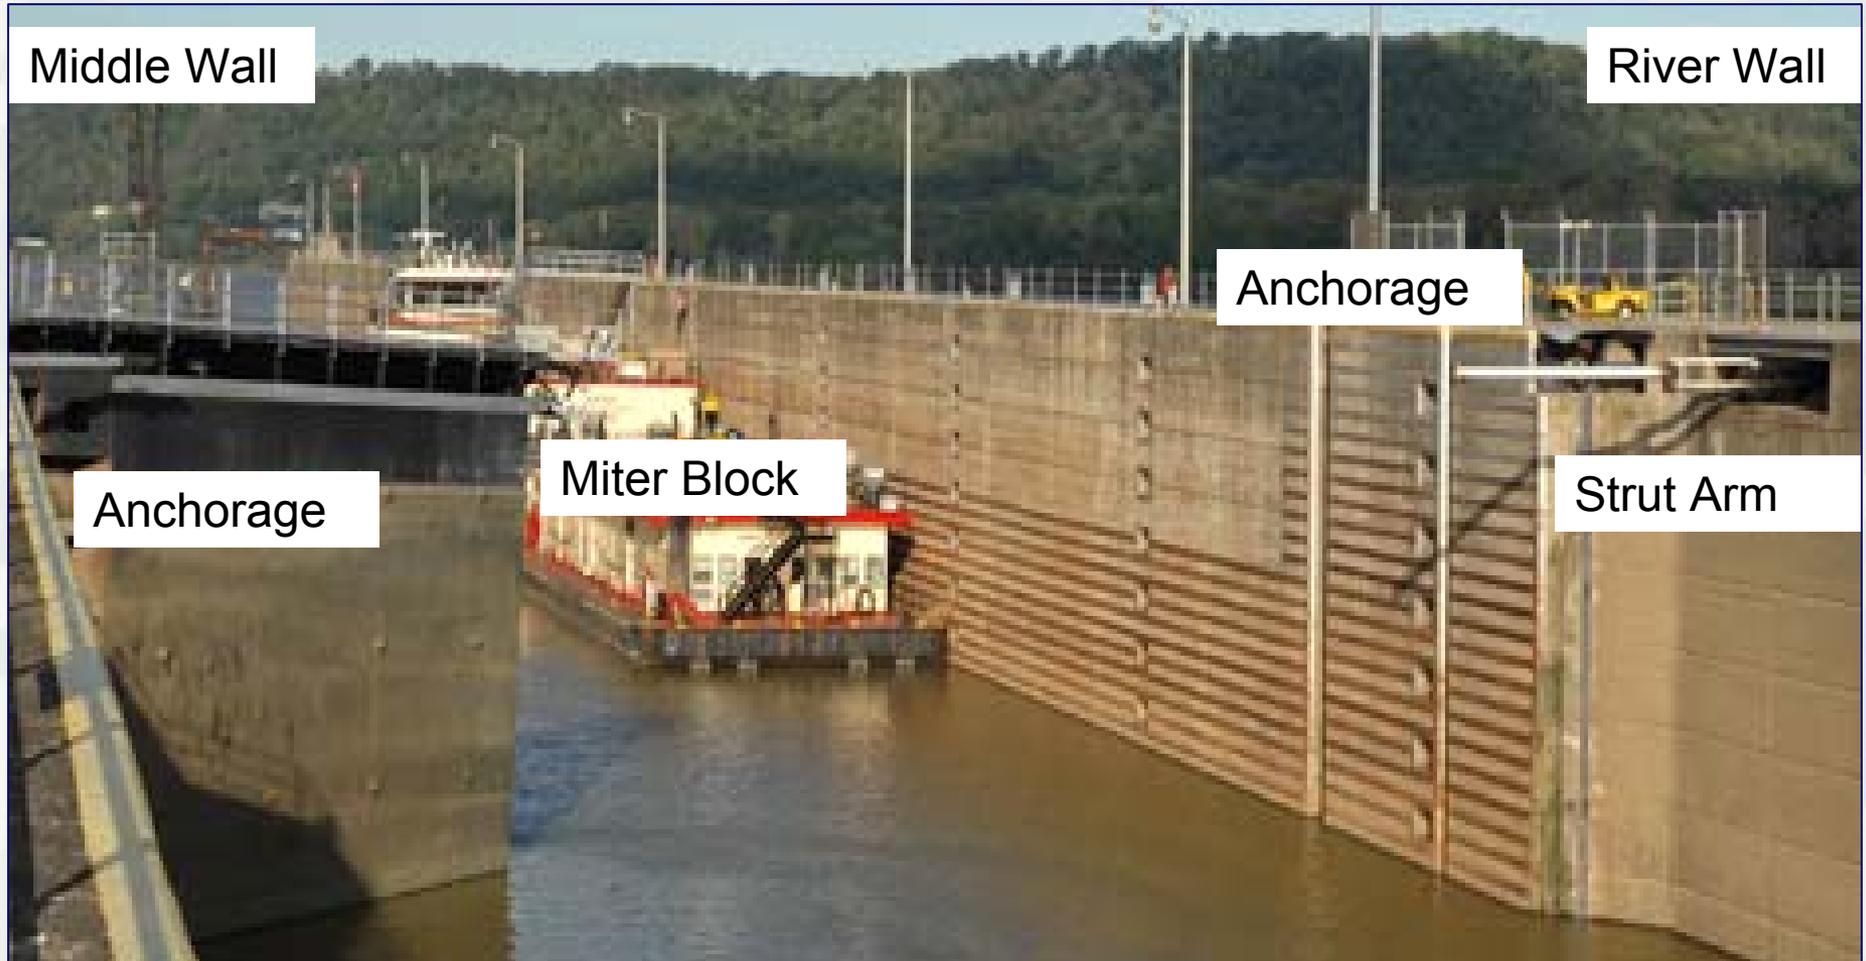
Damage Photo

- Lock operations on the lower 1200 foot miter gate.
- River Wall Filling Valve was 98% opened at the time of the lower miter gate closing.
- The flow of water in the main chamber did not allow the lower miter gates to complete a proper miter.
- The main chamber continued to fill until the improper miter failed.
- Both gates swung far beyond their normal mitered position and until the river wall leaf was torn from its anchorage.
- The middle wall leaf suffered anchorage and miter block damage.

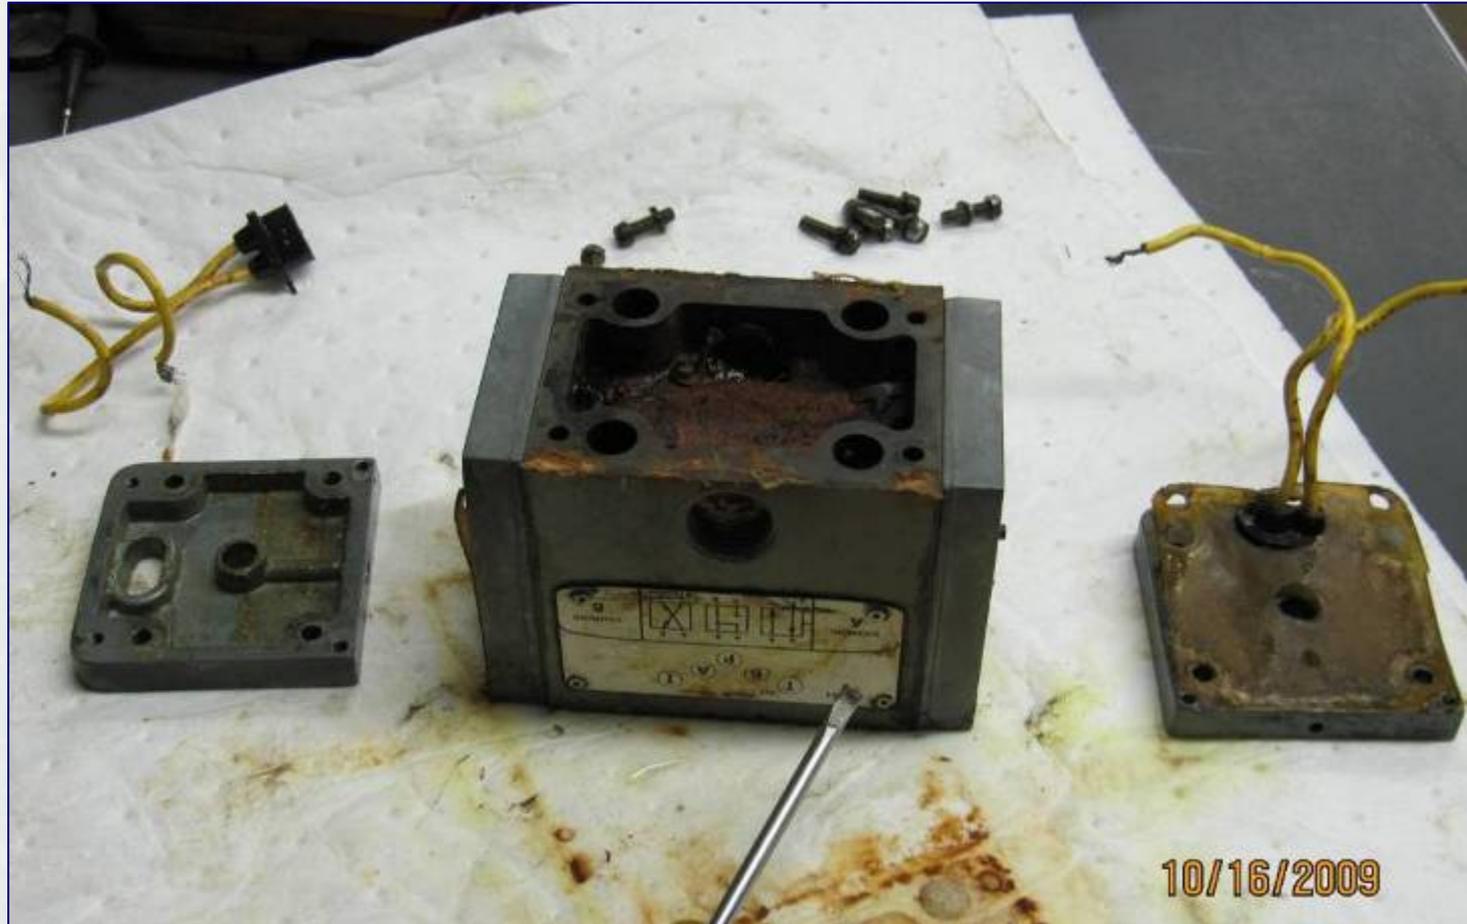
Pilot Valve Inspection

- Inexperience and complacency of the locking crew to recognize changes in conditions.
- The AHA was lacking in the area of the sequence of actions in the locking operation.
- The facility did not have maintenance records readily available for the 4-way valve assembly.
 - ▶ Deteriorated condition of the pilot valve
 - ▶ For over a decade, the pilot valve was wrapped in plastic.
- The facility lacked a Standard Operating Procedure for locking operations.

Heavy Corrosion on Dry Side of Valve Body

- Continue with the implementation of FEM.
- Establish a maintenance interval and procedures for solenoids and gate indicators.
- Conduct review and add Valve to Gate Interlock capability
- Improvement of ergonomics for control shelter layout.

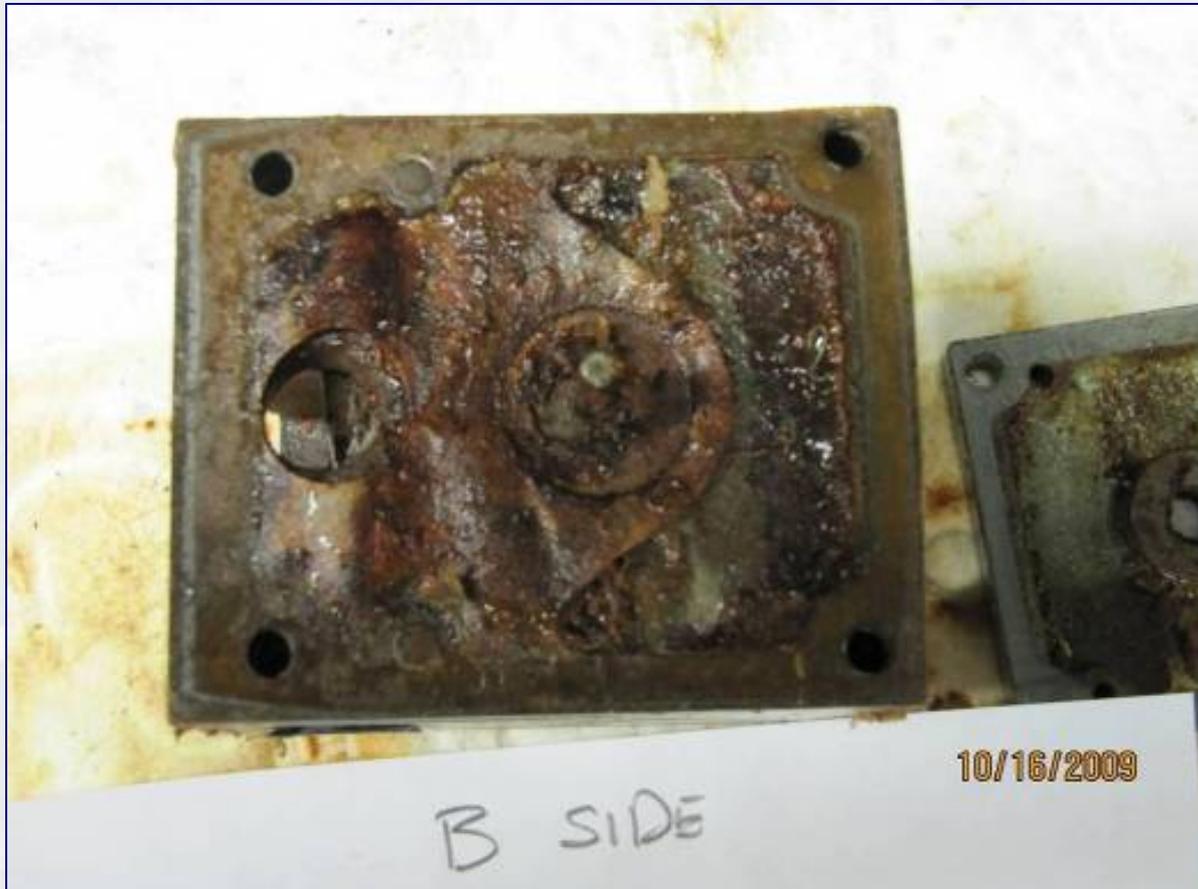
Pilot Valve Inspection

**Dry Side "B" Push Pin exiting the Valve Body
Note the Moisture and Heavy Corrosion**

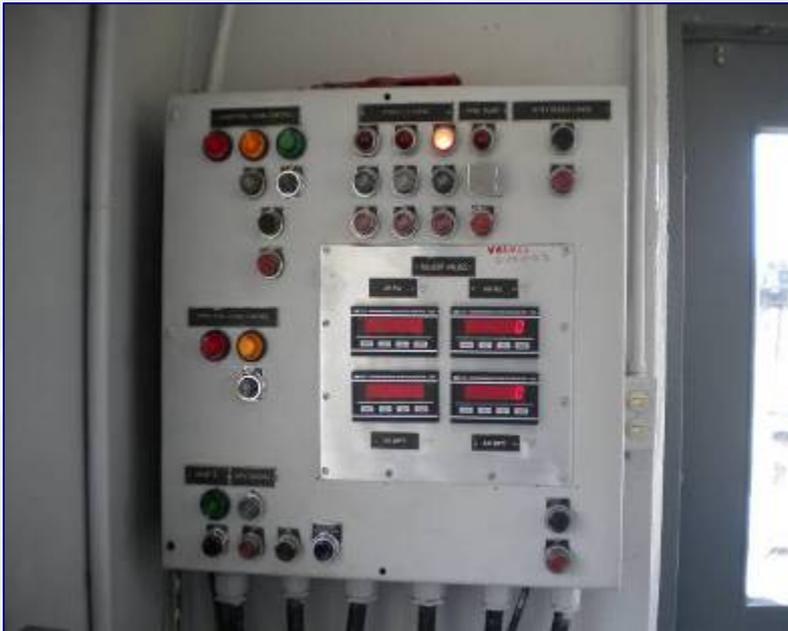
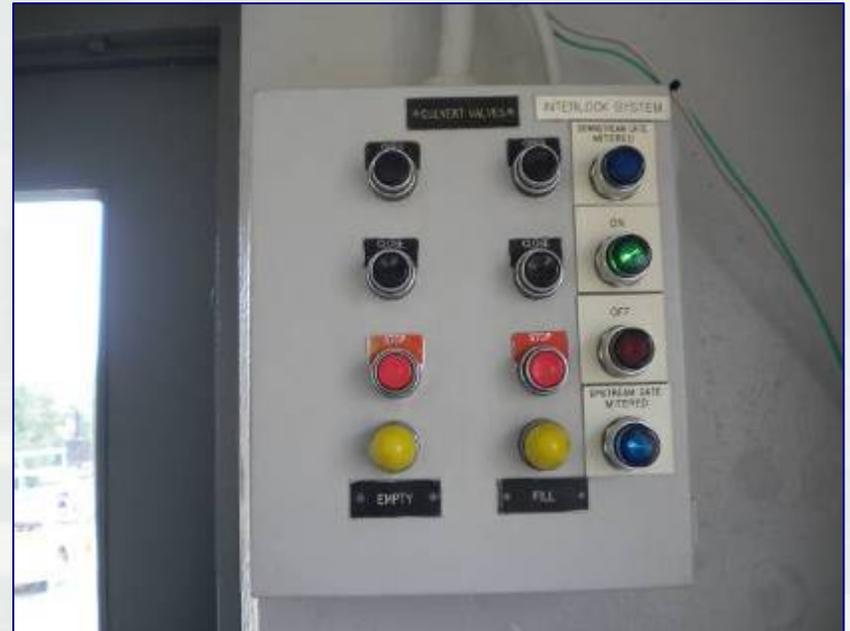
- Poor ergonomic and physical layouts of the control stations' control indicators panels and filling valve indicator rod
- Markland Interlock System does not have a VALVE to GATE component that prevents gate operation if the wrong valves are opened.
