# Belgian Inland Waterways

ir. Peter Van Besien, Lock Maintenance Workshop, St. Louis (USA), 9 feb 2010

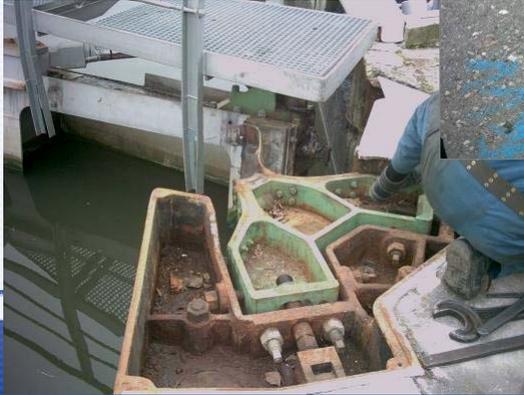
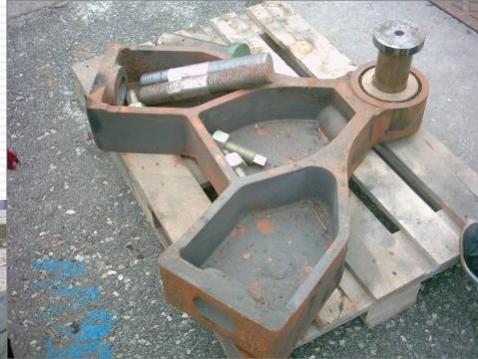
→ broken hinge

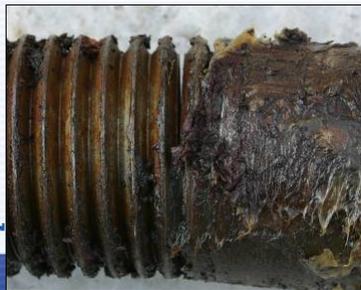
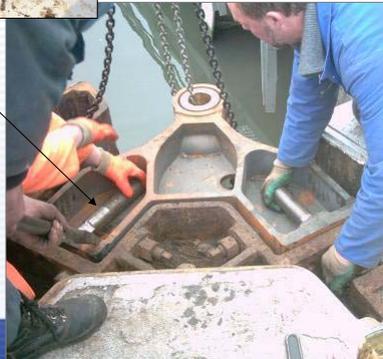
→ broken threaded rod

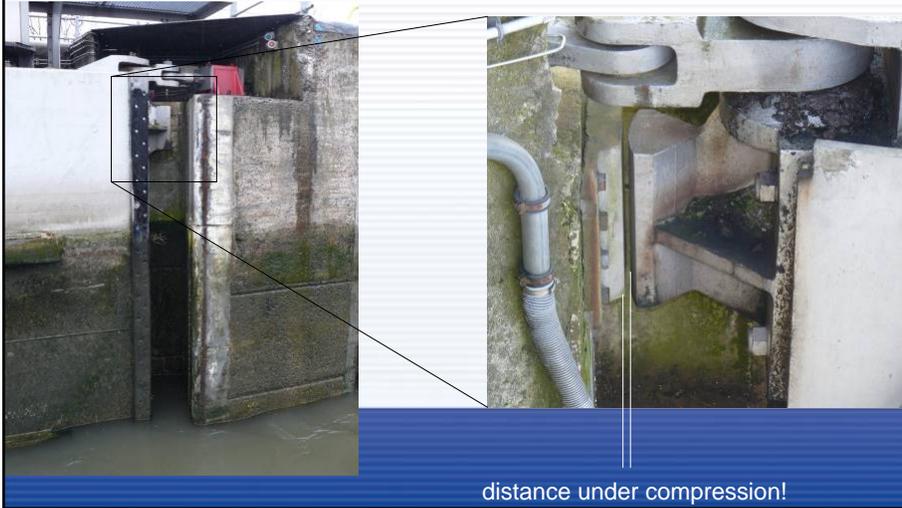
- Position of support blocks

closed position, under hydraulic pressure  
∅ support blocks must take the force  
not the hinge!

→ broken anchor rods, concrete blocks, ...

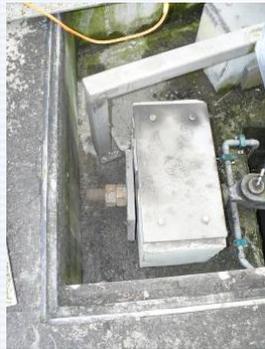
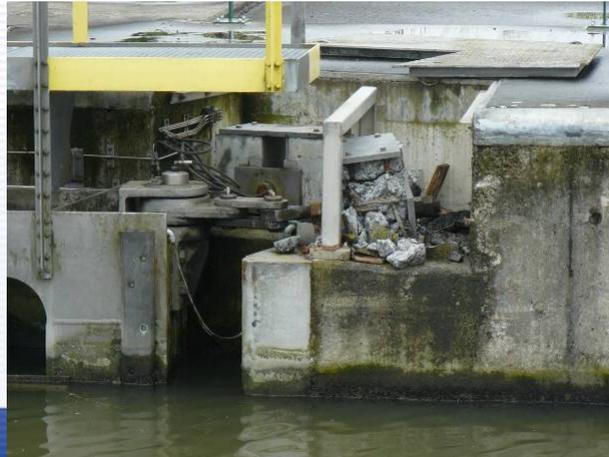
→ crushed concrete anchor block (fatigue)

reconstruction of the anchor block:

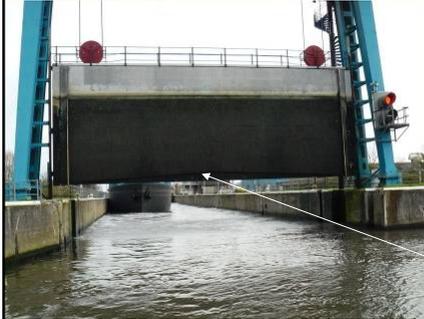
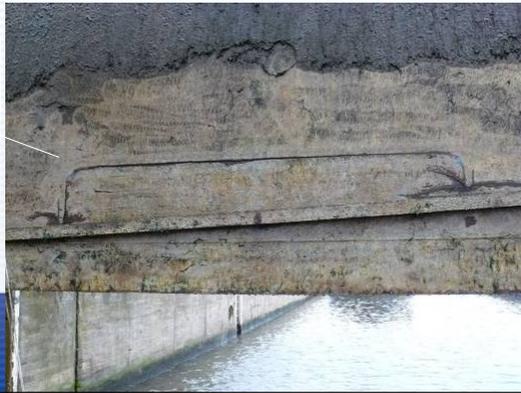
- Cracks in steel plate

origin: debris on the floor, steel fatigue

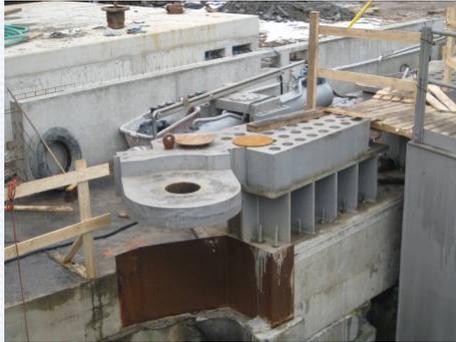
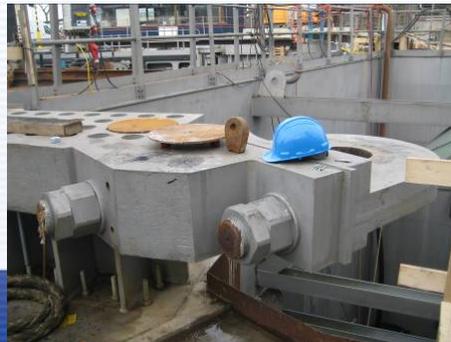
Large cast-iron hinges  
small space for mechanics and soil anchors not possible
