Locks & Dam 52 2010

Miter Gate Leaf Straightening
&
Cell Repairs

ORM 938.9

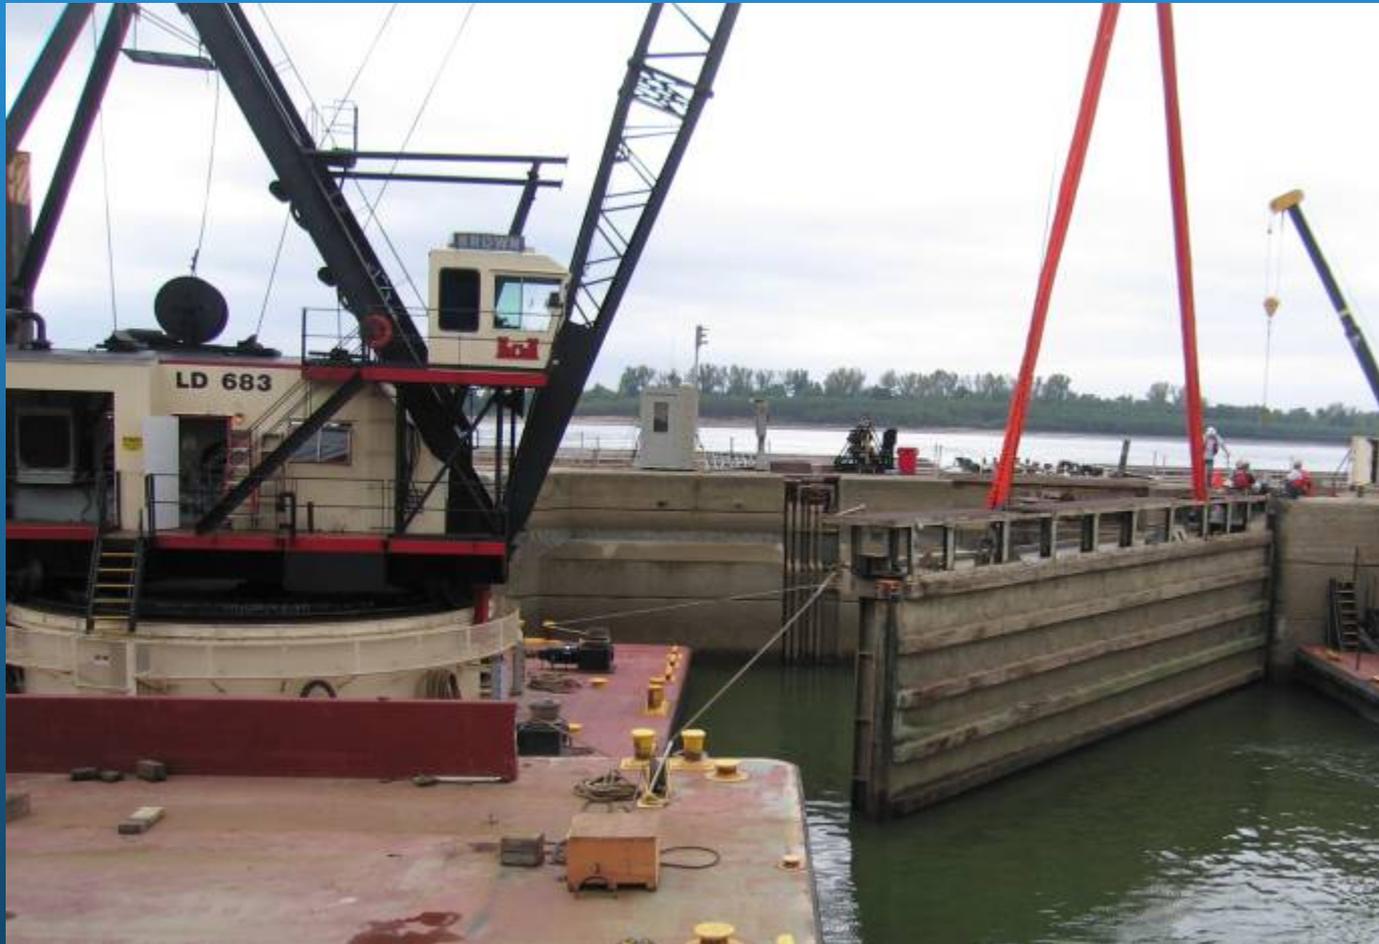
Problems

Lower Middle wall miter gate leaf was twisted 12” out of plumb in 25’ height. Bottom of leaf was hanging out into the chamber to be potentially struck by passing tows.

Leaf was damaged during the process closing the leaves from open river conditions.
