# Ruptured Pipe and Fish Tails!

Lake Washington Dewatering Pump Plant is almost 100 years old and still pumping, but for how long?

# LWSC Dewatering Pump Plant

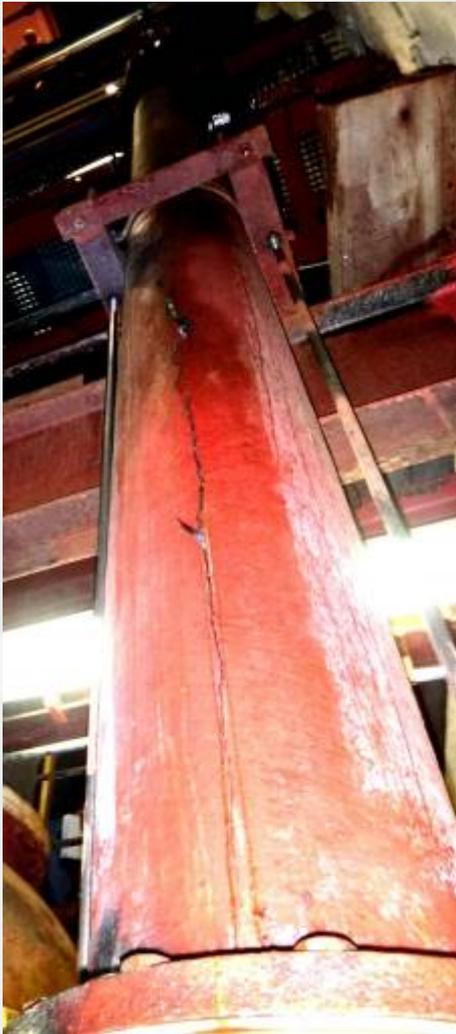
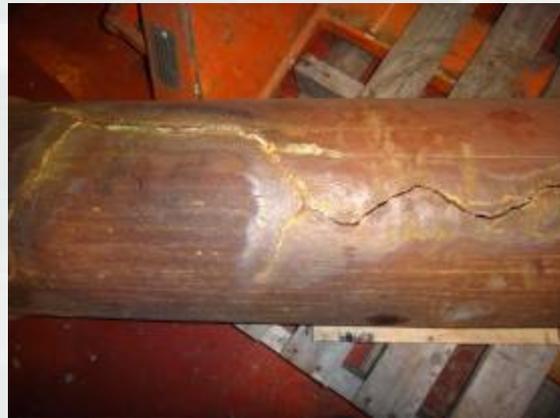
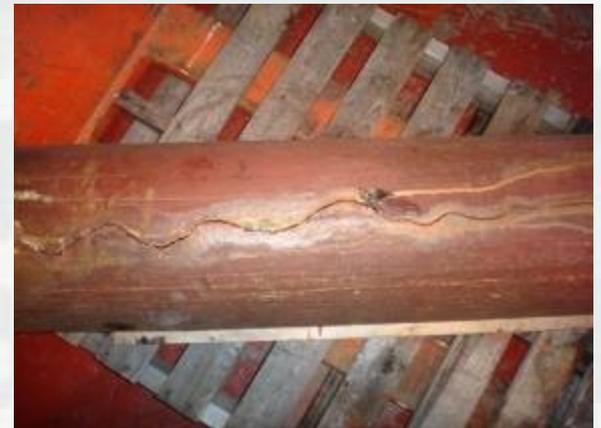
- 10" Discharge pipe for the small pump ruptured last November during pump out - 6 FT crack with fish tails sticking out.
- Pipe section is currently being replaced
- After this all of the 10" piping will be replaced

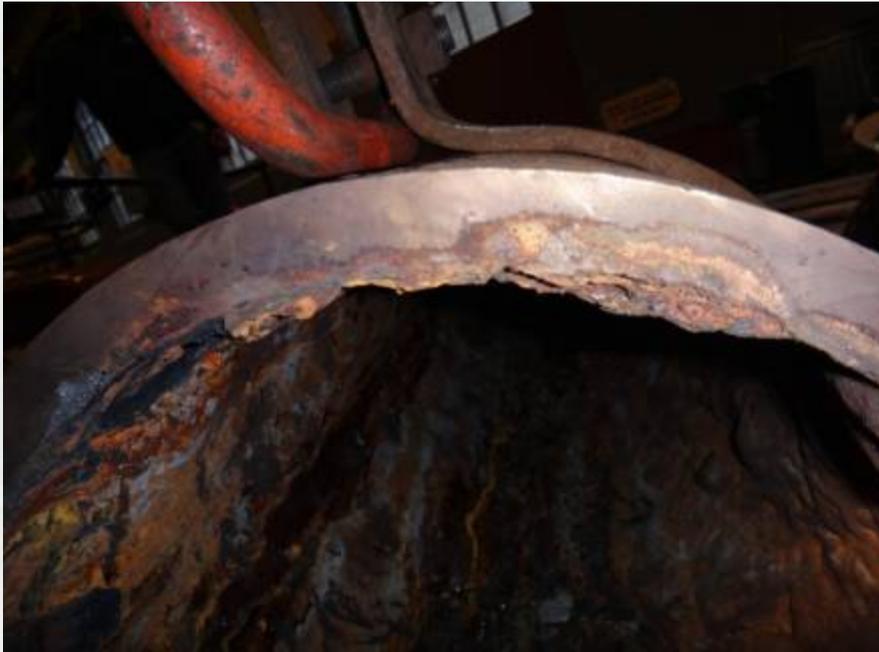
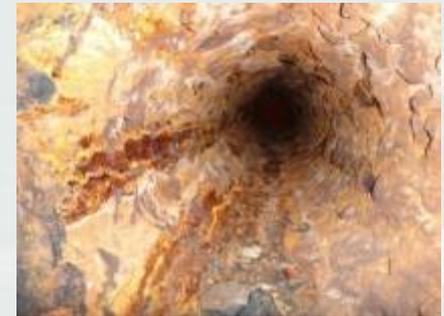
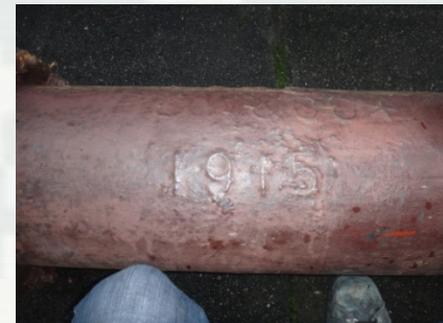
- Cross section of 10" Discharge Pipe that ruptured has severely corroded
- Appears to be graphitization of grey cast iron
- Iron corrodes away leaving matrix of graphite

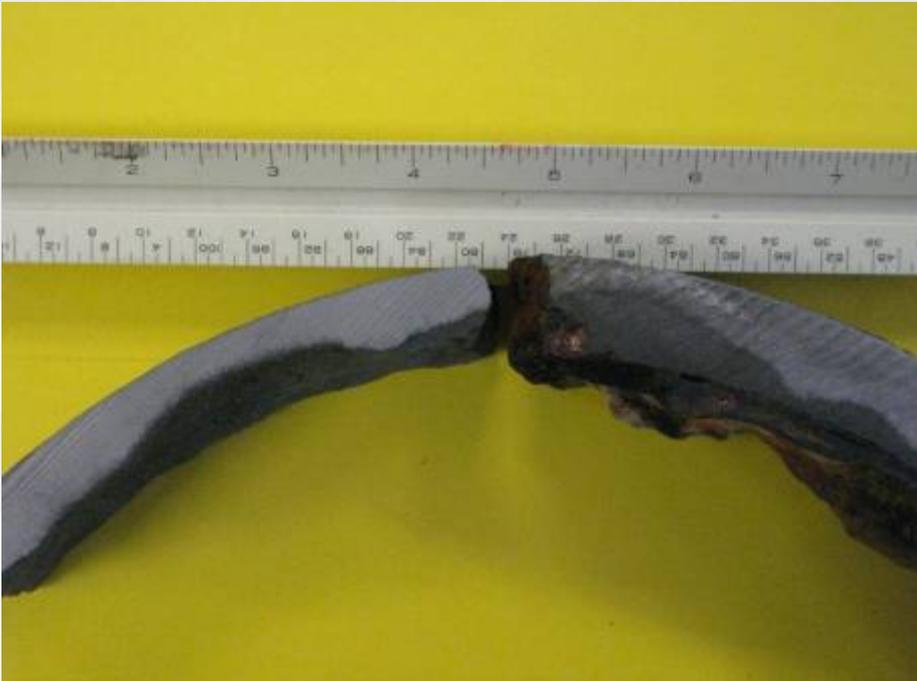
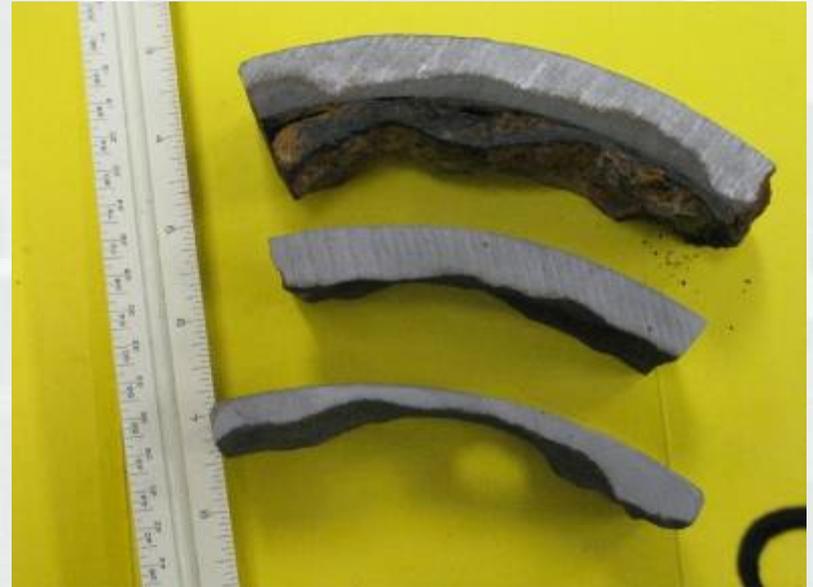
- Sandblasted and untouched coupons from cracked pipe
- Original wall thickness of 0.57"
- Many portions below 1/8"

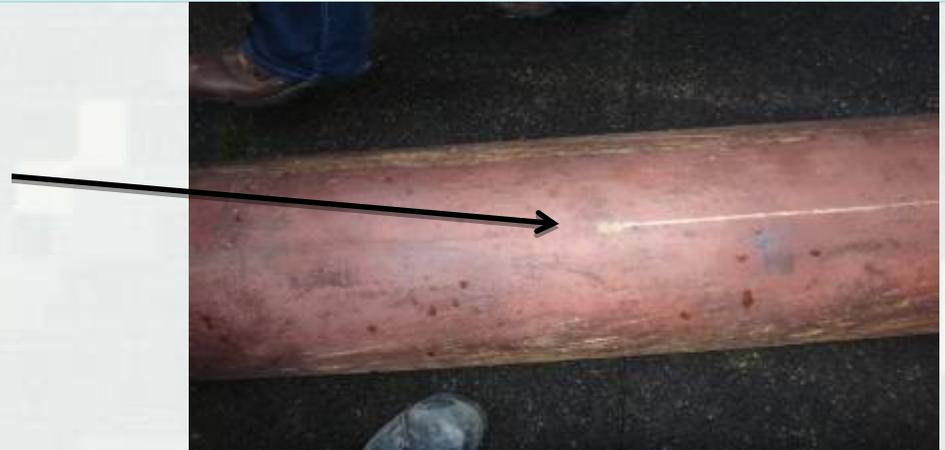
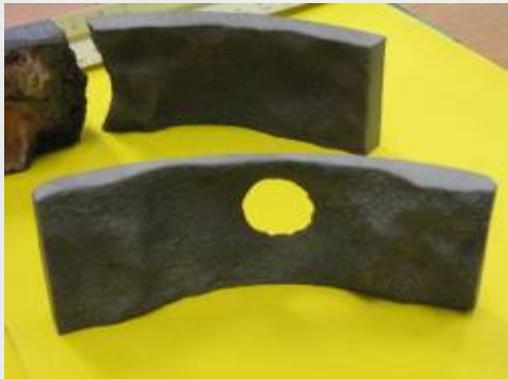
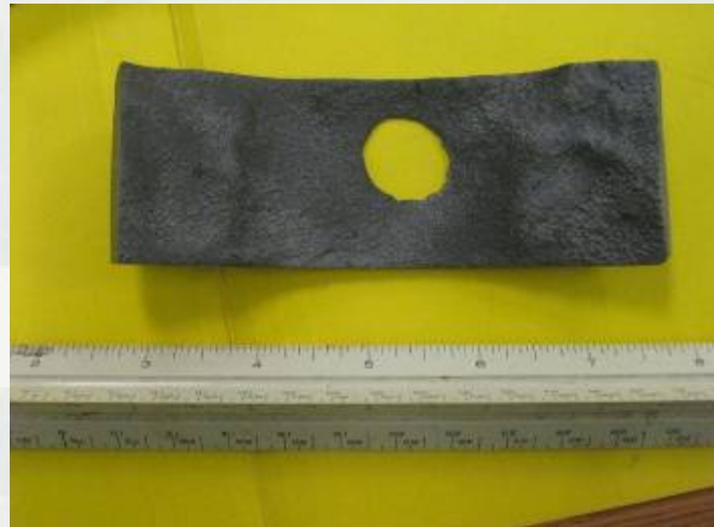
- Crew noticed pinholes in sections of pipe

- Pinhole turned out to be something much larger
- Original wall thickness 0.57"

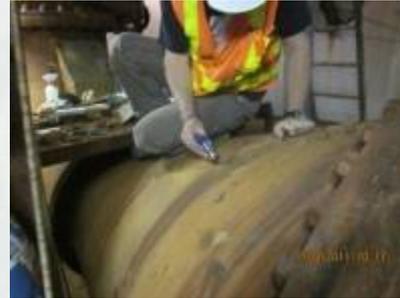
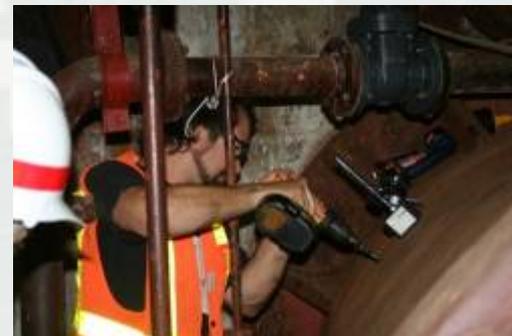
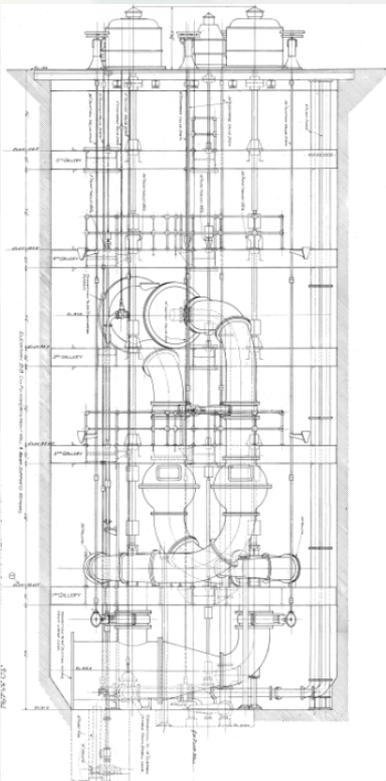
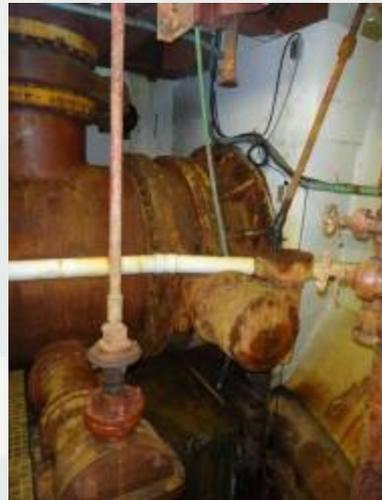
- Condition of most of the 60" and 30" pipe is unknown

- Unsuccessful NDT testing
- Destructive Testing on 60" Discharge last year

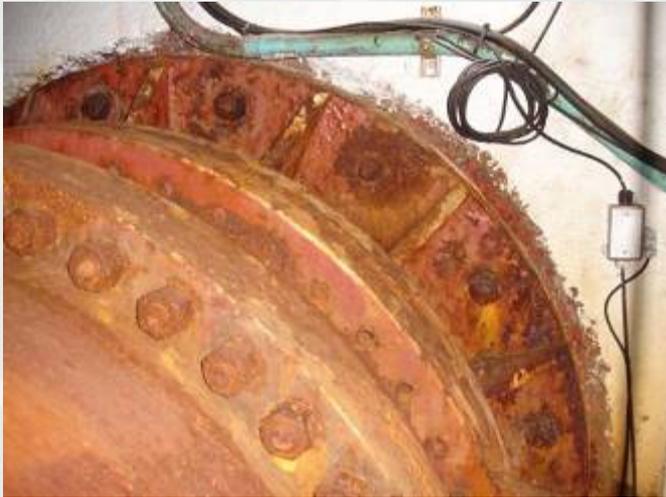
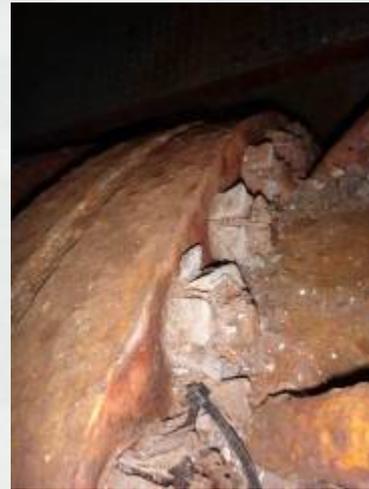
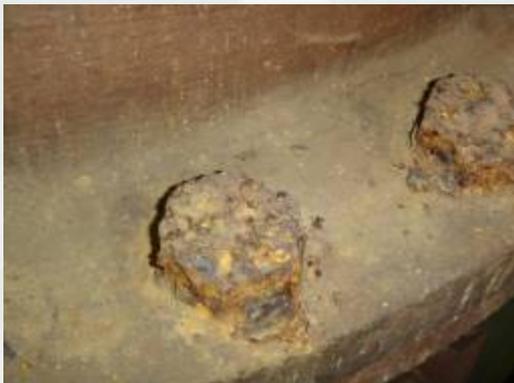
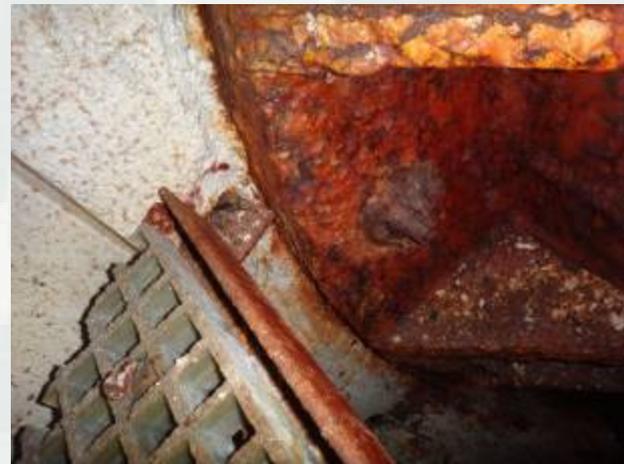
- Exterior of 60" Intake

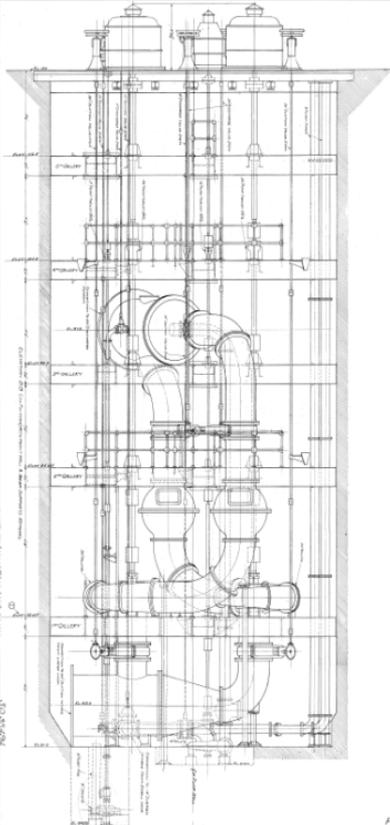
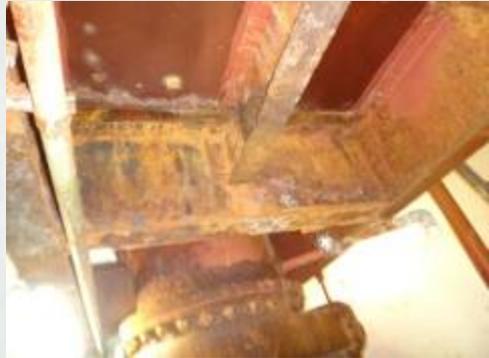
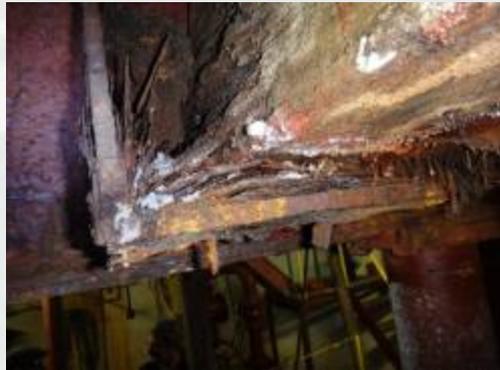
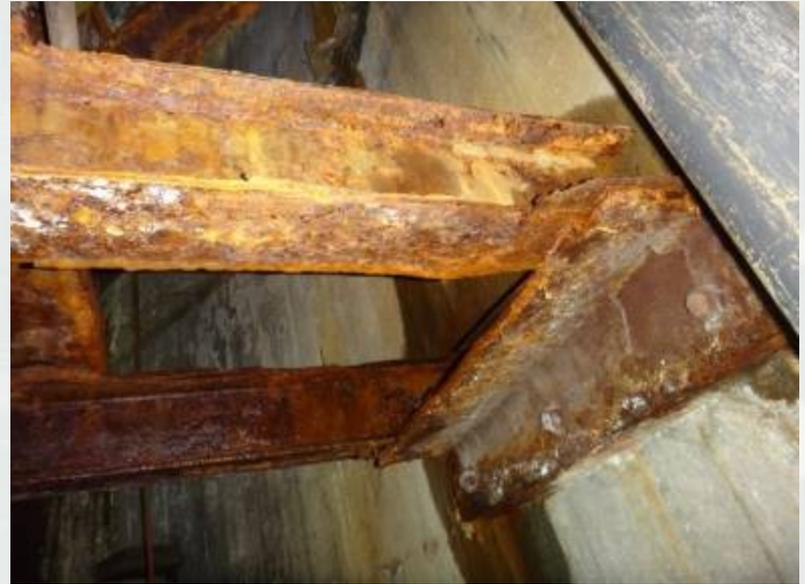
Multiple Locations

- Original Thickness: Web = 0.6", Flange 0.917"
- Current: Web = 0.23", Flange = 0.22"

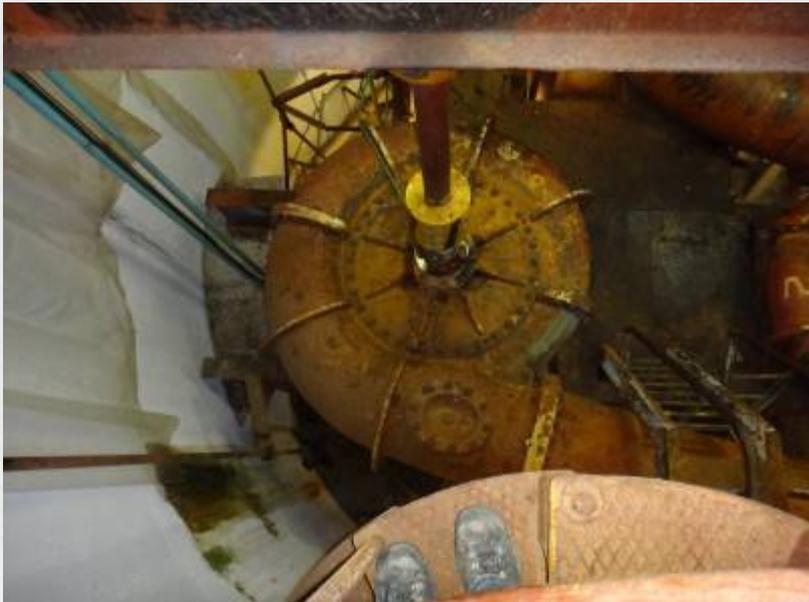
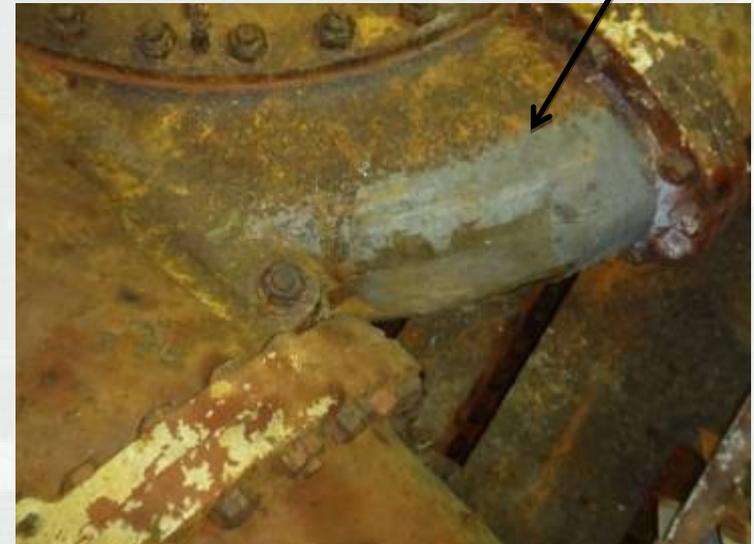
- 30" pumps received new impellers in 1943 and new castings in 1951
- Castings received temporary patches shortly after with in 1 year (still patched)

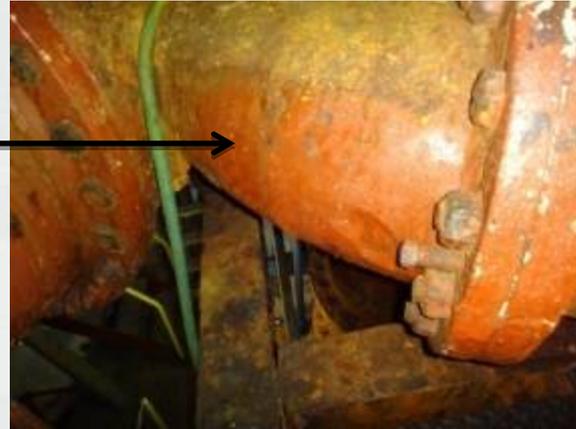
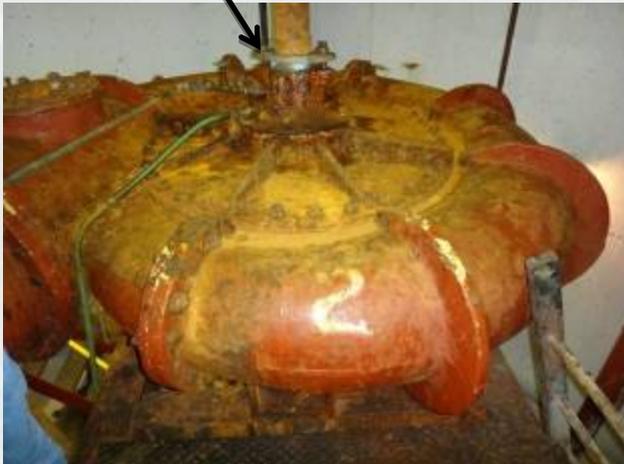
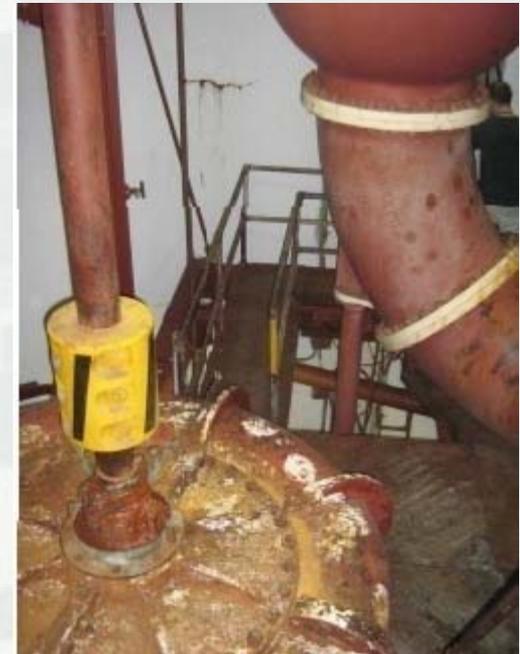
Repair Patches  
and Pack seals  
Periodically

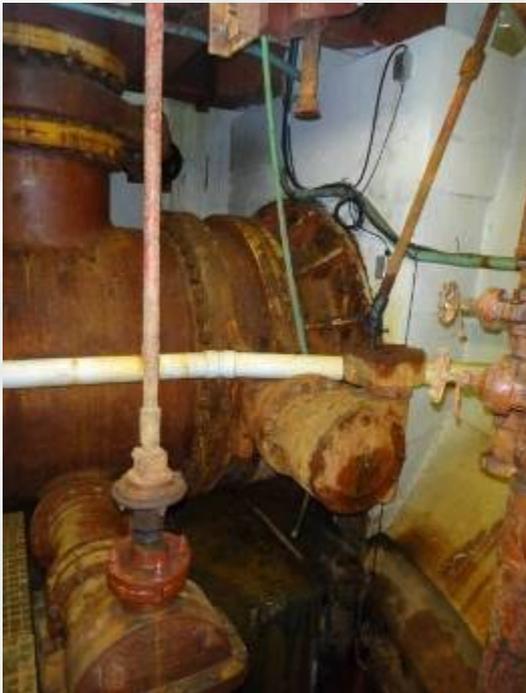
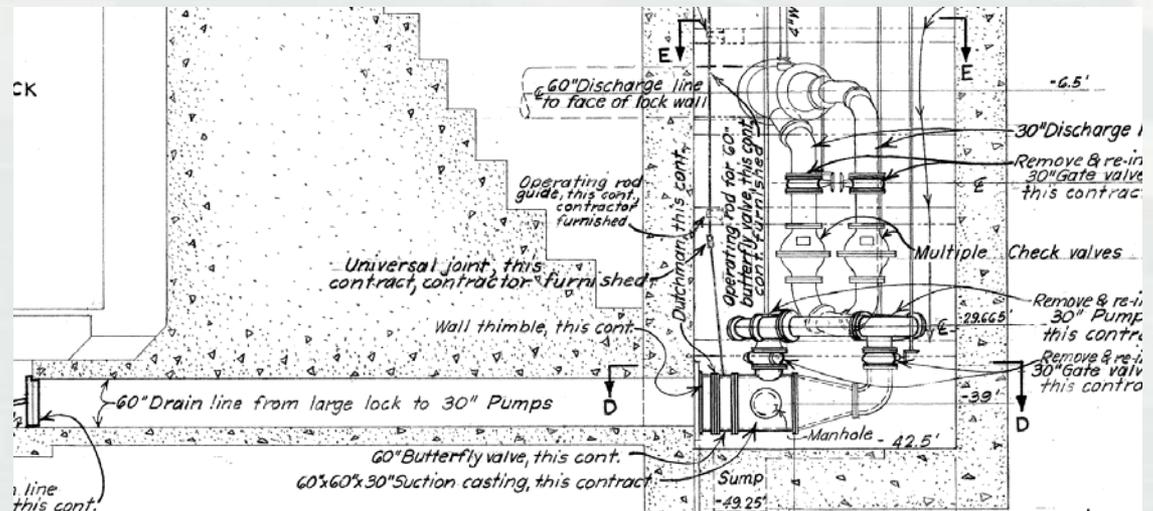
- Intake butterfly valve was added in 1954
- Intake valve slows down flow but will not shut it off

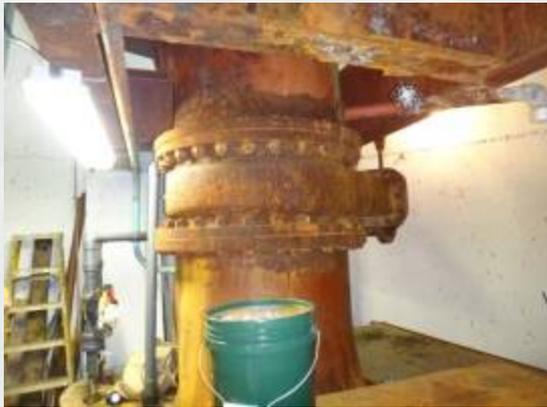
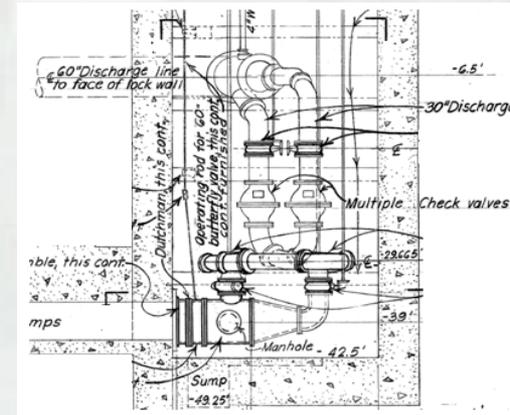
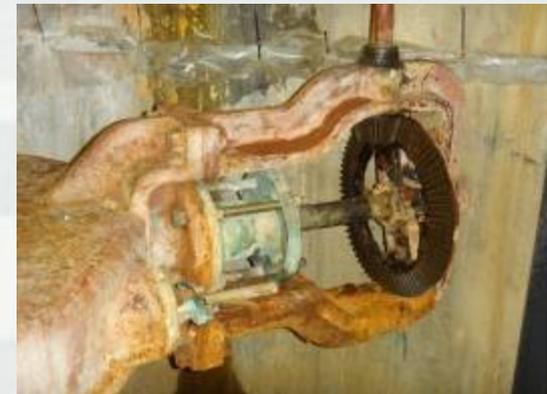
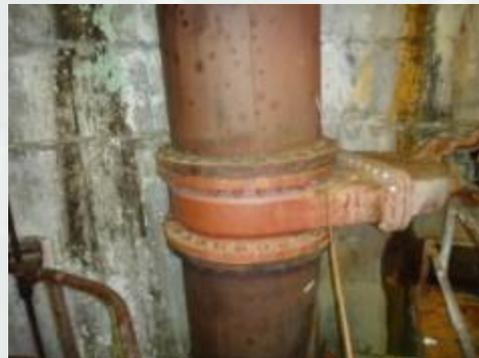
- Four gate valves rehabbed in 1954
- Gate valves close but do not seal

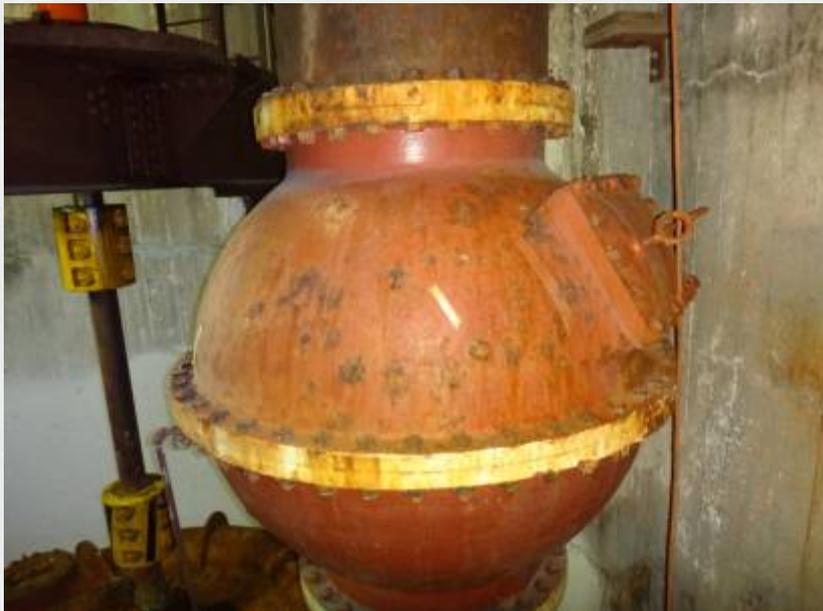
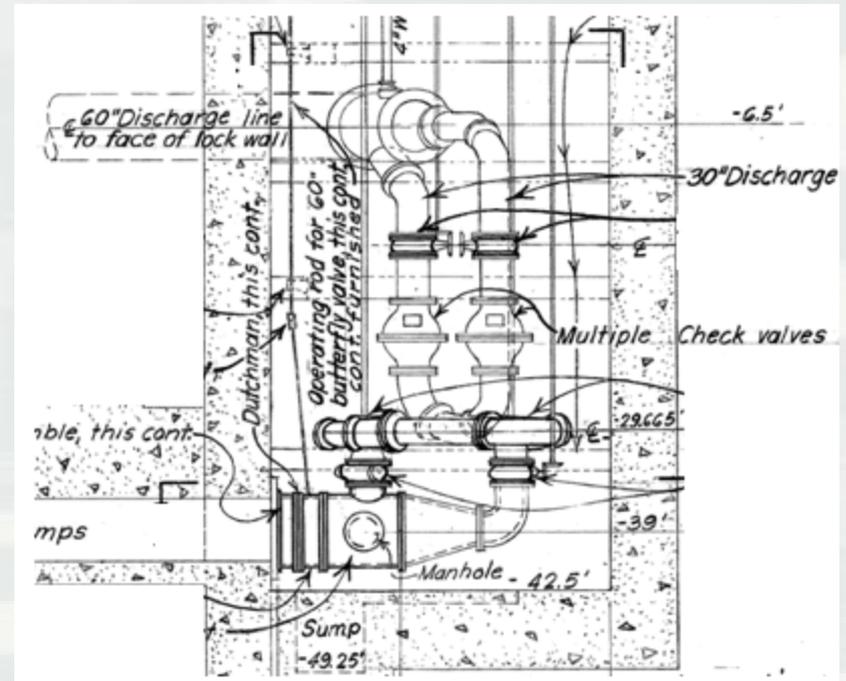
- Both check valves internal parts are completely corroded away

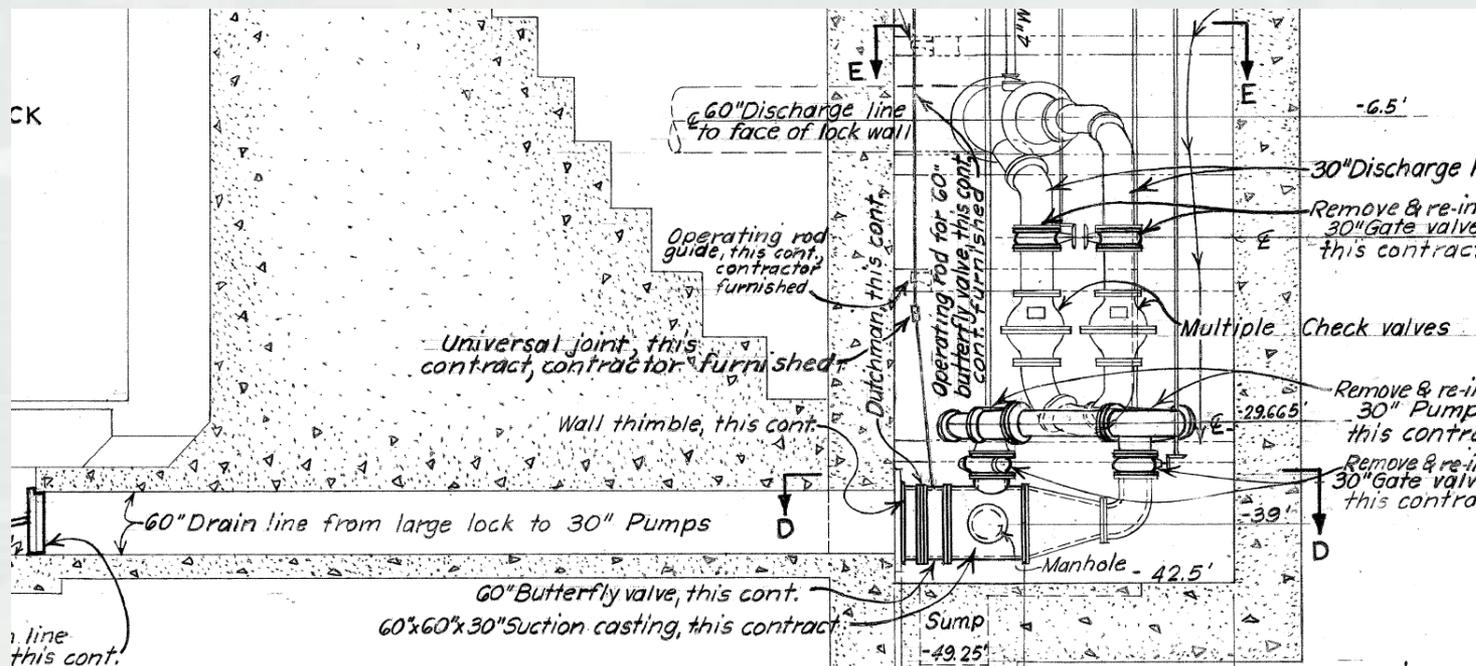
- Check valves are gone. Pump Start up and Shutdown has to be done carefully and valves manually actuated to prevent damage to pumps, shaft, and motors.

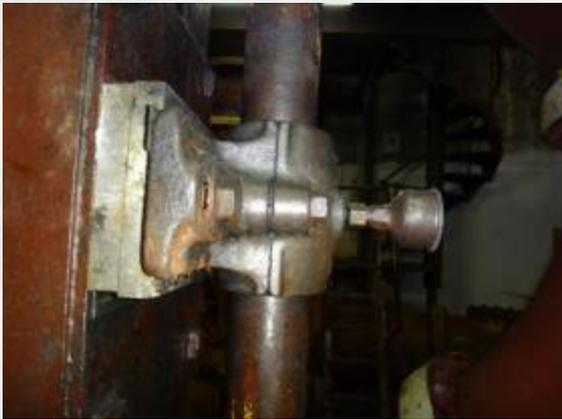
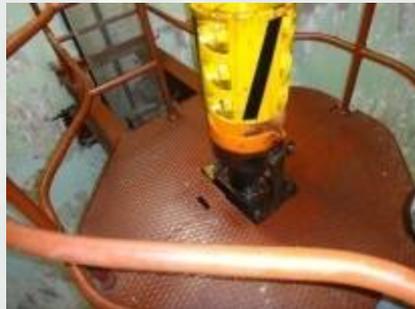
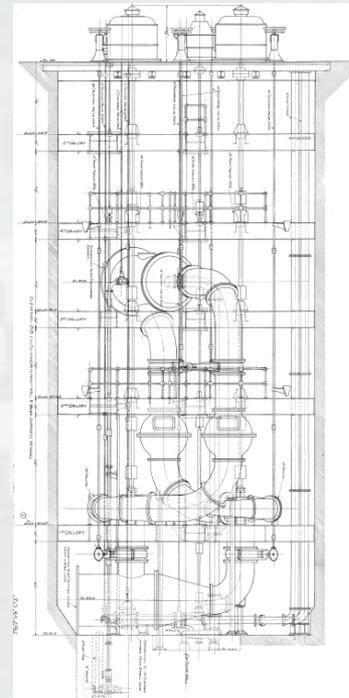
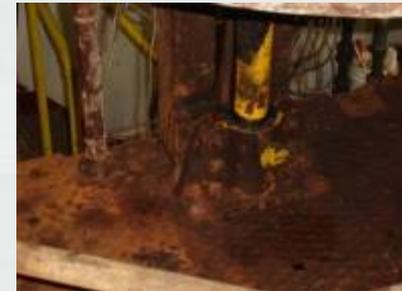
- Grease cups need to be manually turned for babbit bearings on shafts
- Life risk if major failure during operation
