# Meldahl & Greenup Miter Gate and Top anchorage replacement

# Meldahl Miter Gate Replacement

# Greenup Miter Gate Replacement

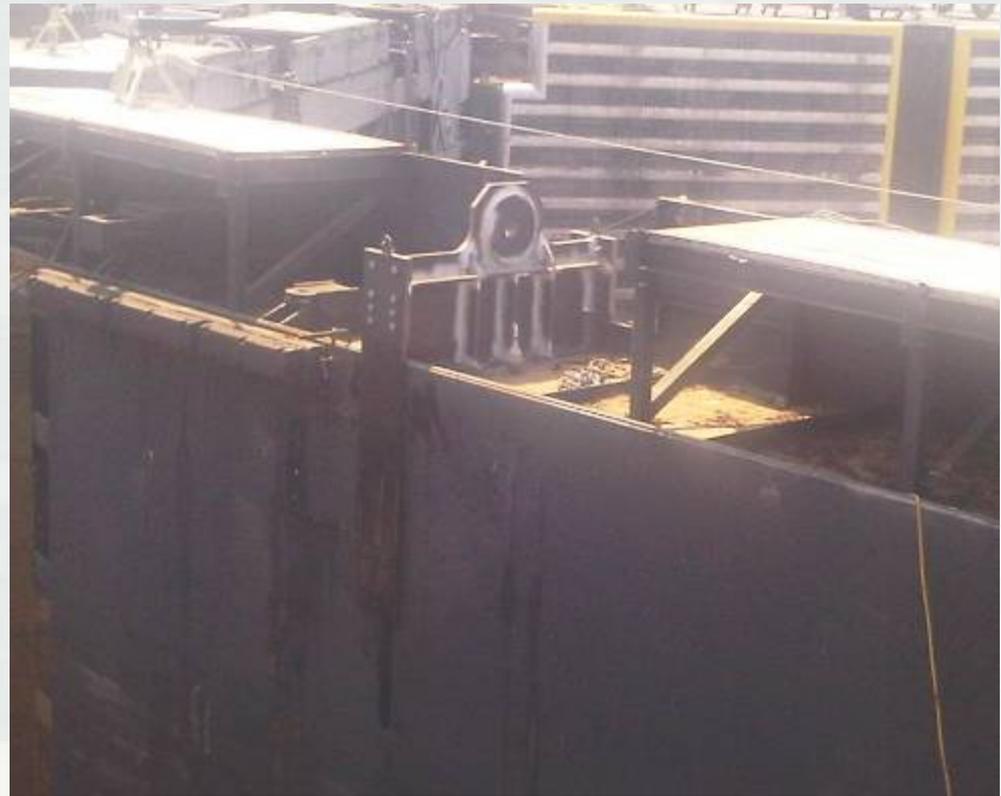
- Lifting Lugs installed on Upper gates
- Upper gates removed and placed on Shreve 9 Sept 2011.
- Transported to scrap facility and offloaded

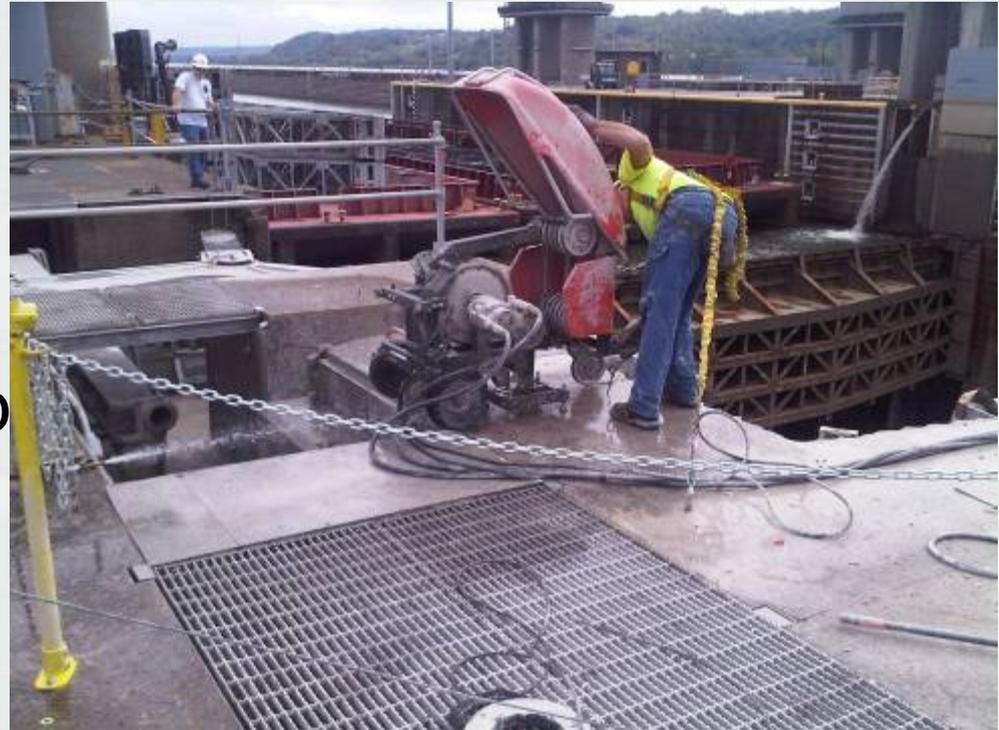
- Concrete cutting contractor on-site 12 September 2011.
- Began removal of top anchorage concrete
- Removal completed 30 Sept 2011

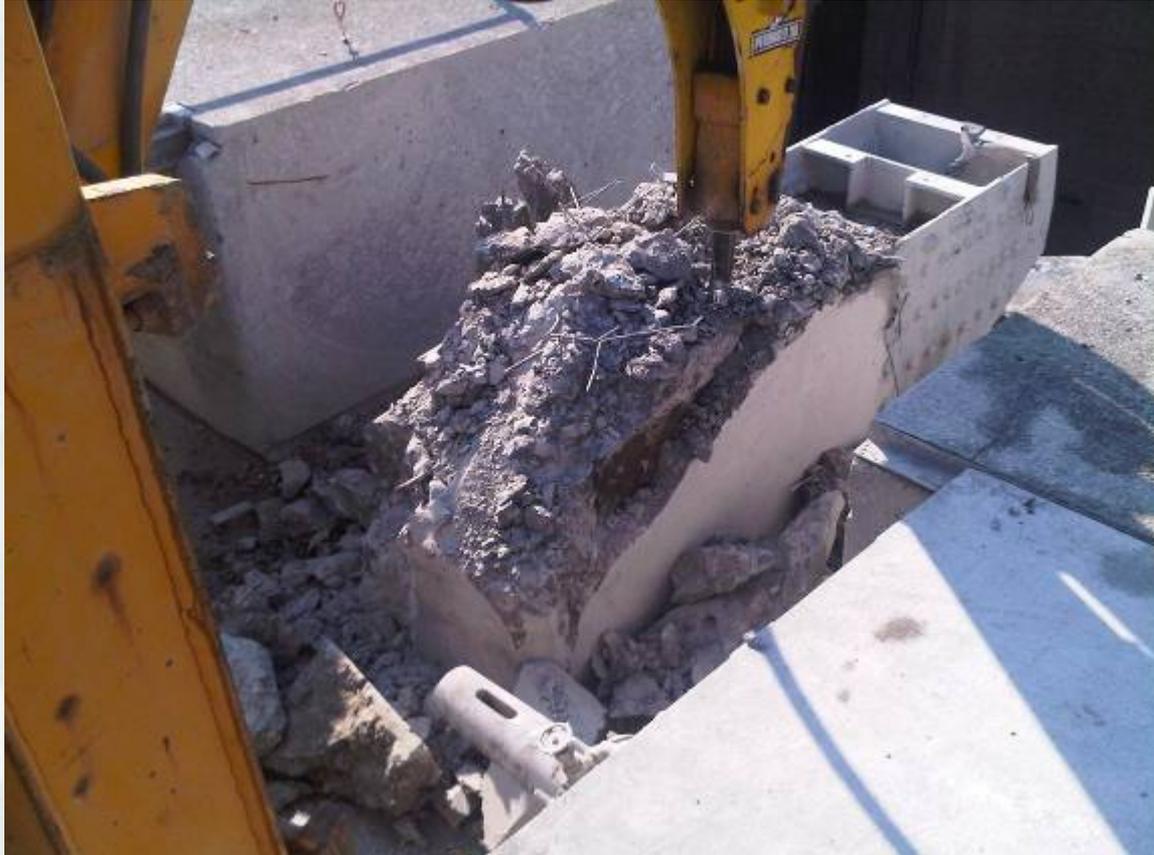
# Removal of Concrete

Concrete removed from embedded anchorage area to expose upper section

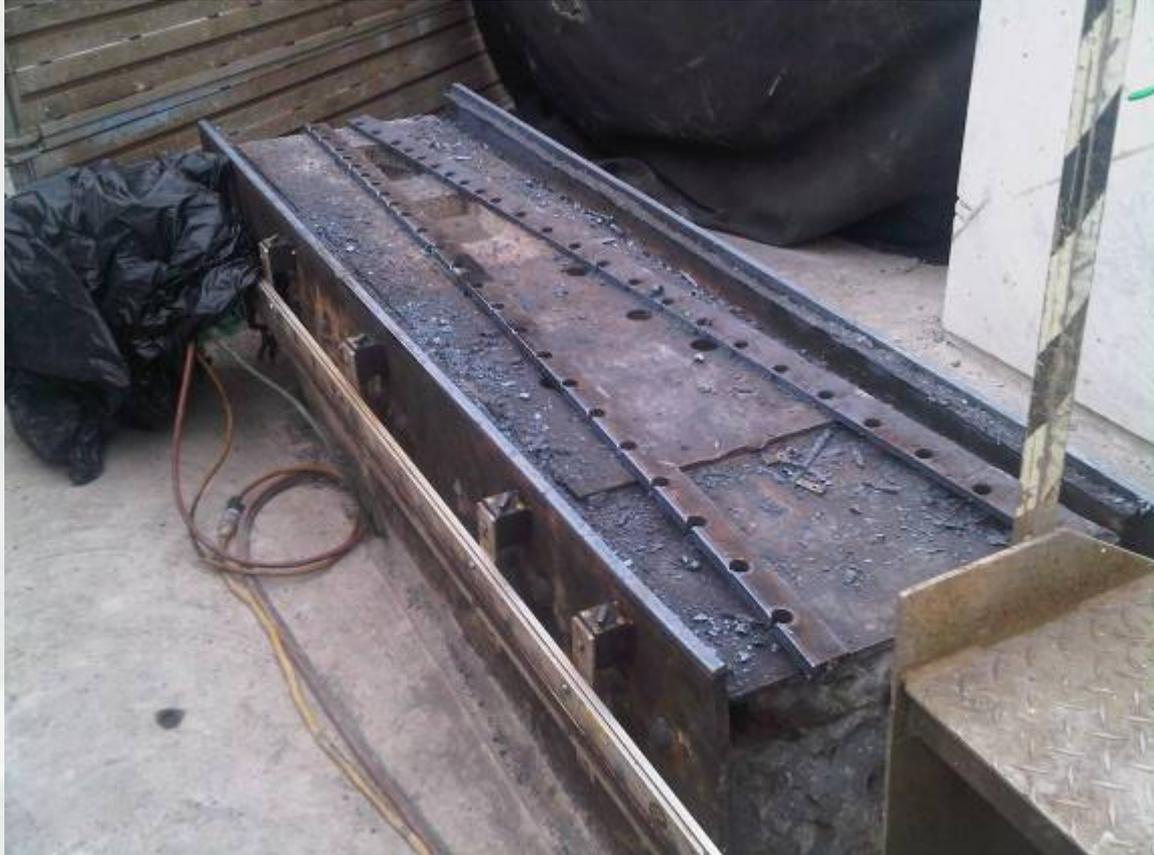
# Top Anchorage

Top Anchorage prepared for addition of new weldment – Top will be milled down to final elevation

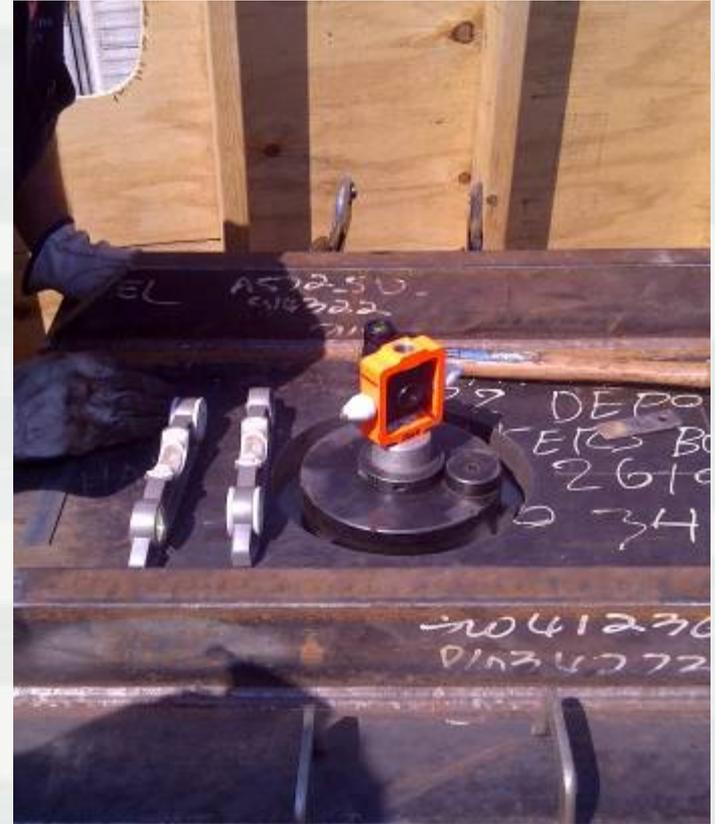
- Top anchorage cut, milled and new weldment installed to accept new top anchorage design
- Surveyed into position
  - ▶ All components installed within a tolerance of +/- 1/4"

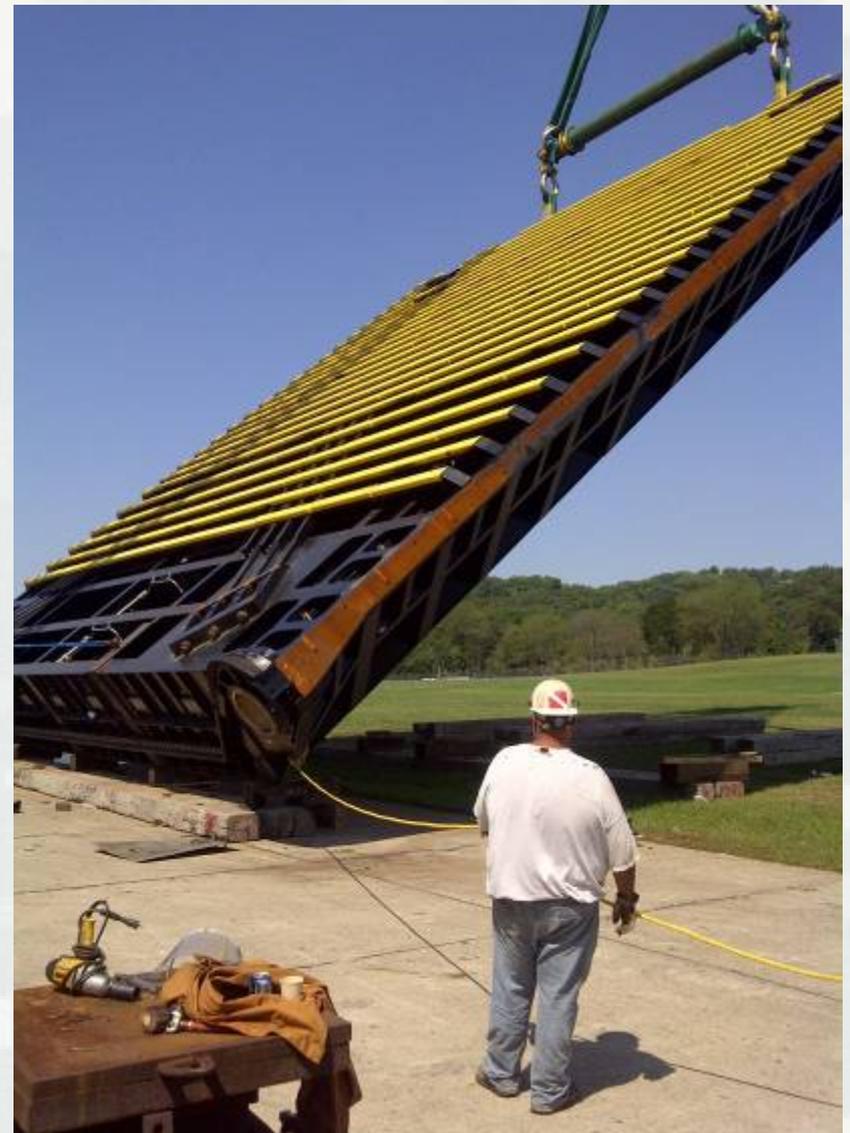
- Small crew sent to CAM to pick-up miter gates
  - ▶ Gates were delivered horizontally
    - Crew set-up cribbing to allow rotation of gates to vertical position

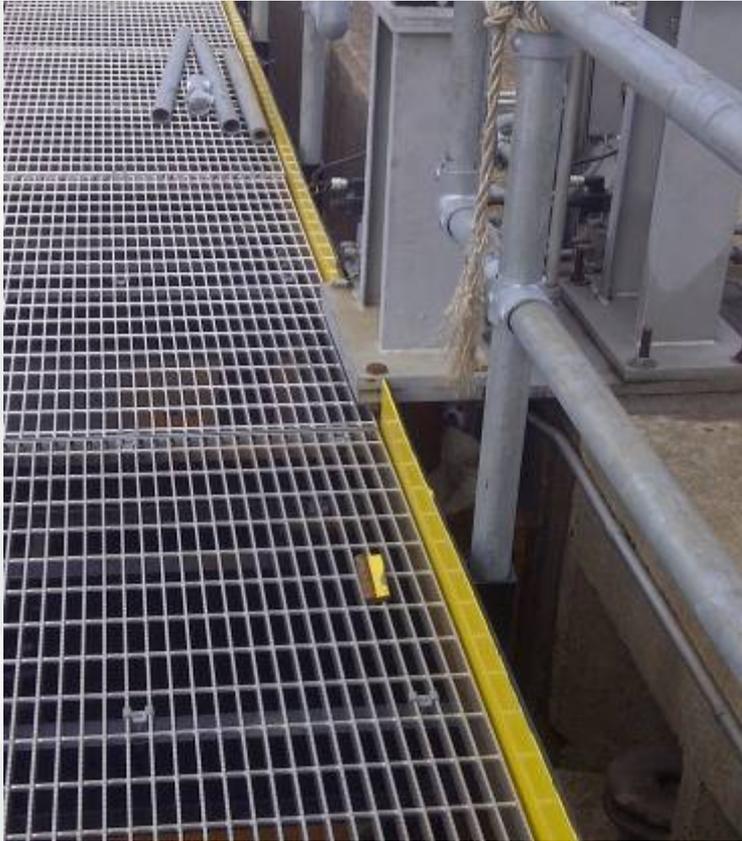
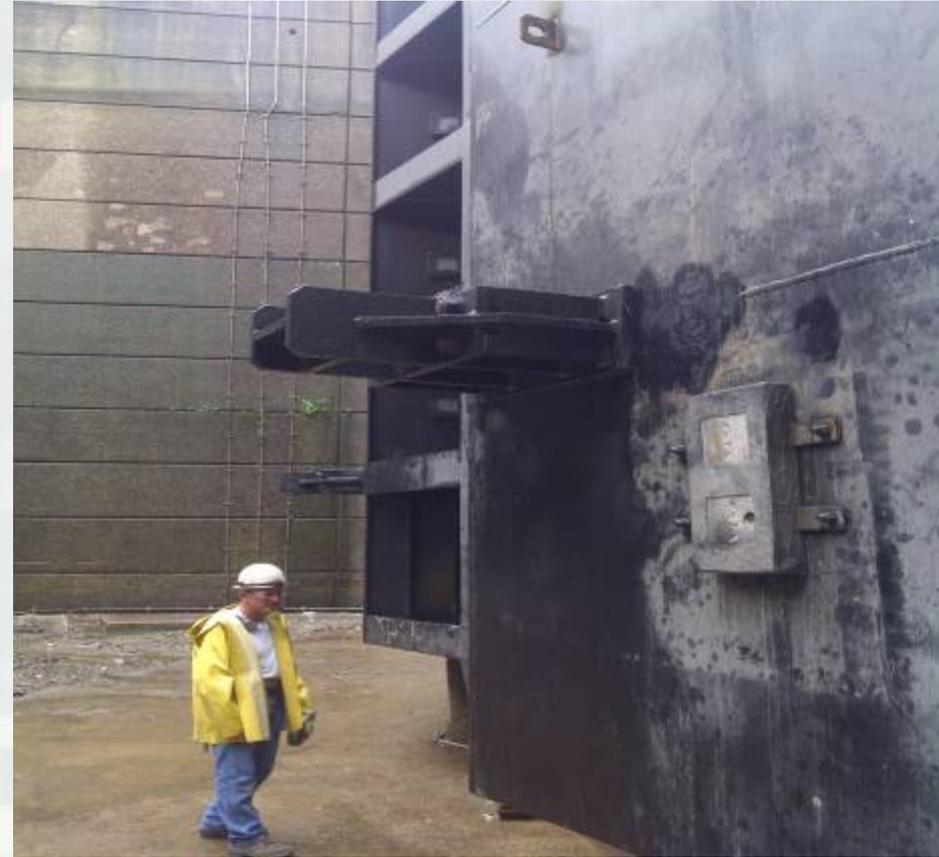
# The OOPS factor:

Upper and lower latching devices were not in the correct location

CAM: Had to be moved approx 8"

GRO: Had to be moved 18"

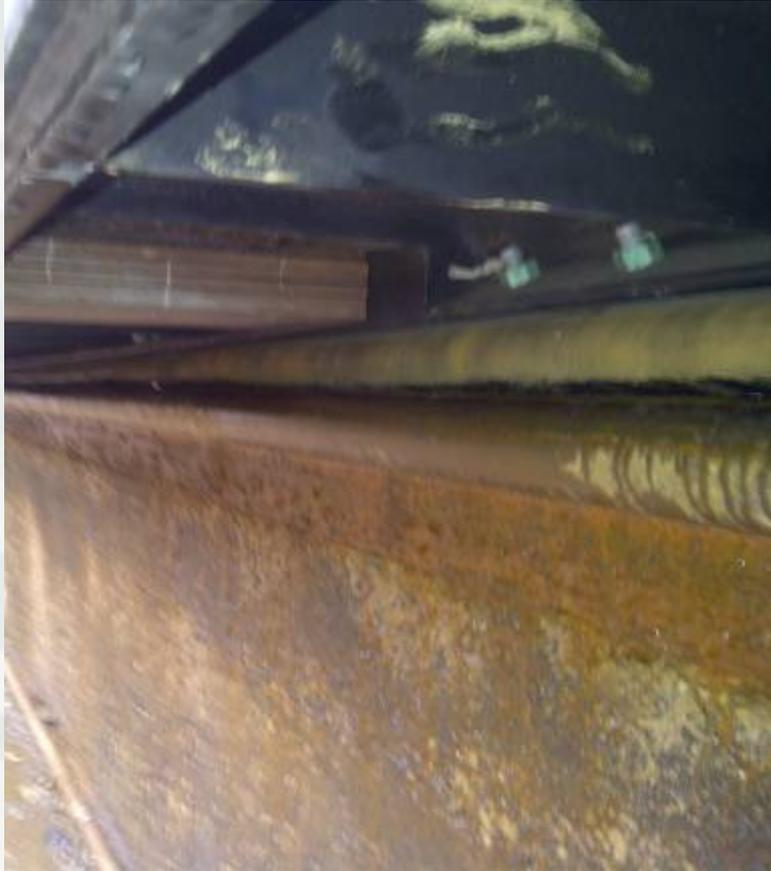
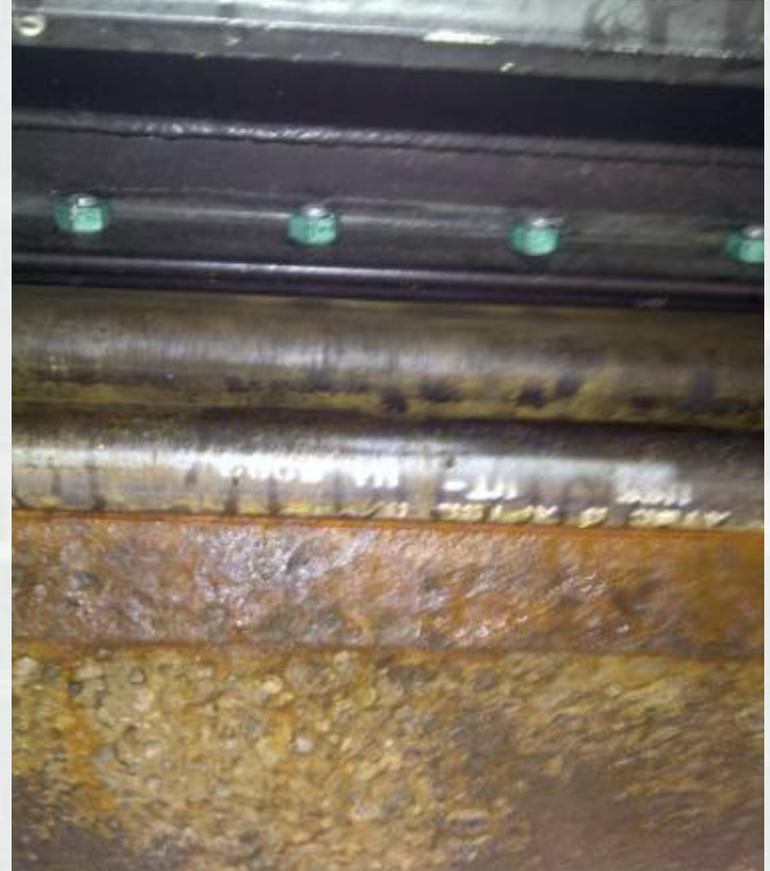
# The OOPS factor

Bottom seal has NO adjustment. GRO embedded sill was actually over 1" higher on the middle wall side. Rubber seal had to be cut to fit.
