# L&D 52 Wicket Sill Dewatering Box & Wicket Sill Replacement

**Keith Fleck**

Louisville District

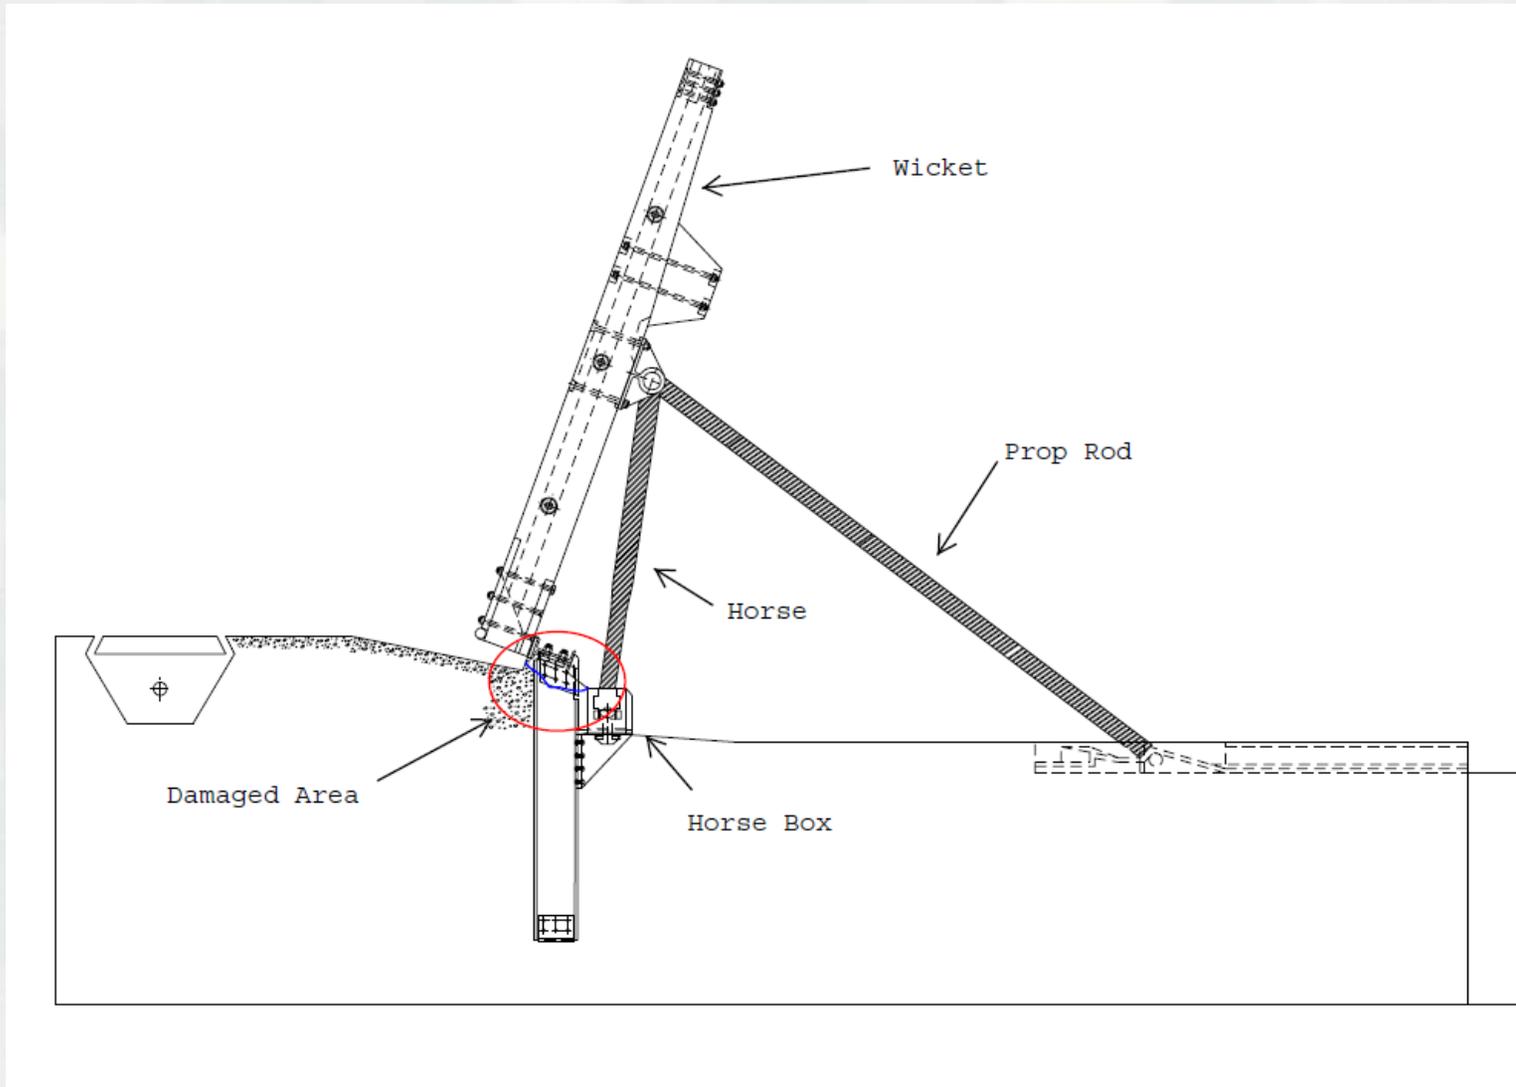
# Locks & Dam 52 Wicket Sill Damage

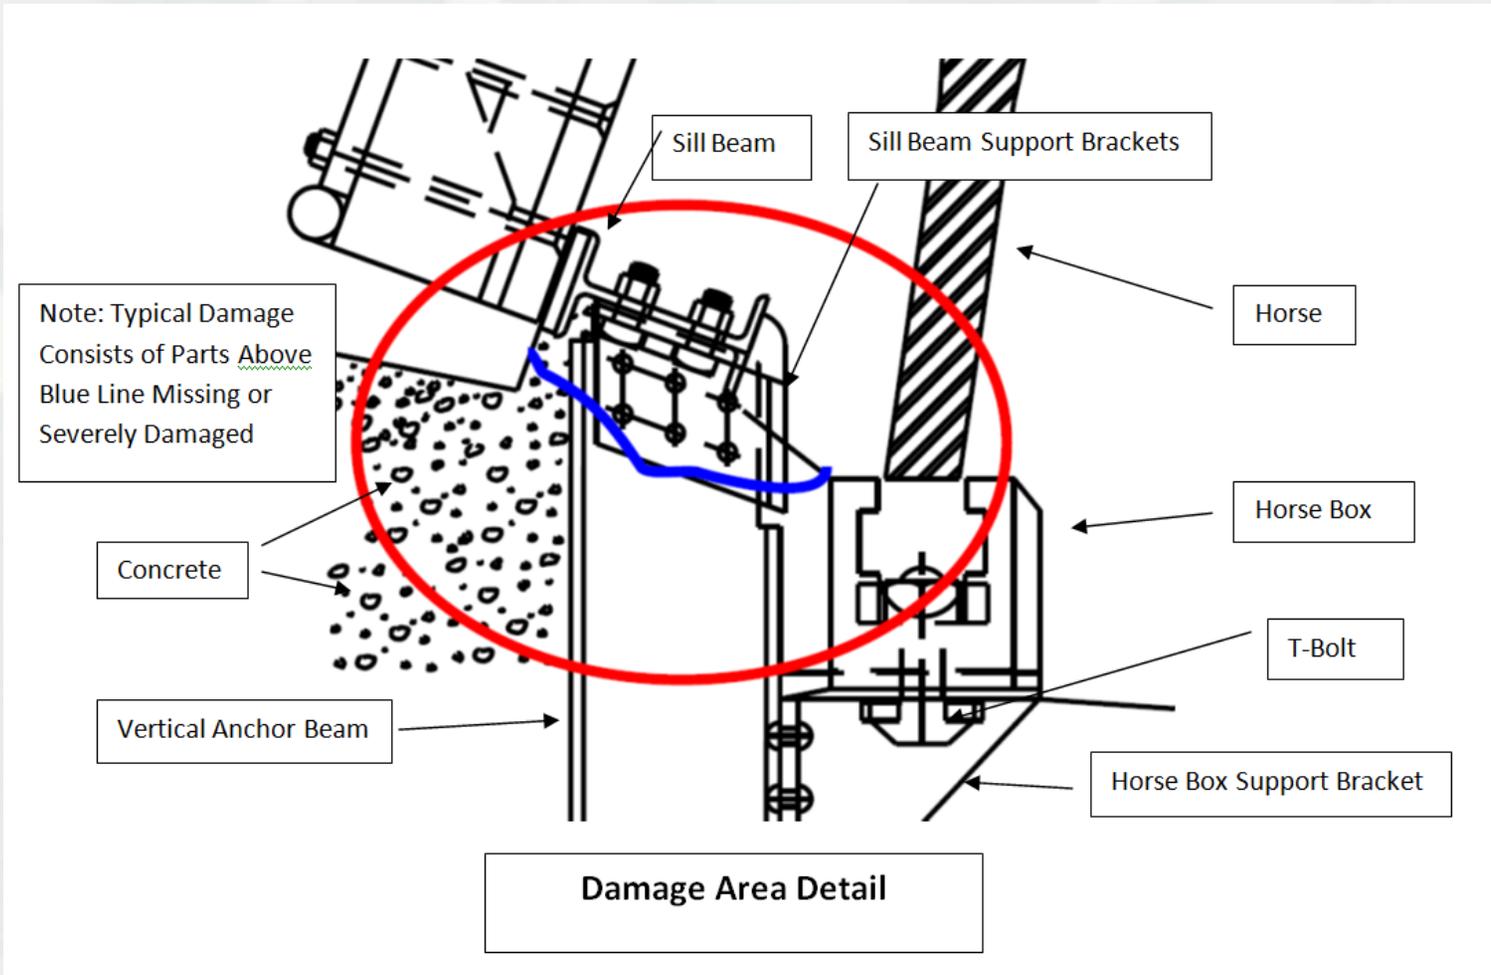
# Locks & Dam 52 Wicket Sill Damage

In some locations on the chanoine weir the wicket travels past the sill and rests on the horse. The t-bolts were not designed for that shear load.

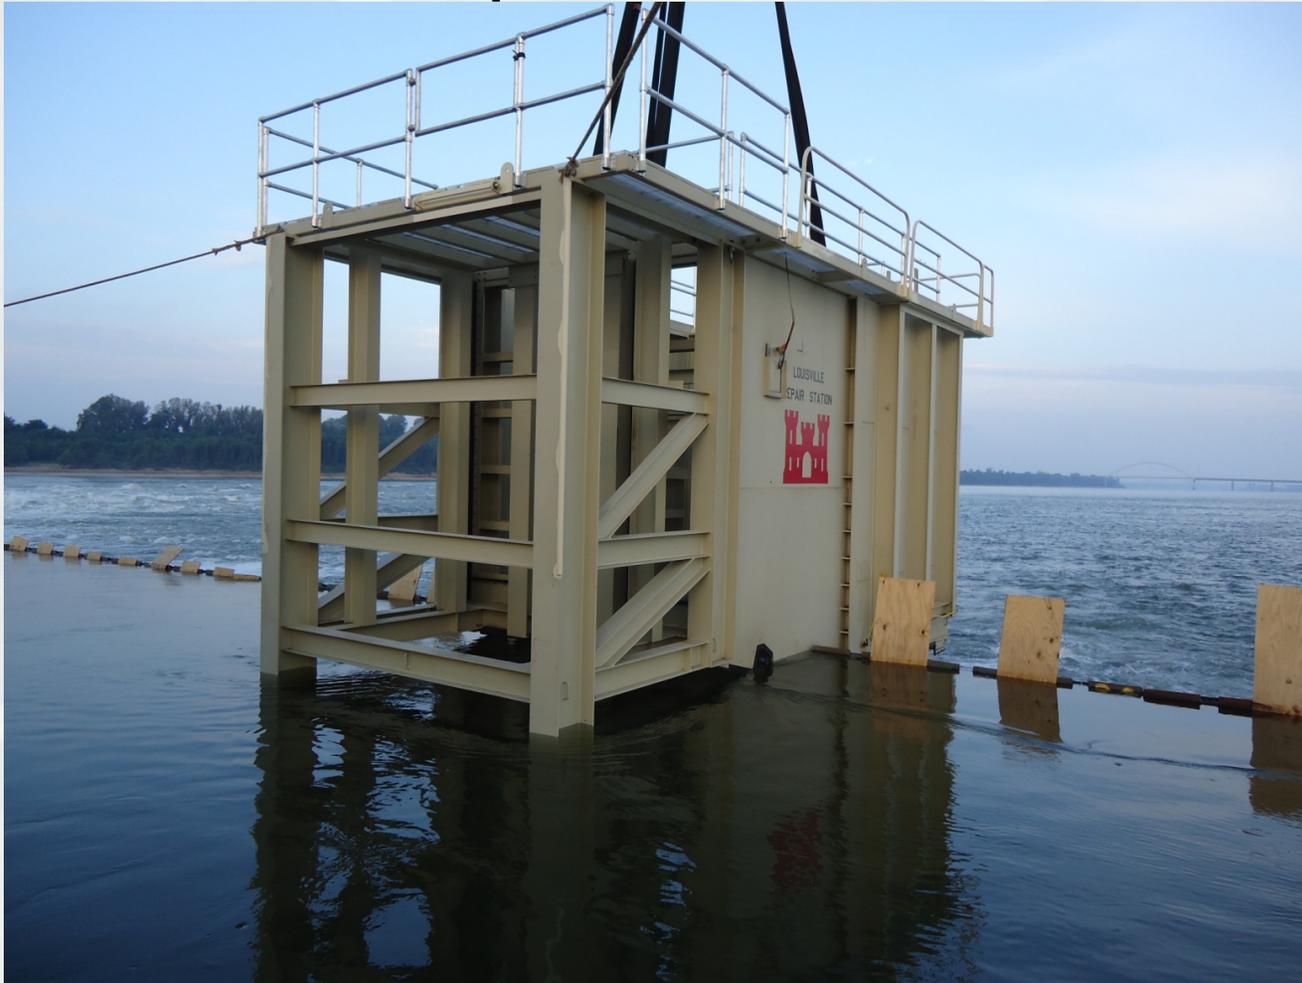
Water conditions did not allow LRS to set the box at the failed sill locations. Other sill problem areas were identified prior to the repair for higher river flow conditions.

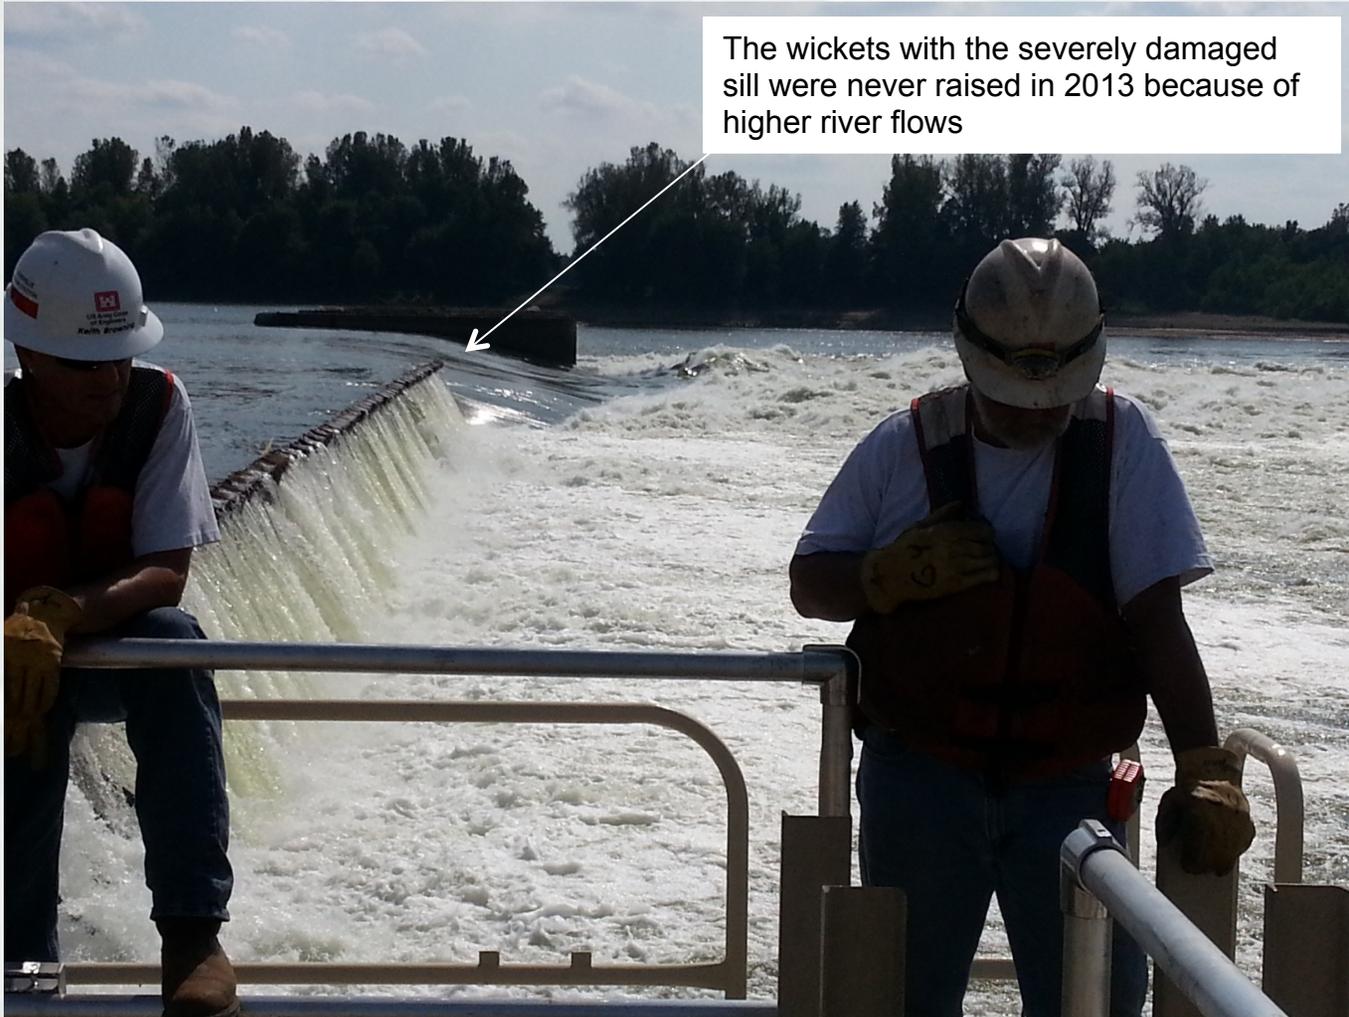
The wickets with the severely damaged sill were never raised in 2013 because of higher river flows

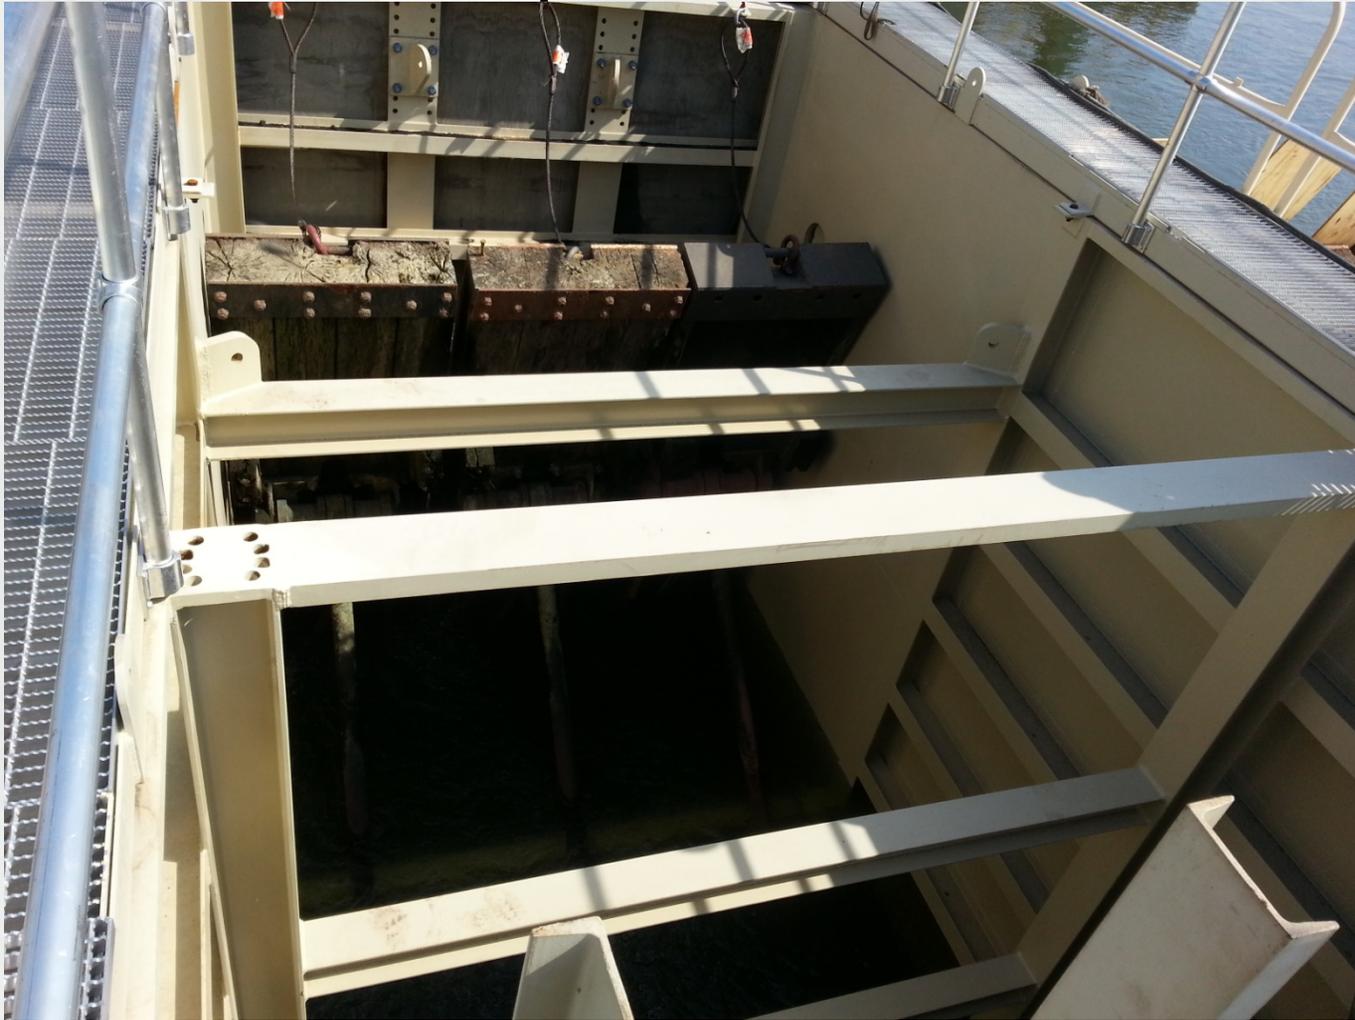
The box is 12 ft. wide, but only the middle 8 ft. of sill can be replaced per setting.

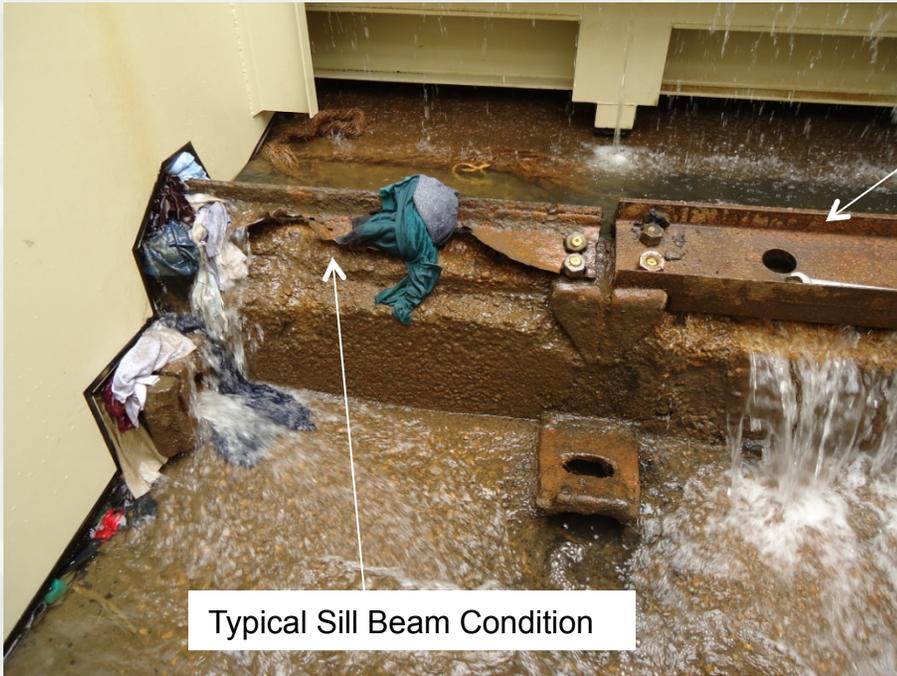
The Horizontal Sill Beam had been replaced by divers

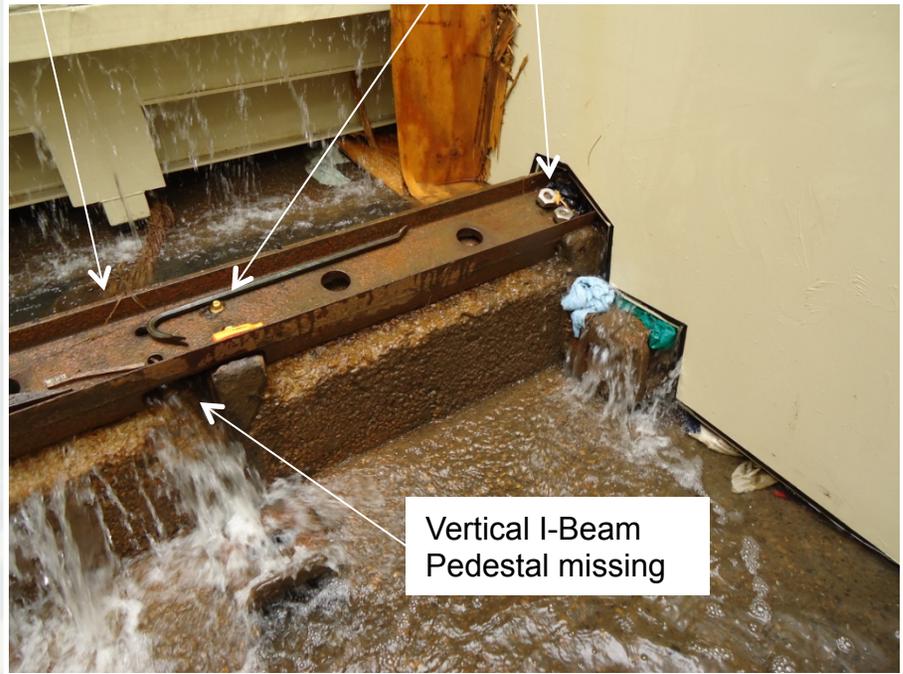
Missing and loose sill nuts.

The horizontal sill beams that have been replaced by divers, usually the nuts are loose or missing because the divers are unable to tighten them due to the deteriorated brass bolts.

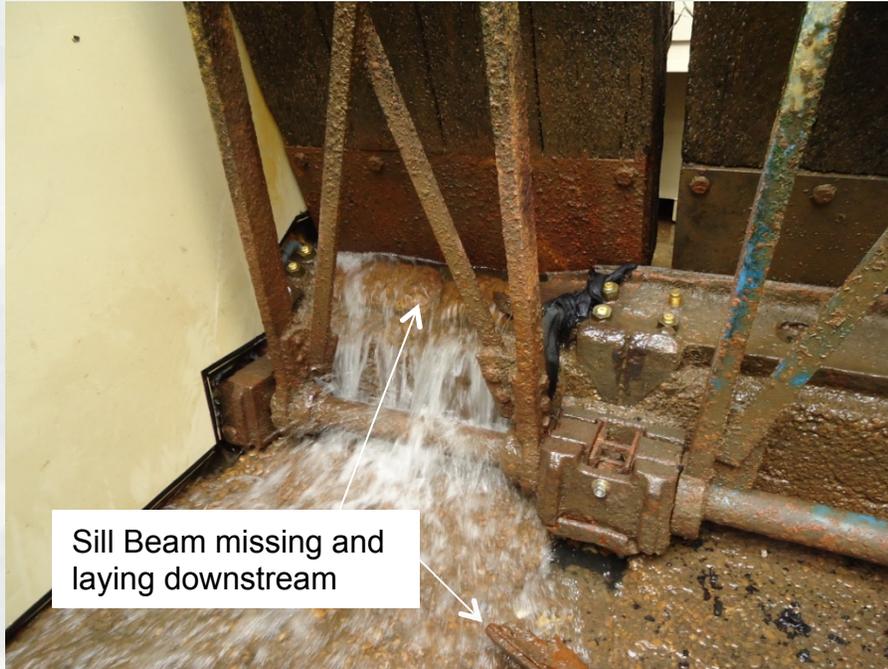
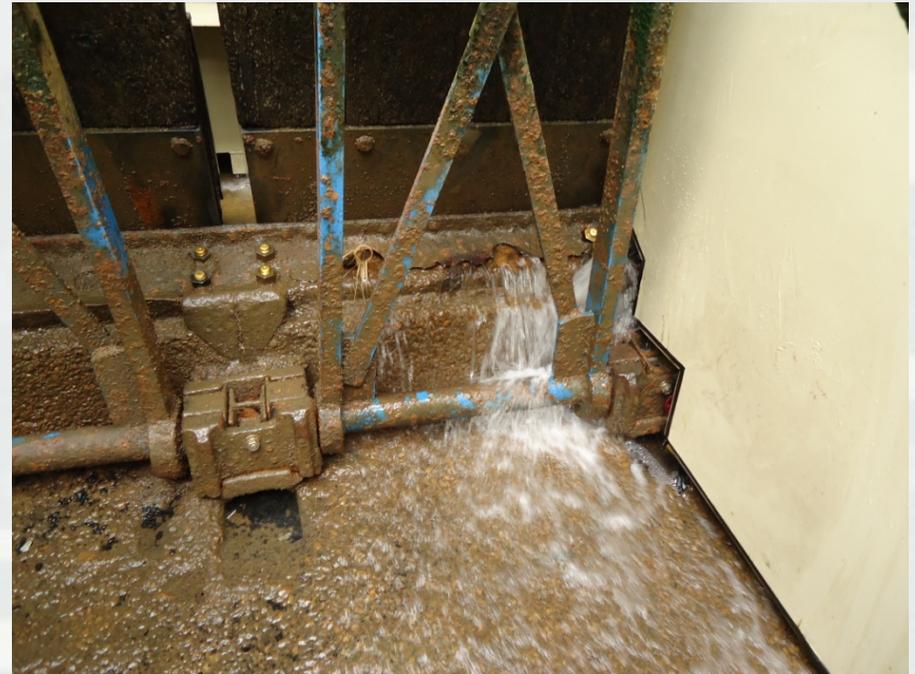
The left wicket was bearing only on the concrete.
