# Winfield Hydraulic Cylinder Replacement

Waylon Humphrey, PE

LRL-Maintenance Section

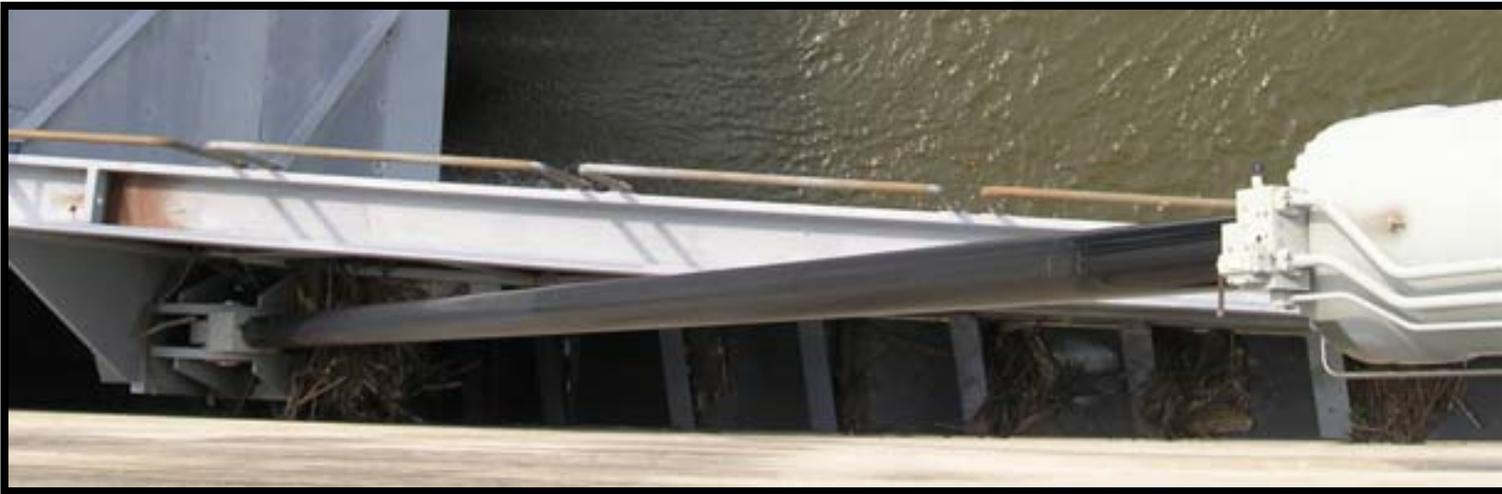
May 2005

- New Lock Chamber/Tainter Gate were commissioned in 1997
- By 2005 ceramic coating was visibly failing

- Corrosion was caused by water penetration through the porous ceramic coating
- Water penetration occurred after the rod lost its coating of hydraulic oil due to never being retracted
- Contributing factors were sunlight and maybe natural bending of the rod
- The rods are not salvageable

- Chrome Plated Stainless Steel Rods
- Ordered by LRH – on site at Winfield

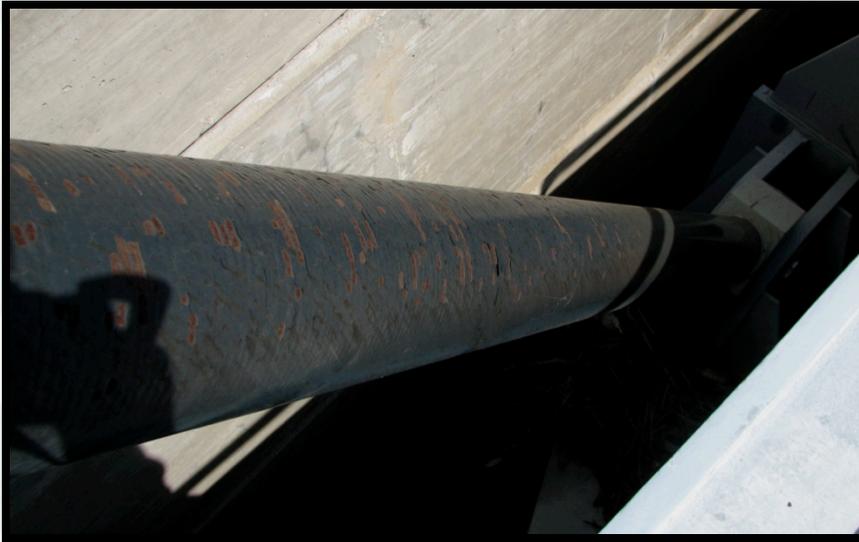
2008

- Failed ceramic coating prevented raising of gate for fear of damaging seals.

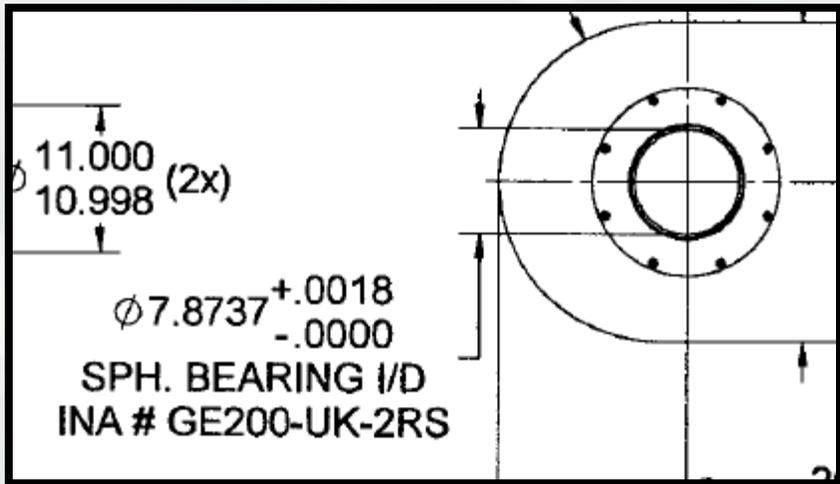
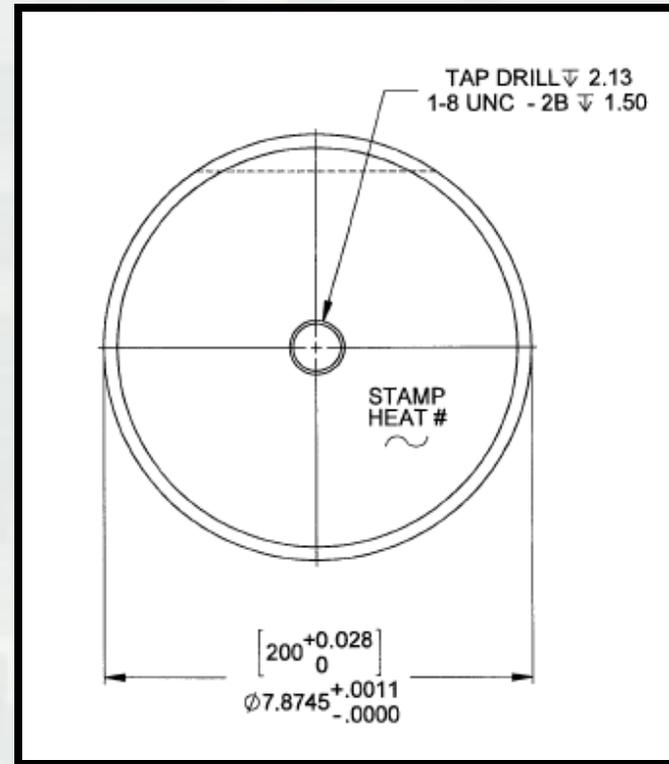
- Largest Clearance  
 Bearing 7.8755" & Pin 7.8745" = +.001"

- Smallest Clearance  
 Bearing 7.8737" & Pin 7.8756" = -.002"

Gate Ear Design 7.876"+.002 vs. Actual 7.872"
