EROSION AT LOCKS ENTRANCE, ISSUES WITH BIVALVE MOLLUSCS PERFORATING EXPOSED WOOD PILES SUPPORTING LOCKS APPROACH WALL

**USACE 2015
Tulsa, Oklahoma**

**Fernando Sucre
Locks Overhaul Engineer**

GATUN LOCKS NORTH ENTRANCE

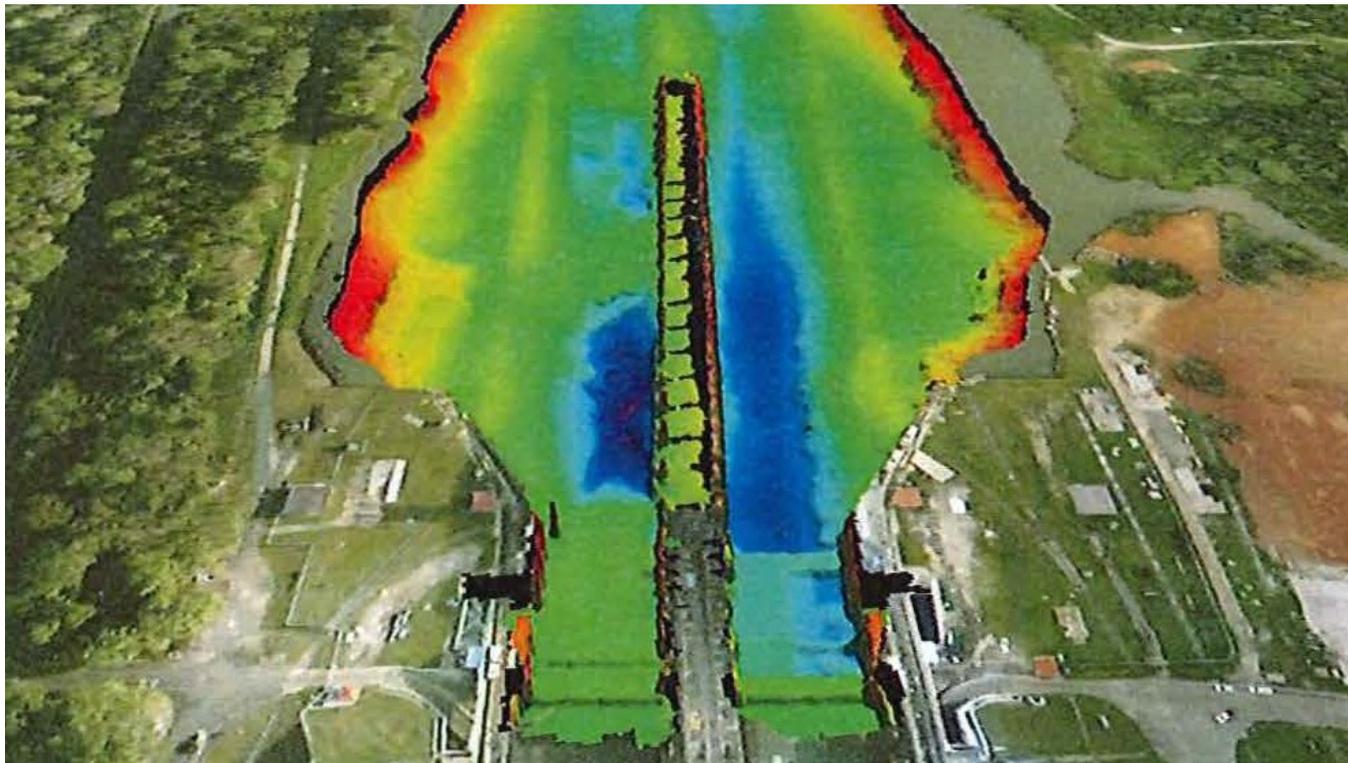
EROSION AT SEAFLOOR, GATUN LOCKS NORTH ENTRANCE

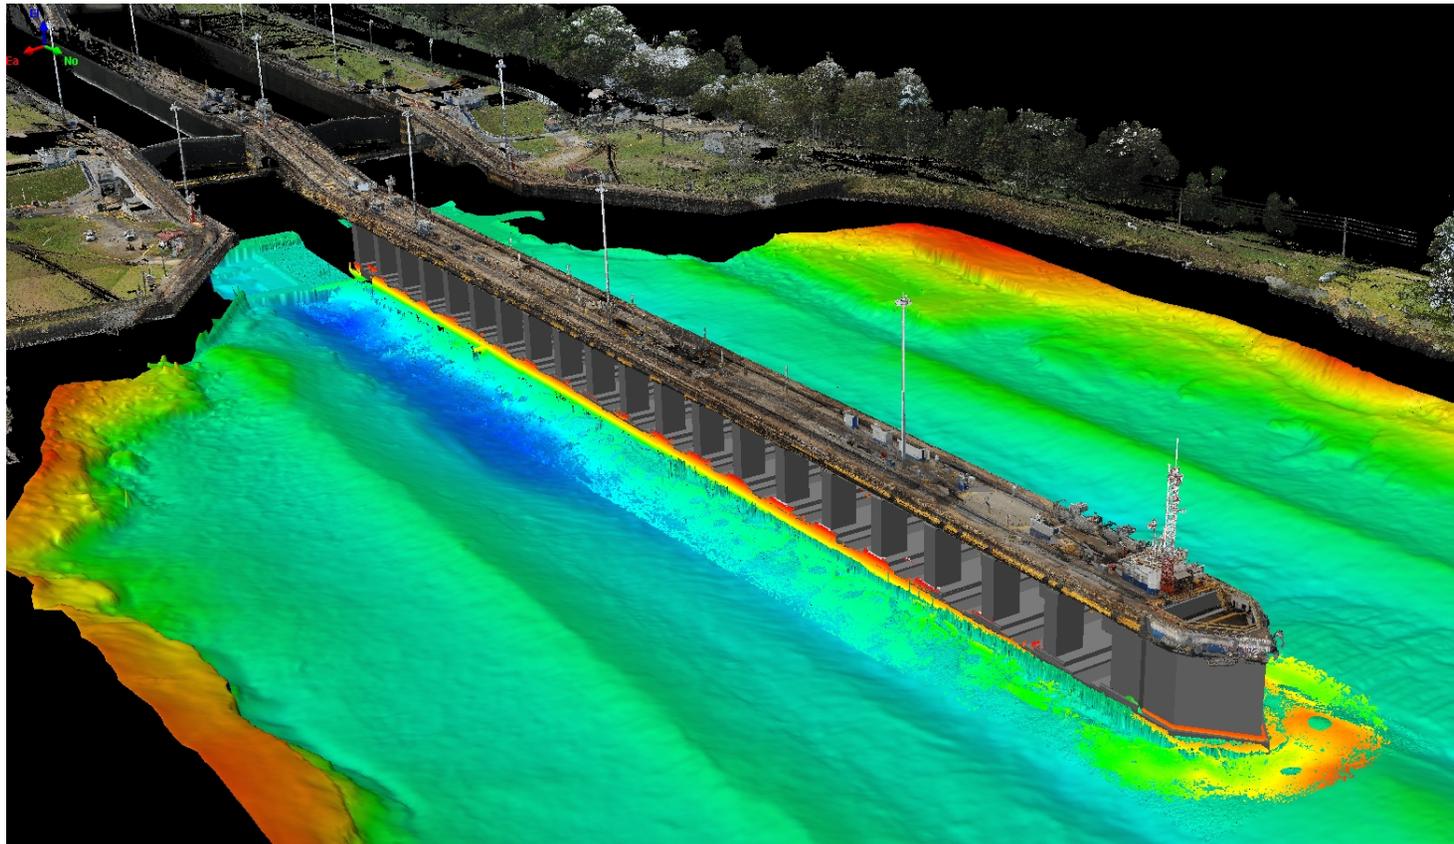
BLUEVIEW SONAR INSPECTIONS

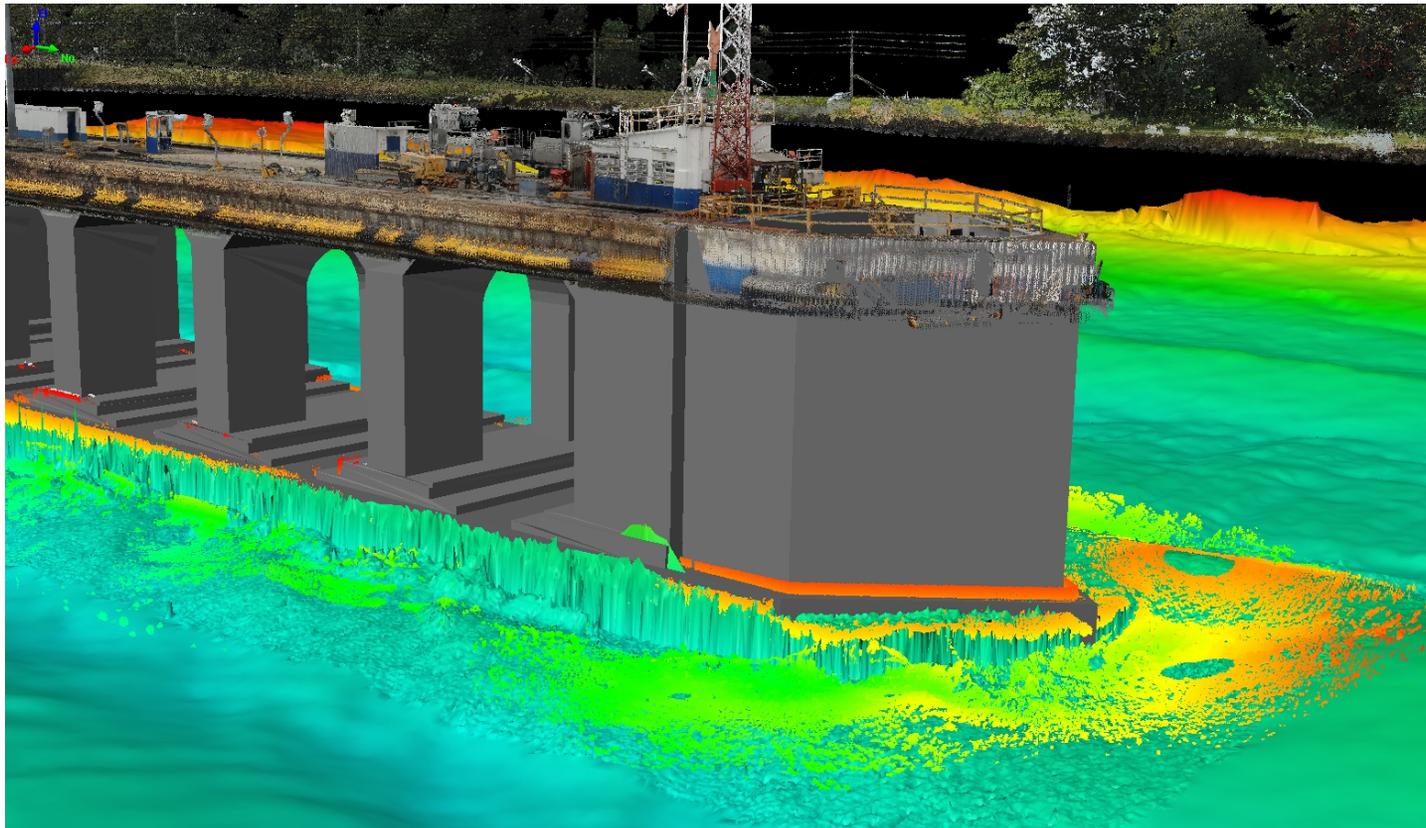
BLUEVIEW SONAR INSPECTIONS

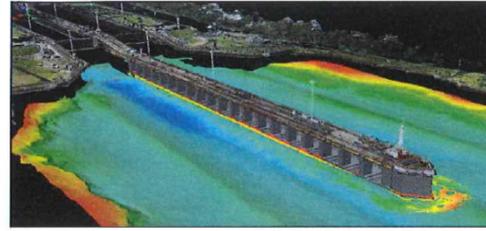
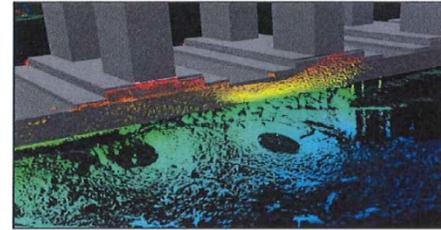
The three dimensional 3D model (above right) is a combination of 2013 ACP multibeam swath data, 2014 Blueview sonar scan data and Riegl terrestrial laser scanner surveys all georeference horizontally to NAD27 and vertically to Panamanian Precise Level Datum (PLD).

The above ACP artist's rendition of the support pile and guidwall illustrates the function of the support piles. The center photograph illustrates the condition of the 100 year old support piles. The combination of ACP bathymetry, Arc Blueview and laser scan data illustrates the bottom of the guidwall slab, the seafloor, debris on the seafloor and sheet piling at the southwest end of the guidwall.

The purpose of this survey was to locate and quantify void areas around and under the perimeter of the north guidwall. In addition to identifying the void areas Arc is providing visual sonar images of the seafloor, broken and deteriorated piling and where possible the bottom surface of the guidwall slab. As built drawings of the 100 year old structure were not available. Therefore, in order to accurately survey and map the project, Arc laser scanned the guidwall utilizing horizontal and vertical control ARC-1 North 1025727.636 East 618491.173 Elevation 4.024 PLD and ARC-2 North 1025642.932 East 618454.829 Elevation 4.399 PLD furnished by ACP surveyors. By laser scanning the guidwall Arc is able to provide georeferenced models and maps suitable for use on other ACP projects.

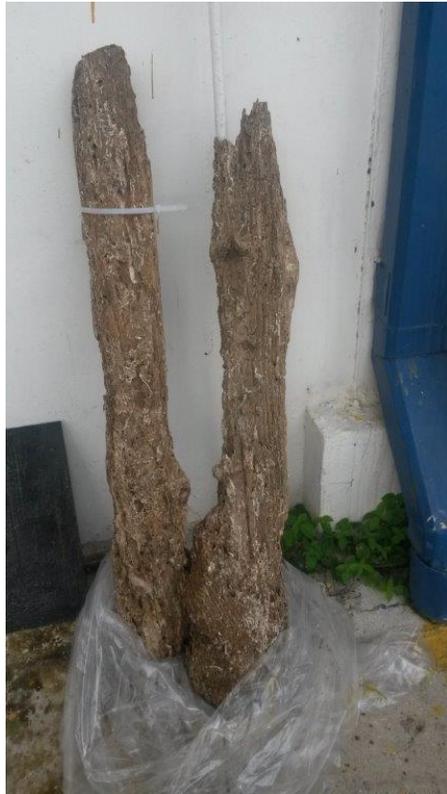
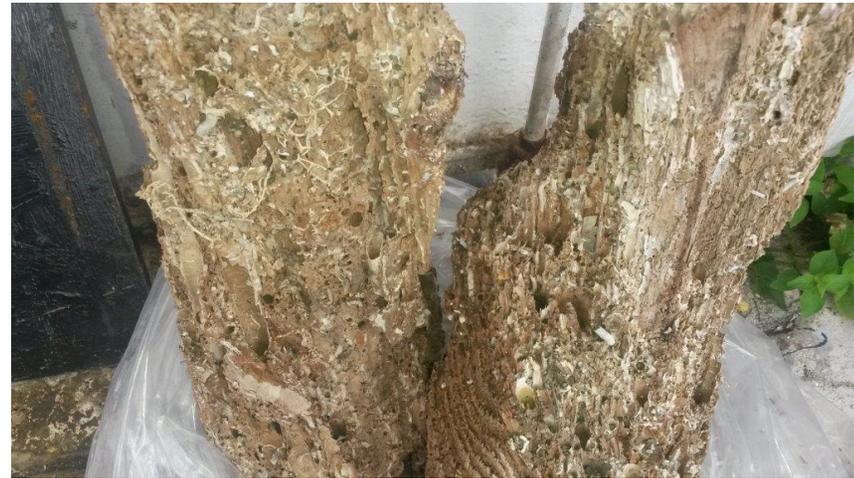
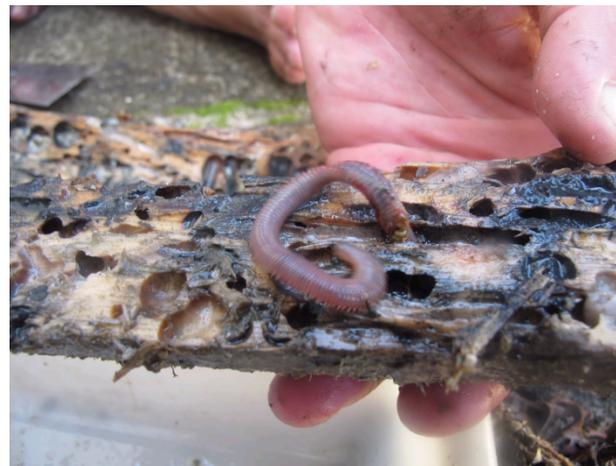
WOOD PILES RETRIEVED BY LOCKS DIVERS

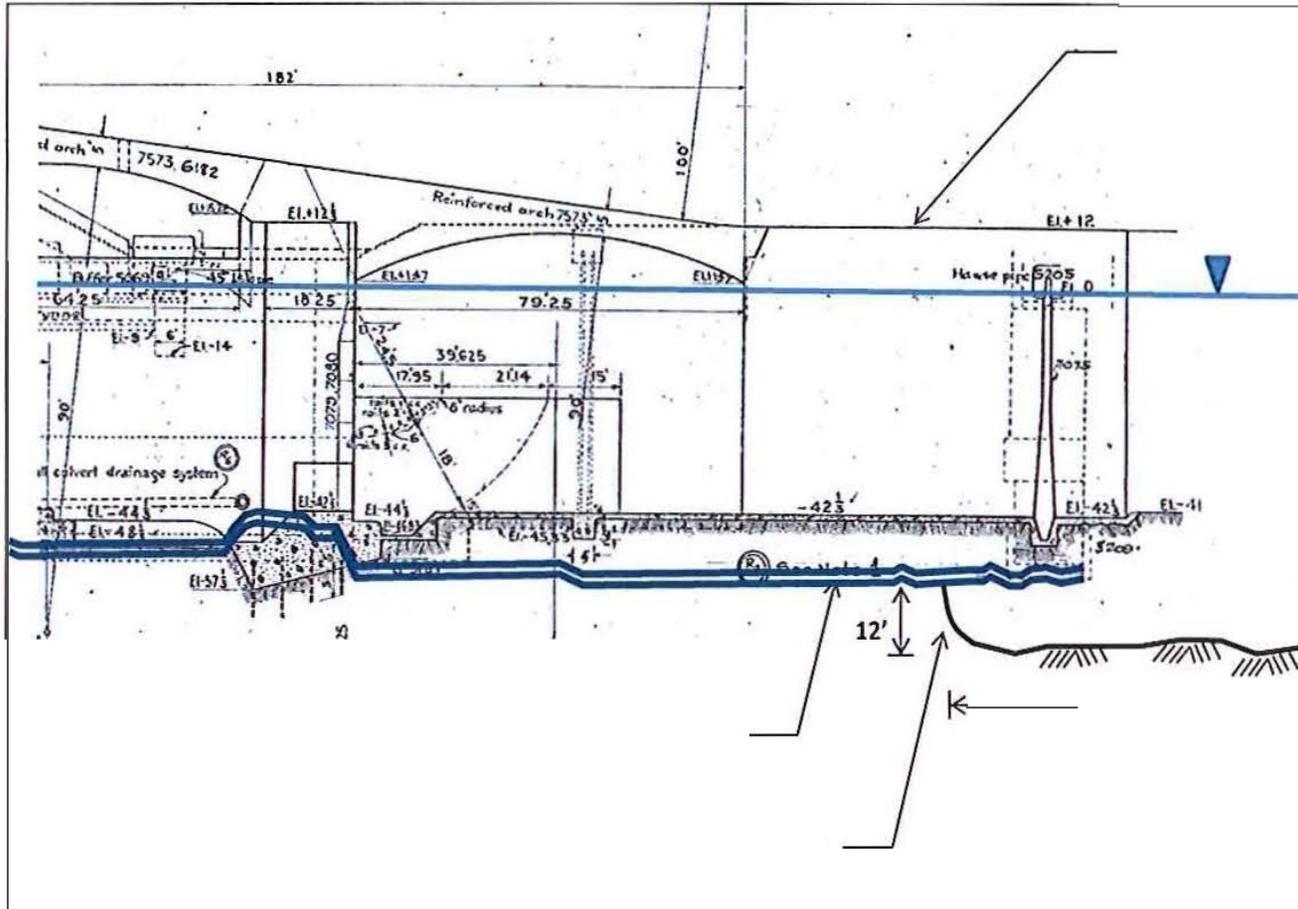
EROSION UNDER CONCRETE SLAB
