Composite Materials for Steel H-Pile Bridge Repair

Lock Maintenance Workshop

10 Feb 2015

East Fork Bridge

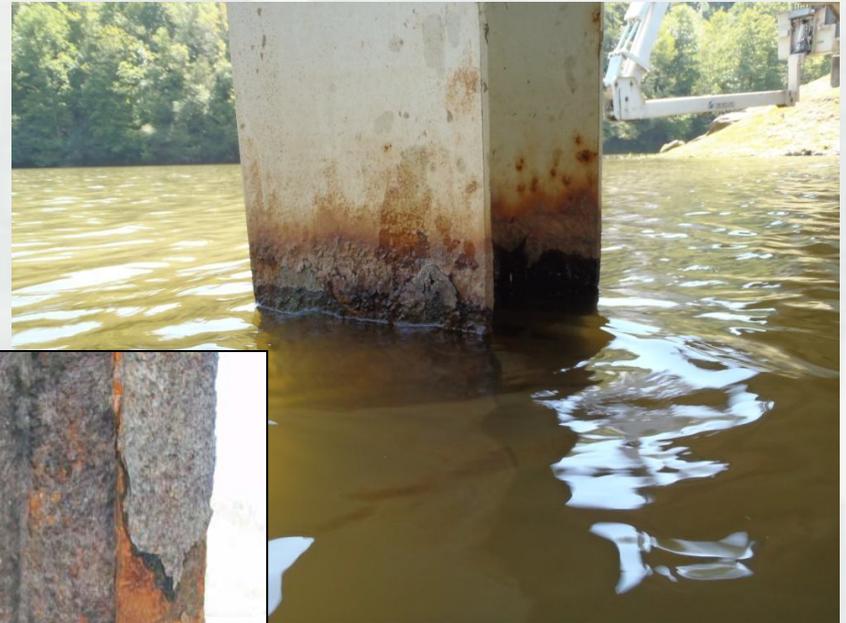
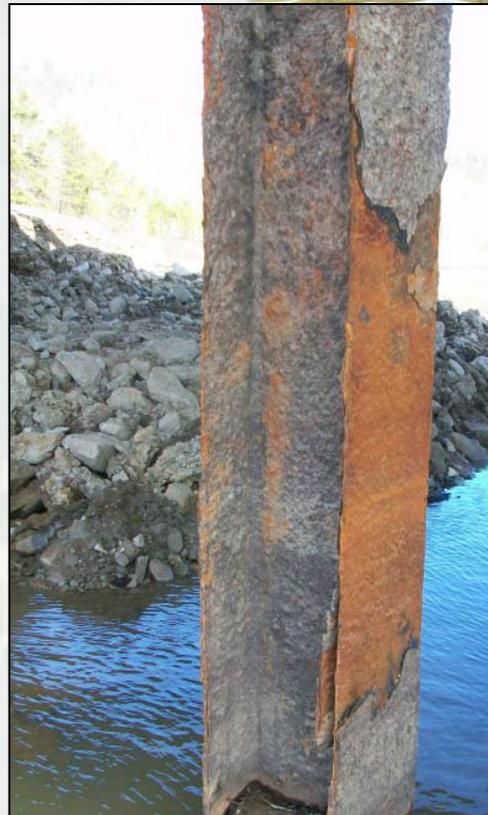
Problem

- **Active Corrosion – 2005 biennial inspection**
- **By 2009, corrosion progressed**
 - ▶ **Began 5' 6" below concrete cap**
 - ▶ **Extended 1' to 2' below winter pool line to mud line**
 - ▶ **4/16" loss of 7/16" flange**

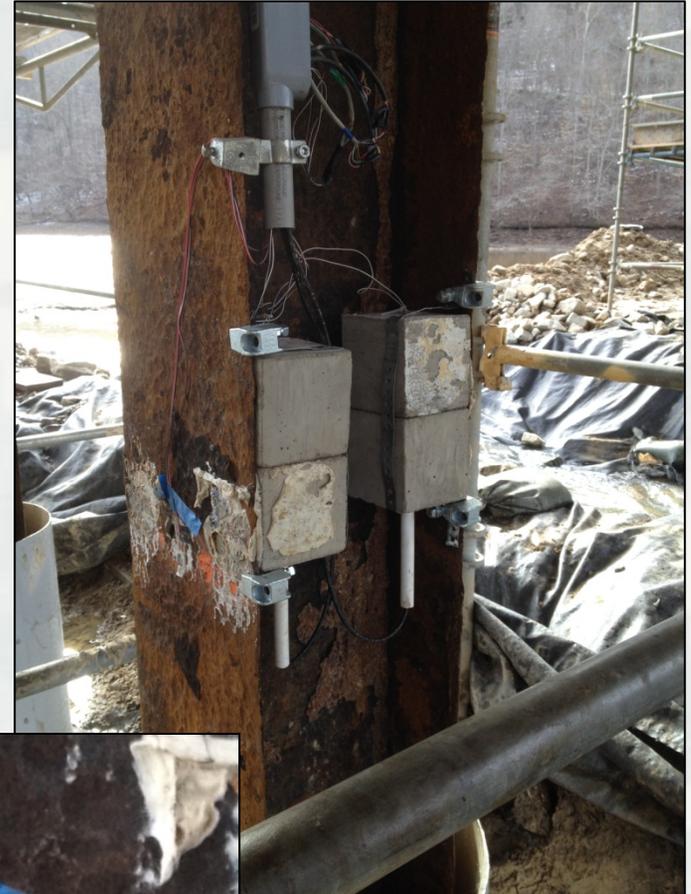
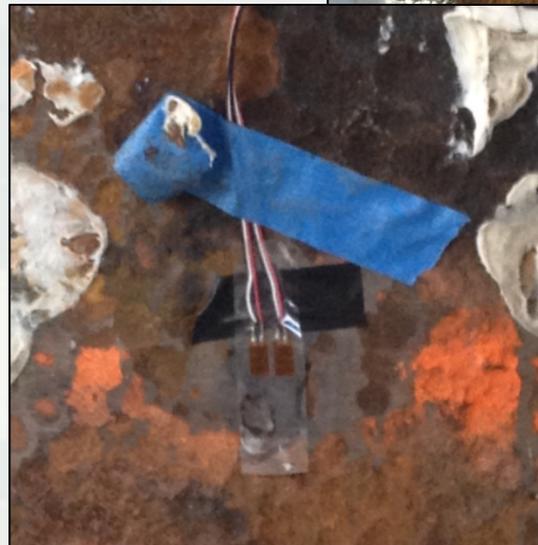
Sensors

- **Corrosion**
 - ▶ Two (2" X 2") steel plates imbedded 2" apart in a 3" X 3" concrete block
- **Temperature & Humidity**
 - ▶ 2 Sensirion SHT1x embedded in 3" x 3" concrete block
- **Strain Gauges**
 - ▶ **Beam**
 - 2 Vishay w/ 1/4" length to measure axial strain of pile
 - ▶ **FRP Wrap**
 - 2 Vishay w/ 1/4" length to measure axial and hoop strain of wrap
 - ▶ **Concrete**
 - 2 Vishay w/ 4" length to mounted to bottom of concrete pile cap

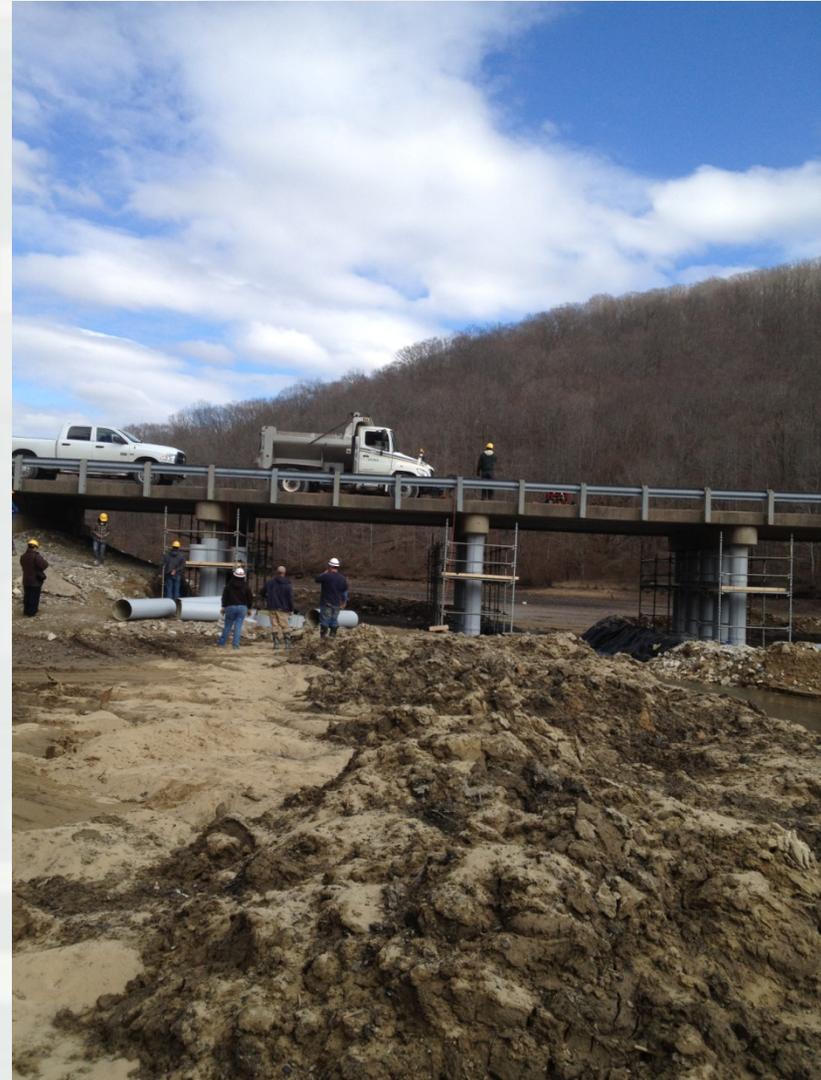
Load Test

- **Load Test Conducted with 19 ton WV DOT truck**
- **Decreased beam stress by a factor of 10 from pre-repair levels while using twice the load**
- **Increased load capacity 2.2 times original design load capacity**
