# Mississippi Valley Division Rock Island District Illinois Waterway Project

T.J. Obrien Lock  
Dewatering 2014-15

# Project Overview

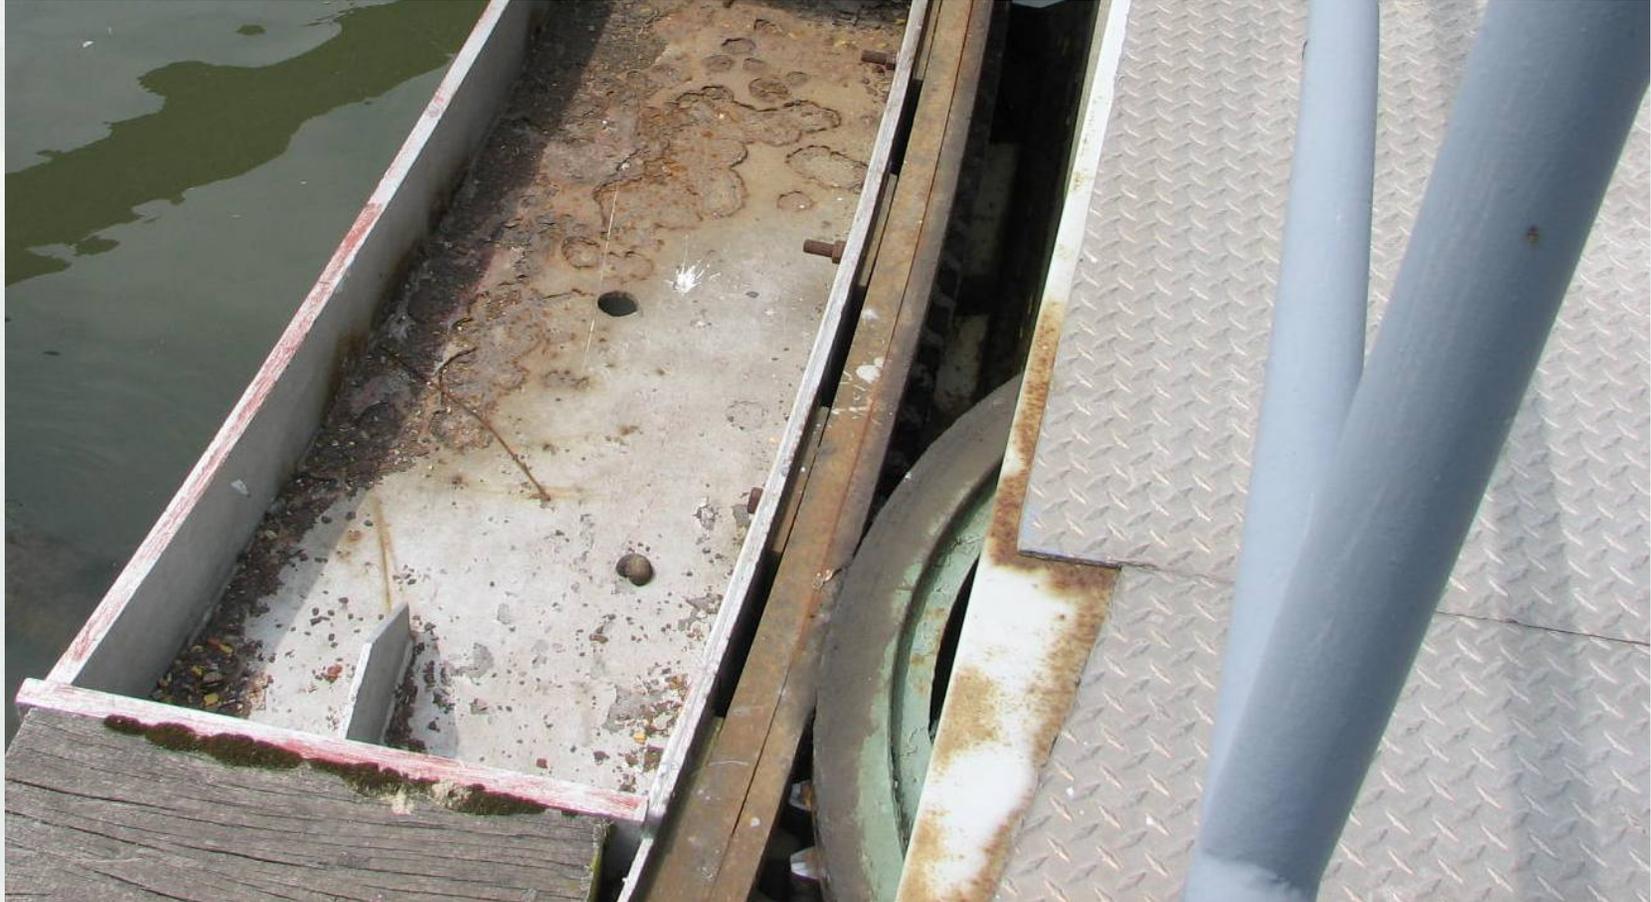
- In 2011, Lock Staff identified an issue with interference between the sector gate bull gear which opens and closes the gates and the gear track it drives which is attached to the skin plate. The top surface of the bull gear was getting contacted by the top rack bar rail on the gate causing abnormal wear on the bull gear

# Bull Gear to Rack Gear Interference

- In early 2011, our Structures Maintenance Unit removed the top rail on both lower gates to alleviate the pressure being put on the bull gear and a plan was formulated to determine the root cause of the misalignment

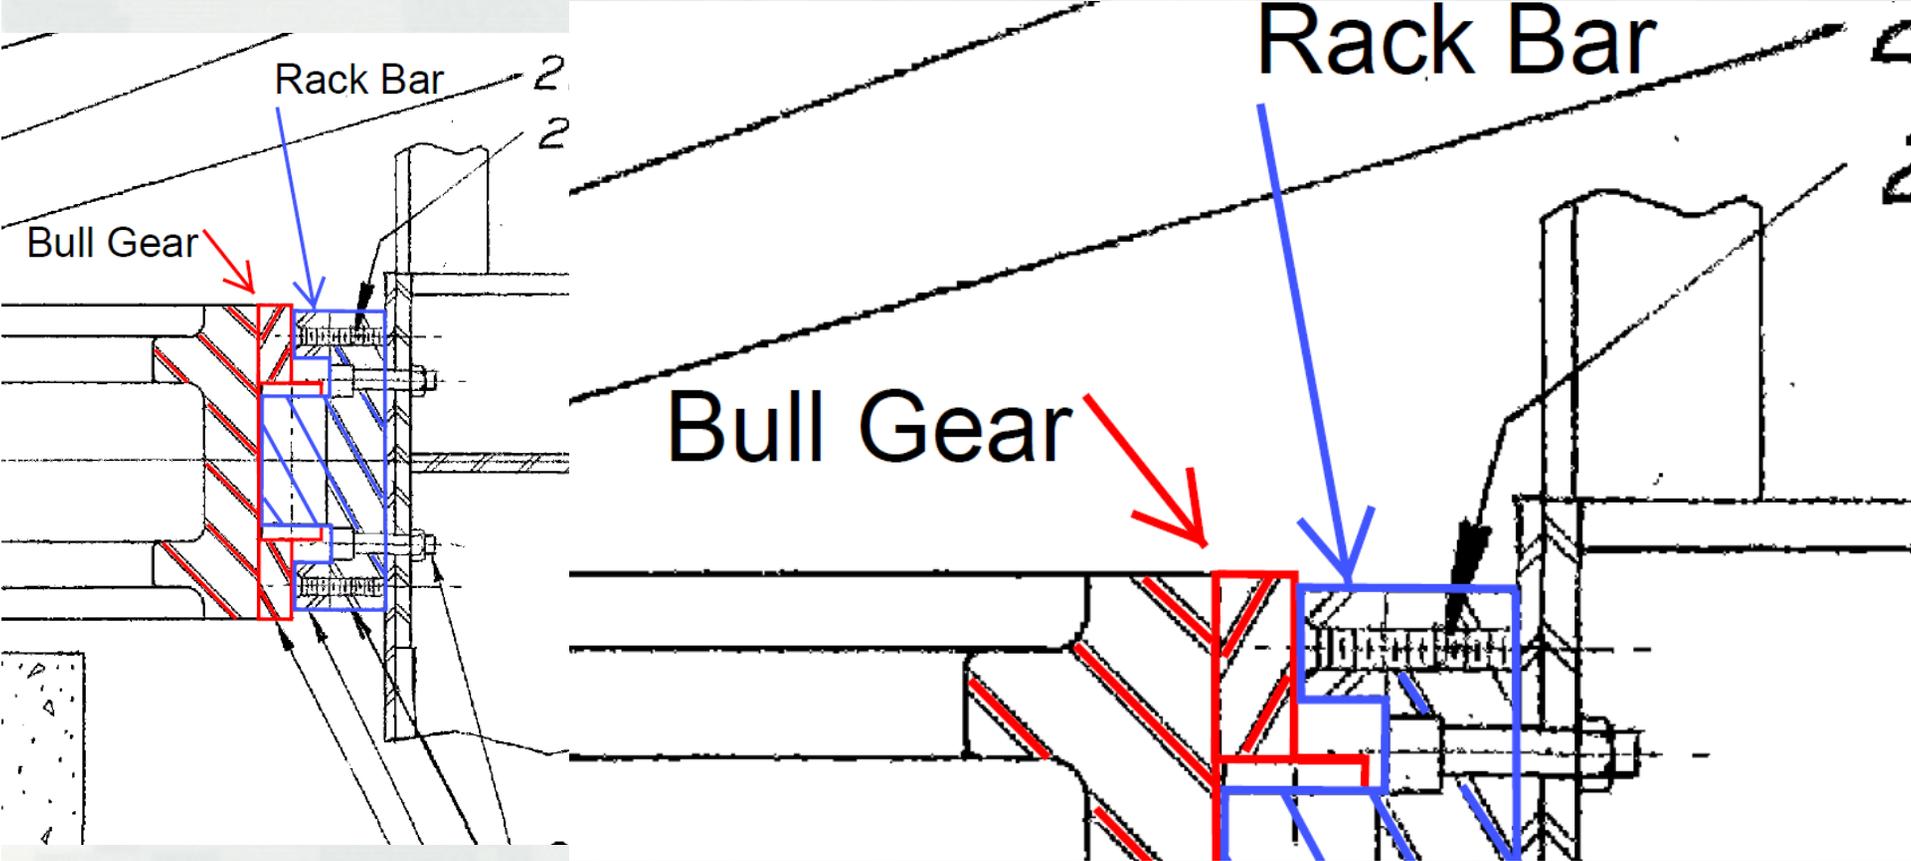
- The conclusion was made following that inspection that there had to be significant wear at the pintle ball and bushing to allow the skin plate end of the gate to drop enough causing the misalignment and that the gates would have to be removed to inspect and replace the worn parts.

# Bull Gear to Rack Gear Misalignment

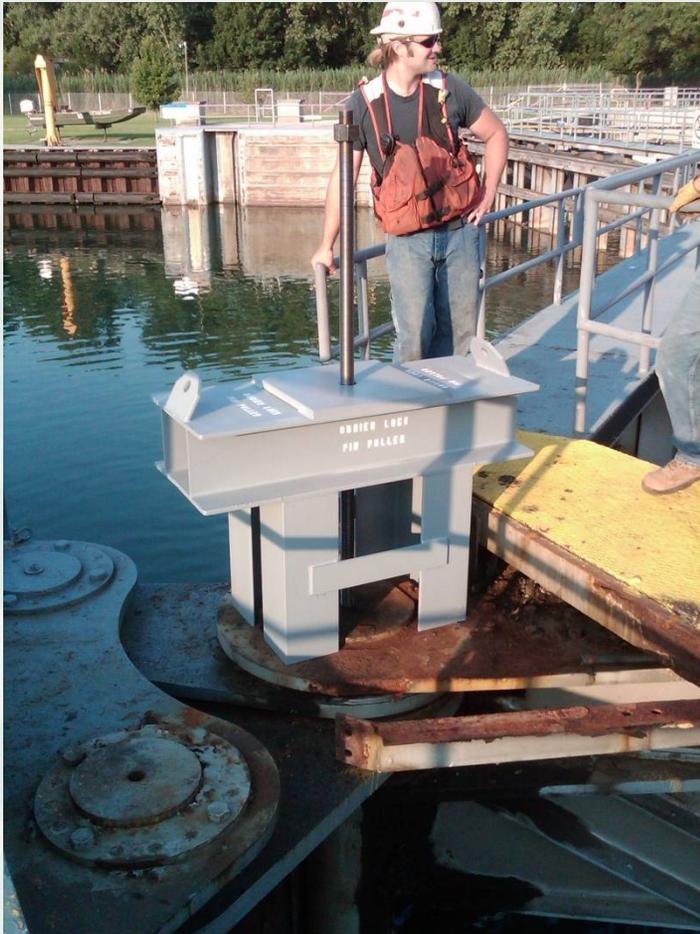
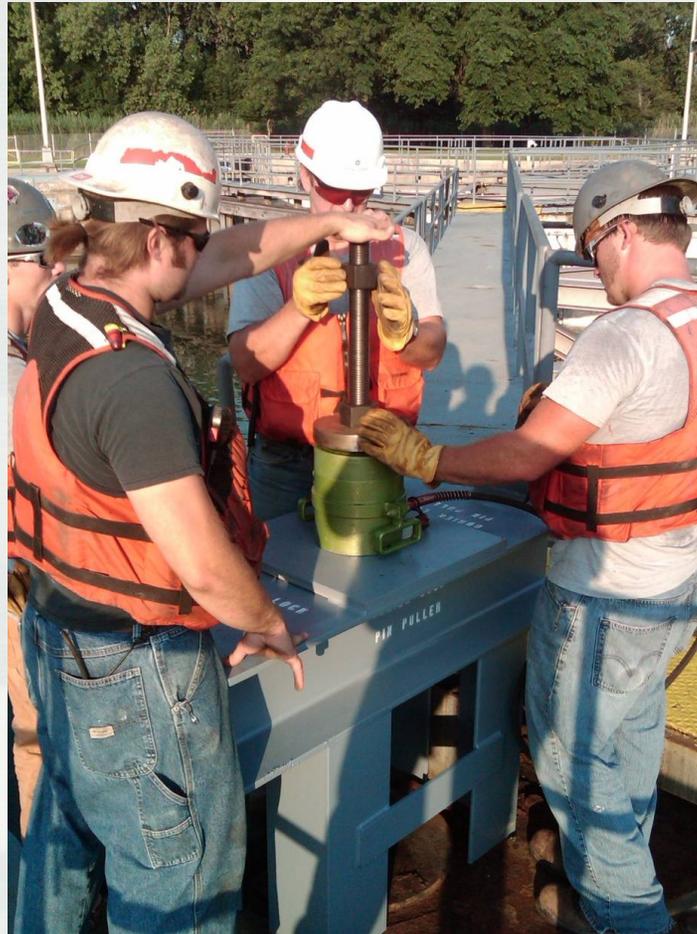
- Upon inspection, it was found that there was some slight pitting and corrosion on the pin, but that there was not enough material loss on the pin nor was there enough wear on the upper bushing to cause the amount of misalignment that was present

## Pulling the Gate Elevation Pin to Check for wear in 2011

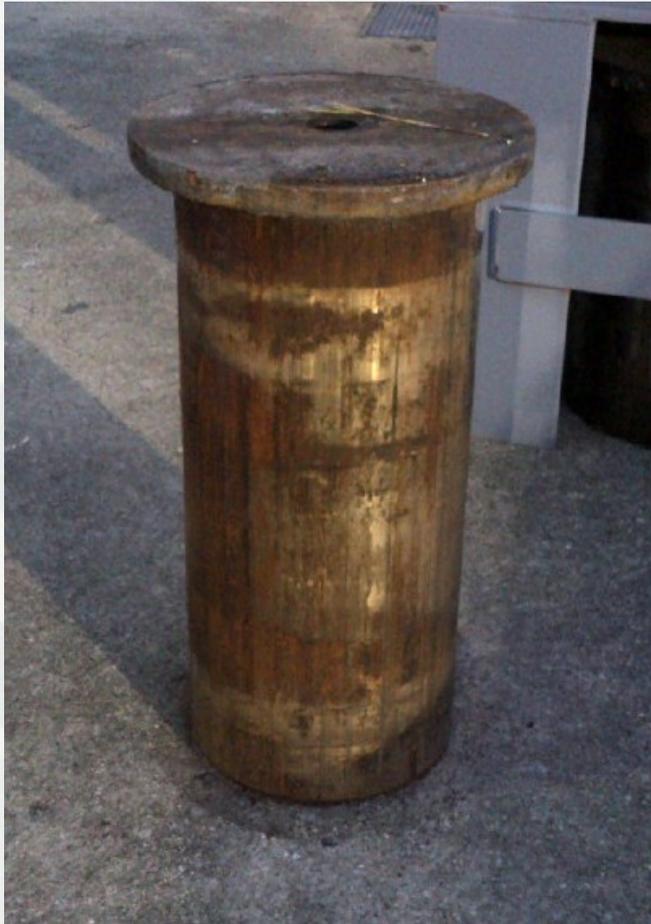
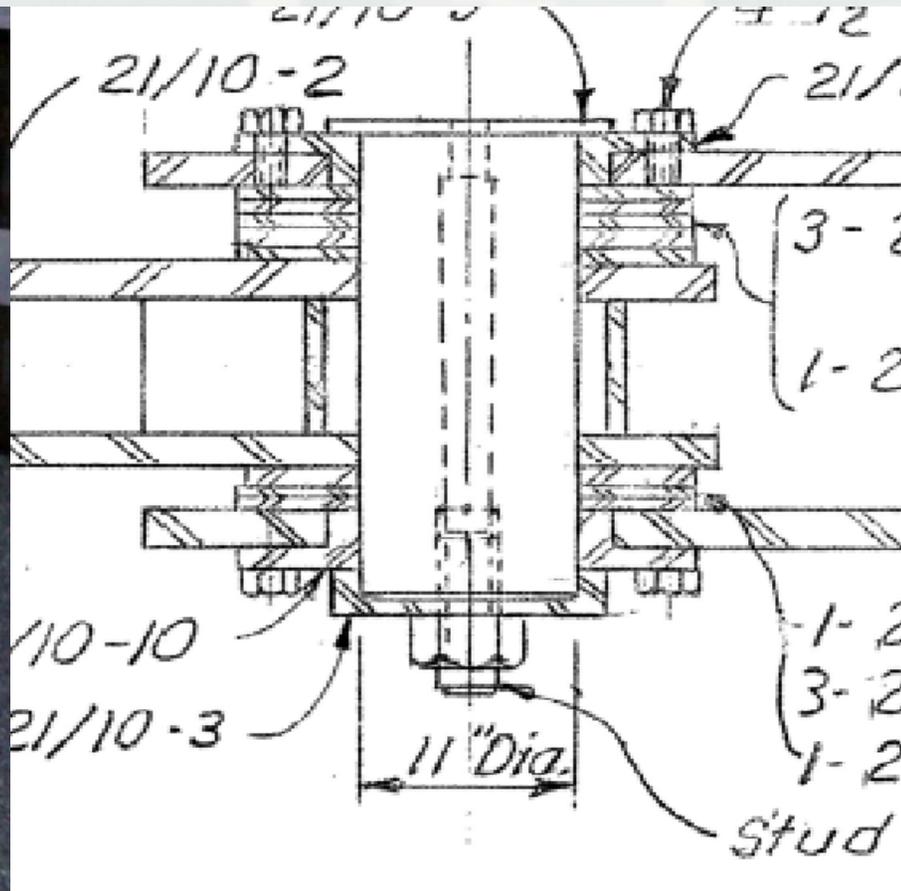
# Not so Easy!

- Static Pins with no provisions for lubrication.

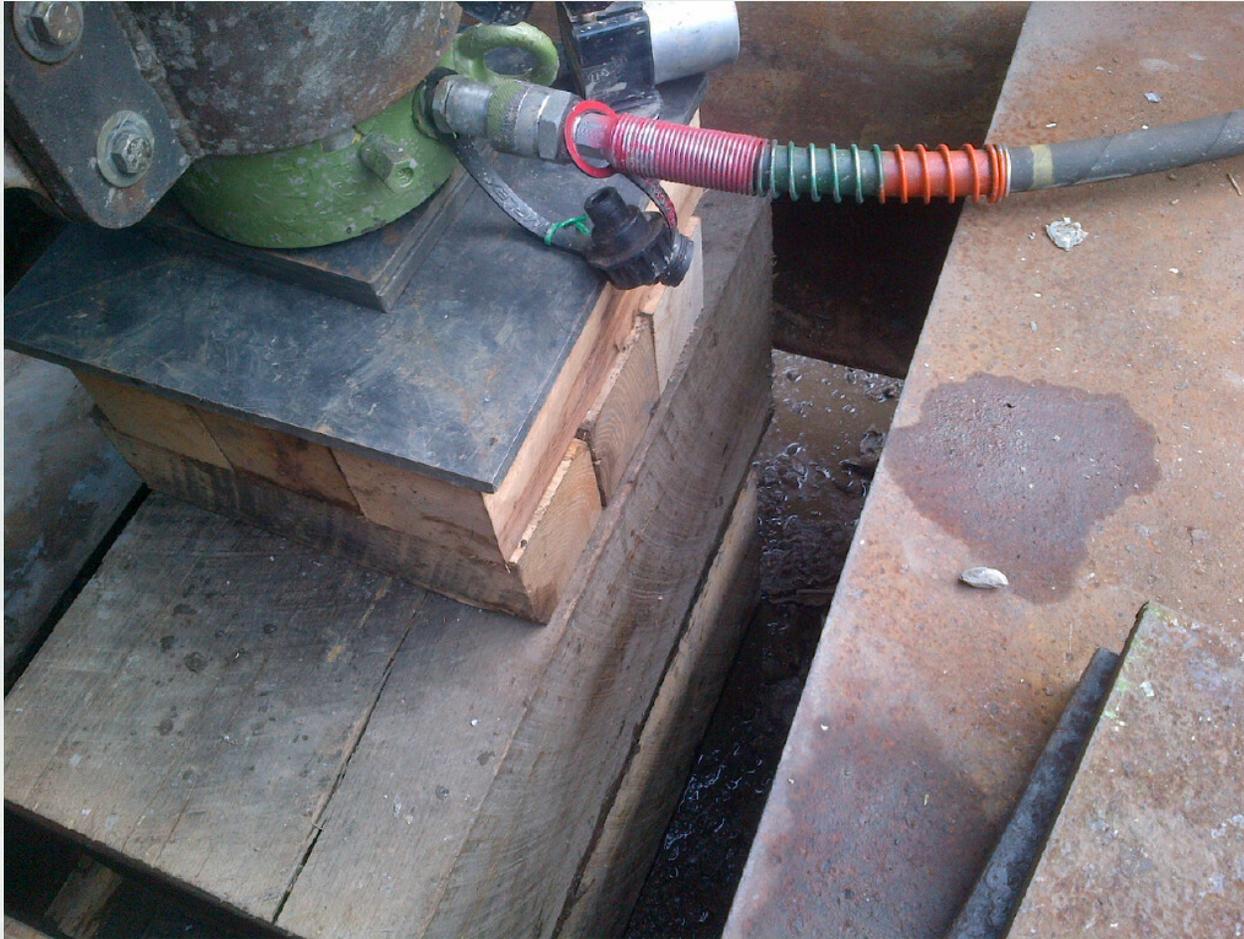
# Jack Cribbing?

- Jack cribbing-had a good idea of what to use, but turned out what we had was not going to be substantial enough to maintain stability through the entire lift. Stopped at 53 inches on the first gate. Ordered custom cribbing and went up the full 60 inches on each of the other gates.

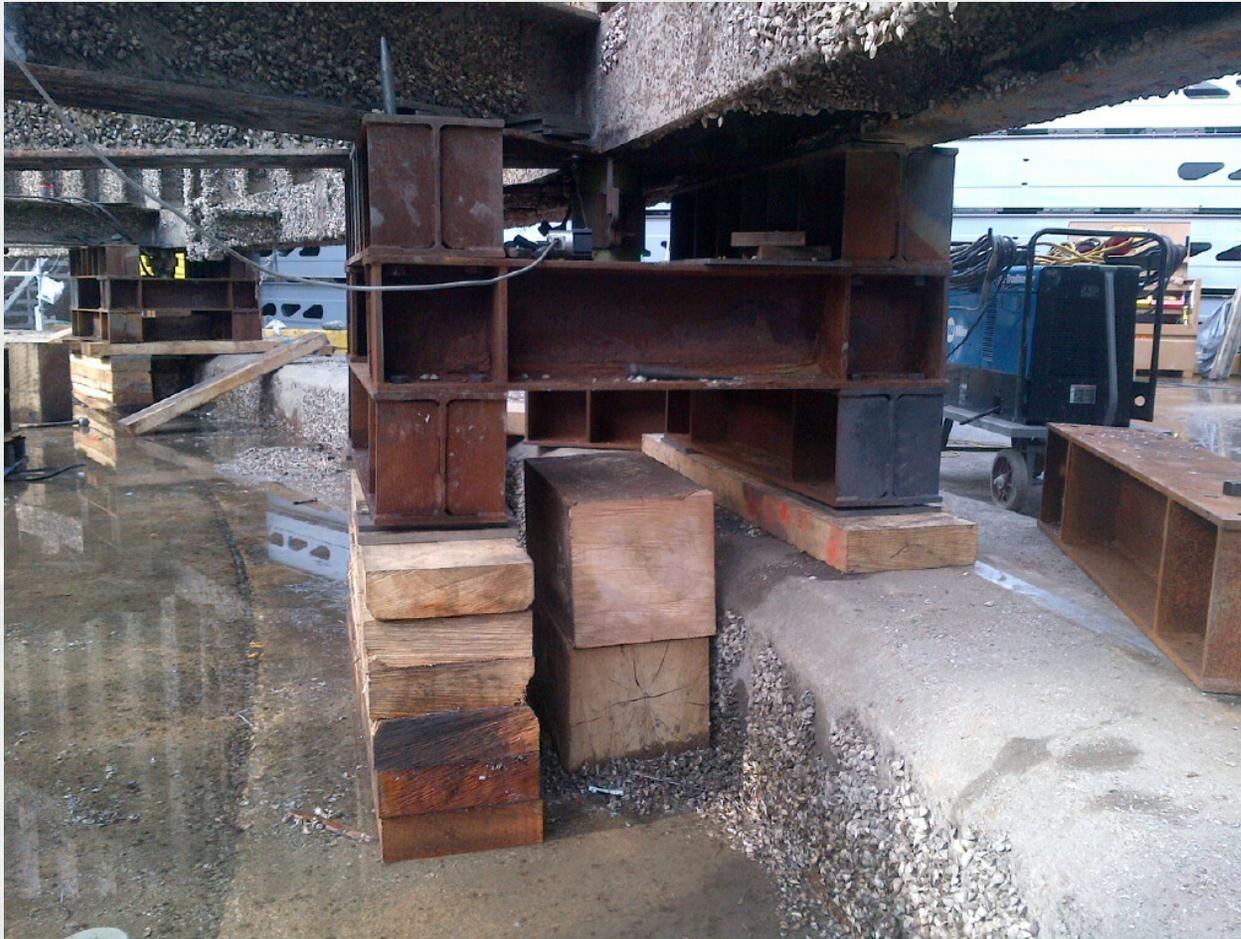
# Raised Sill?

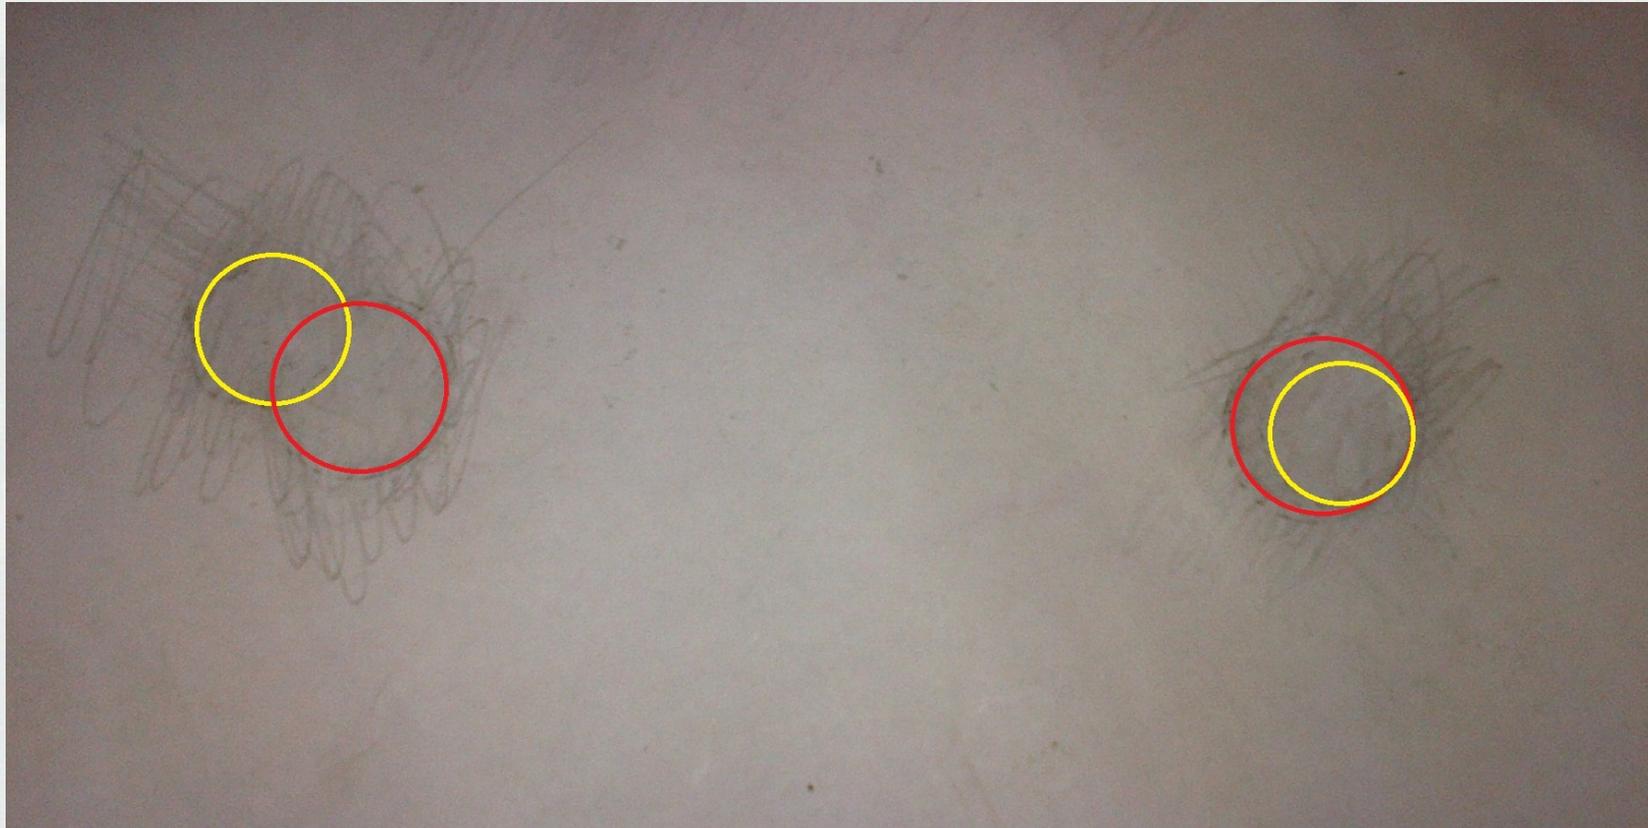
# Uh Oh! They don't line up?

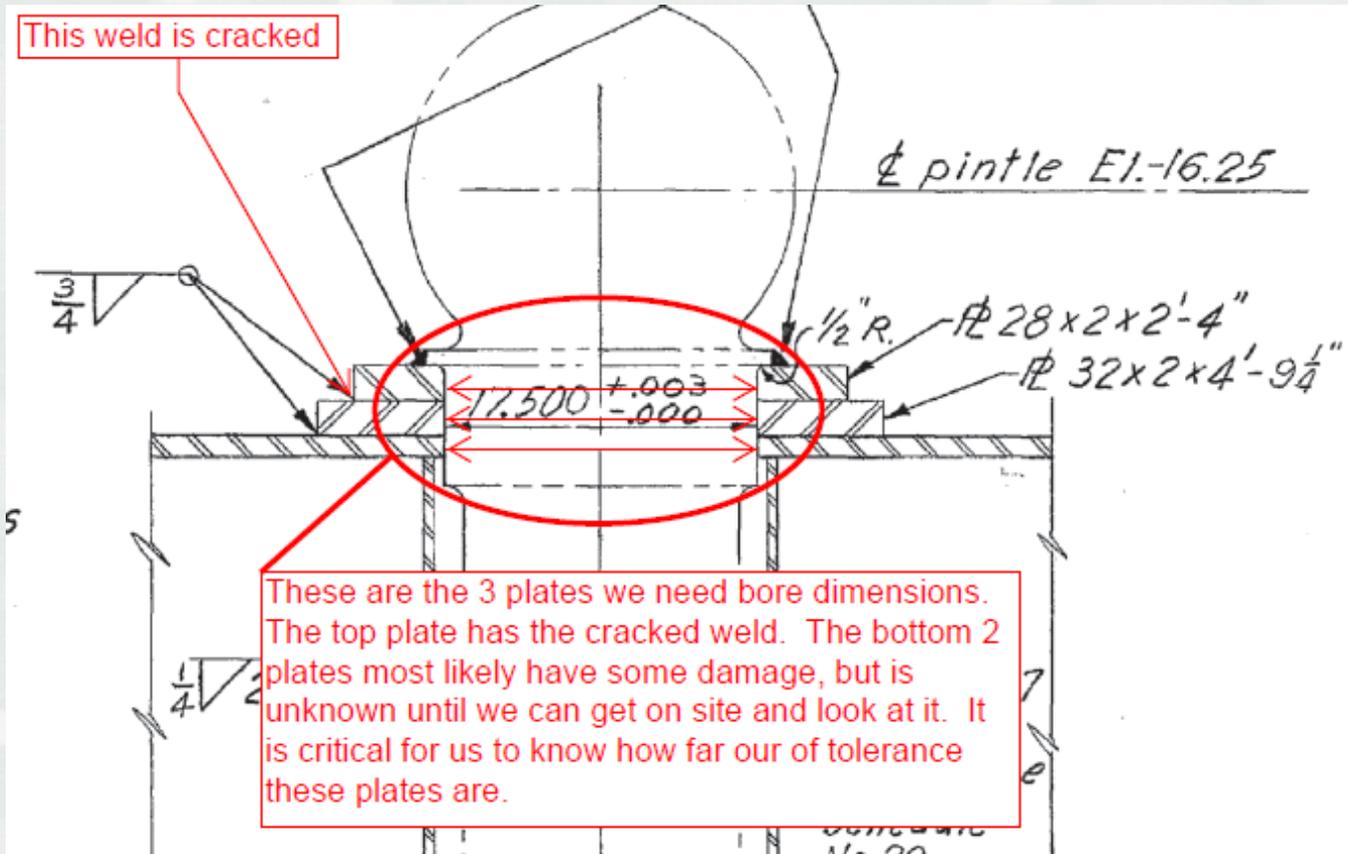
# The Problem

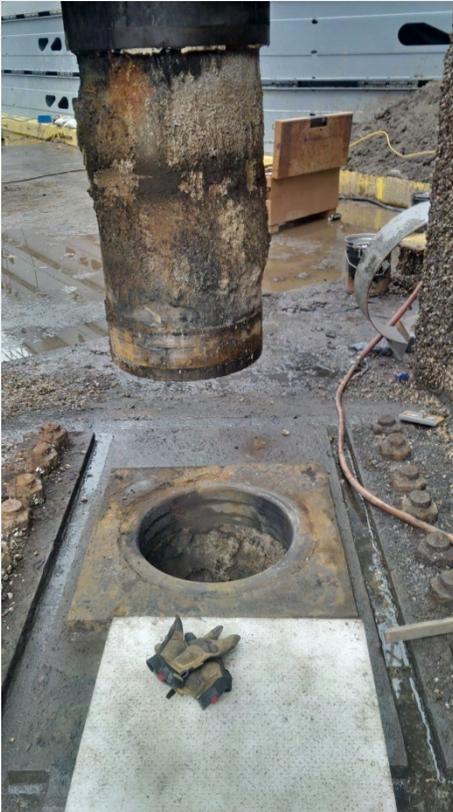
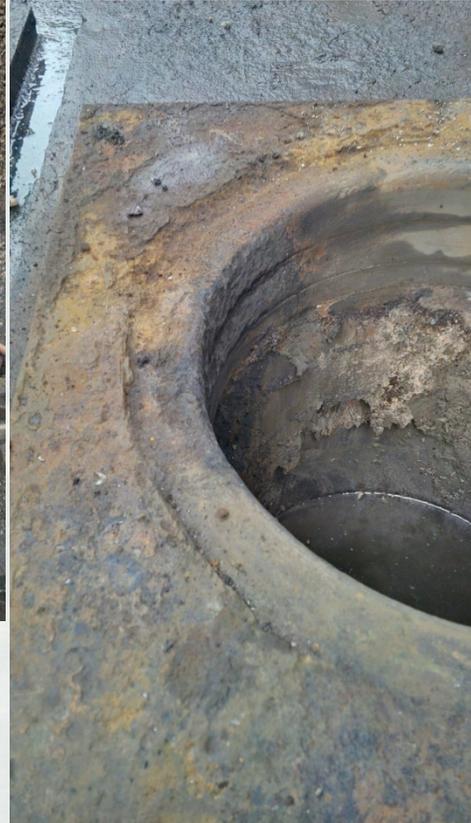
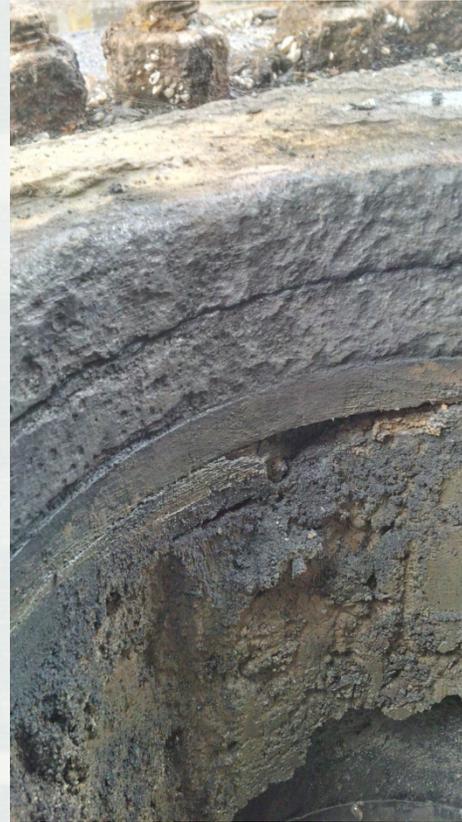
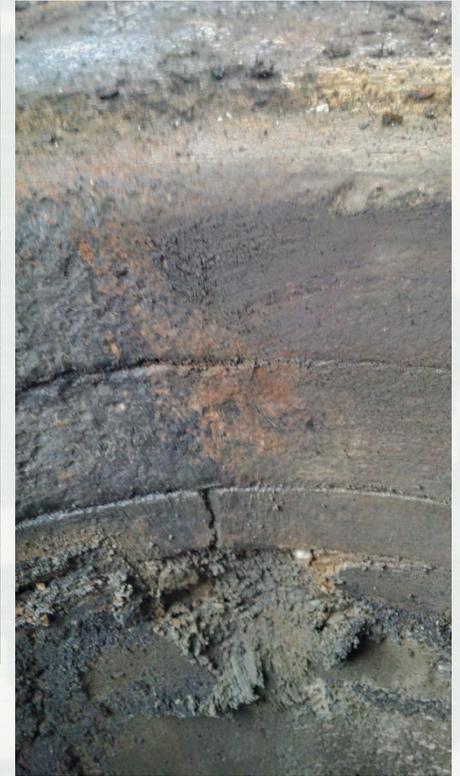
# More Uh Oh's

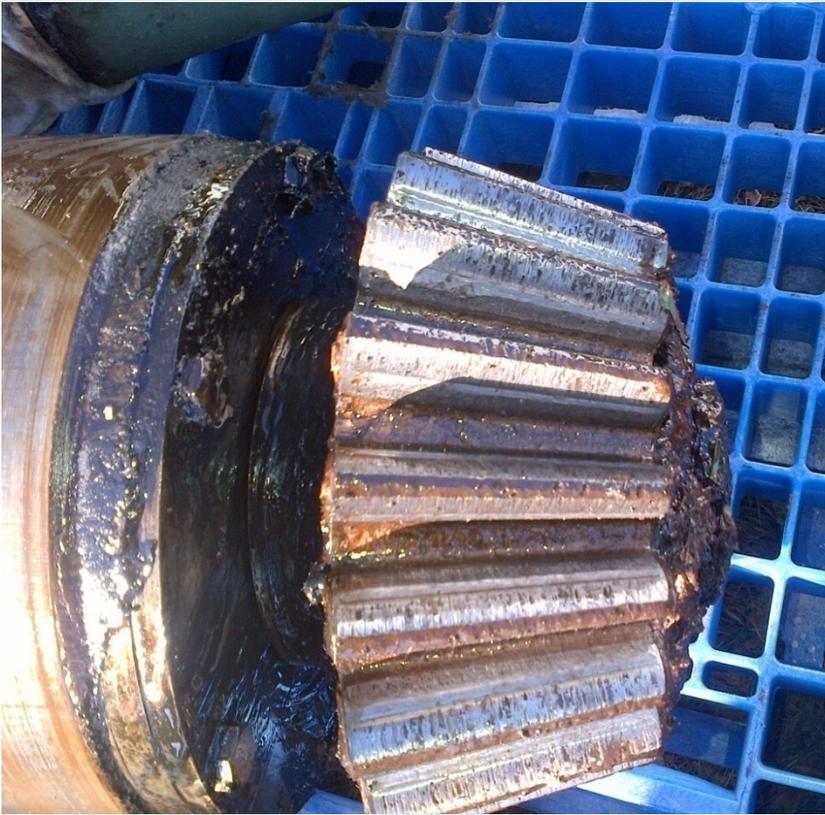
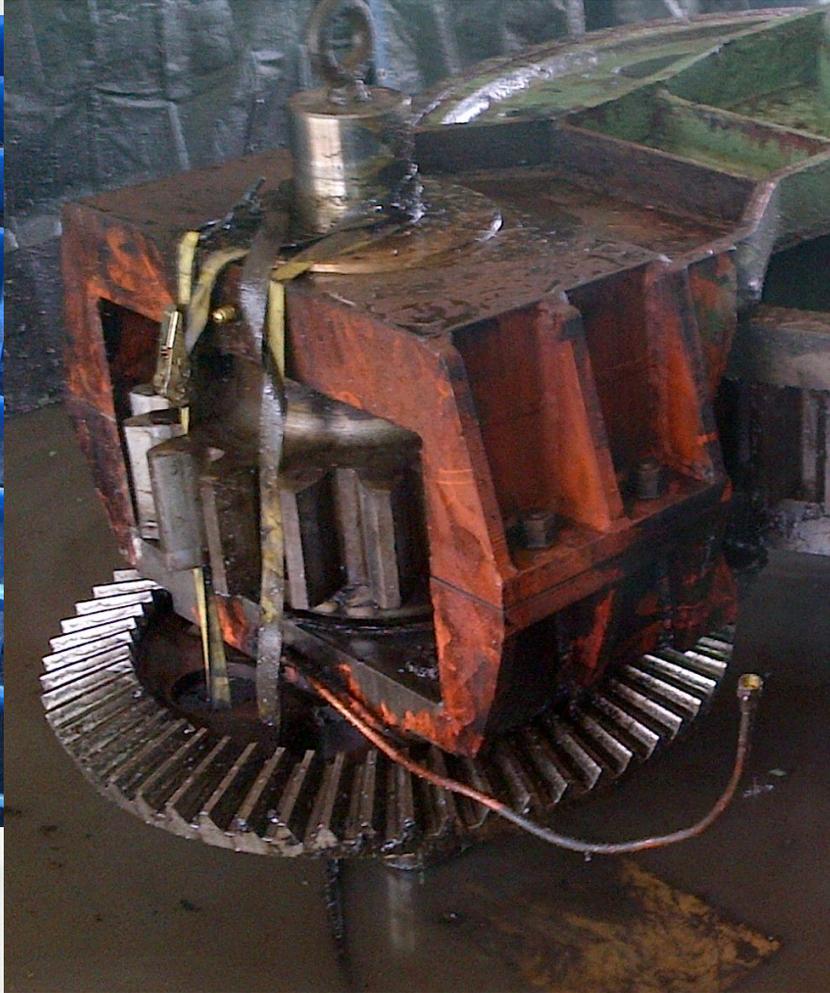
# Inspection results
