Belleville Locks & Dam Main Chamber Dewatering

Lakes and River Division

Louisville District

February 2016

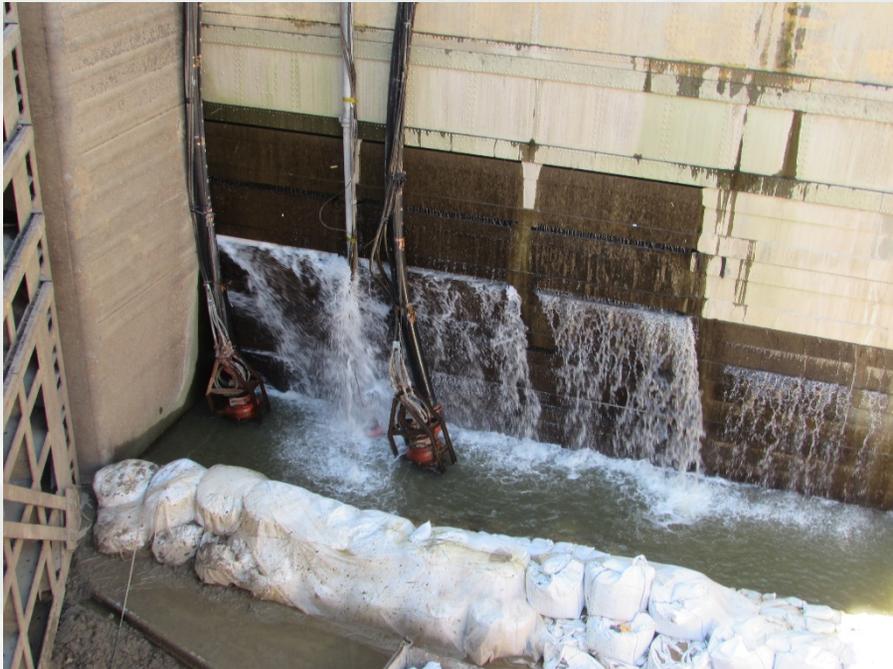
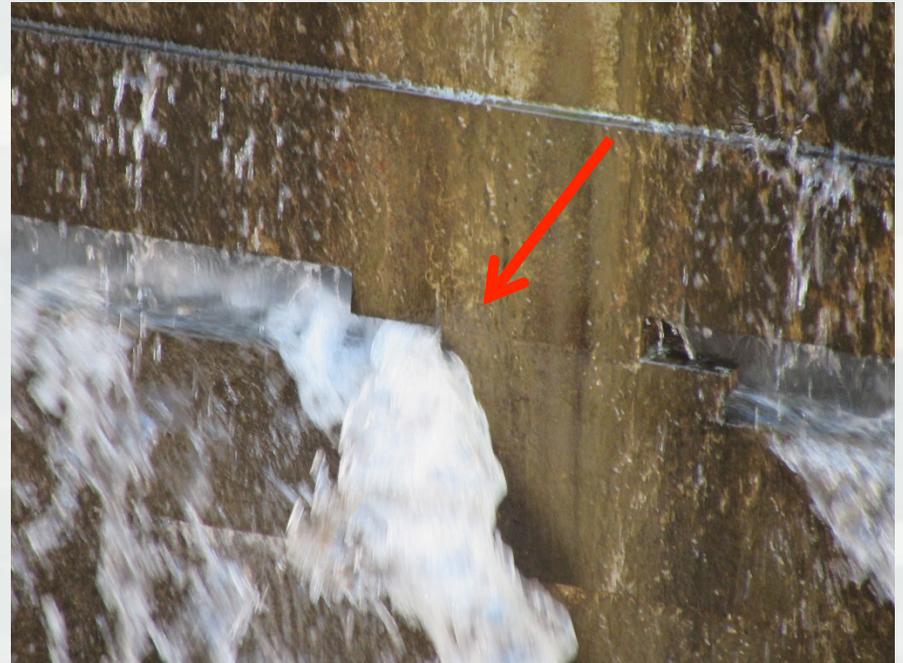
Olmsted Bulkhead Leakage

- The new bulkheads had a design oversight and they need to be lined up within a couple inches from the rest of the stack.
- The Contractor at Olmsted found out the hard way and spent quite some time trying to dewater.
- Leakage at Belleville was manageable.

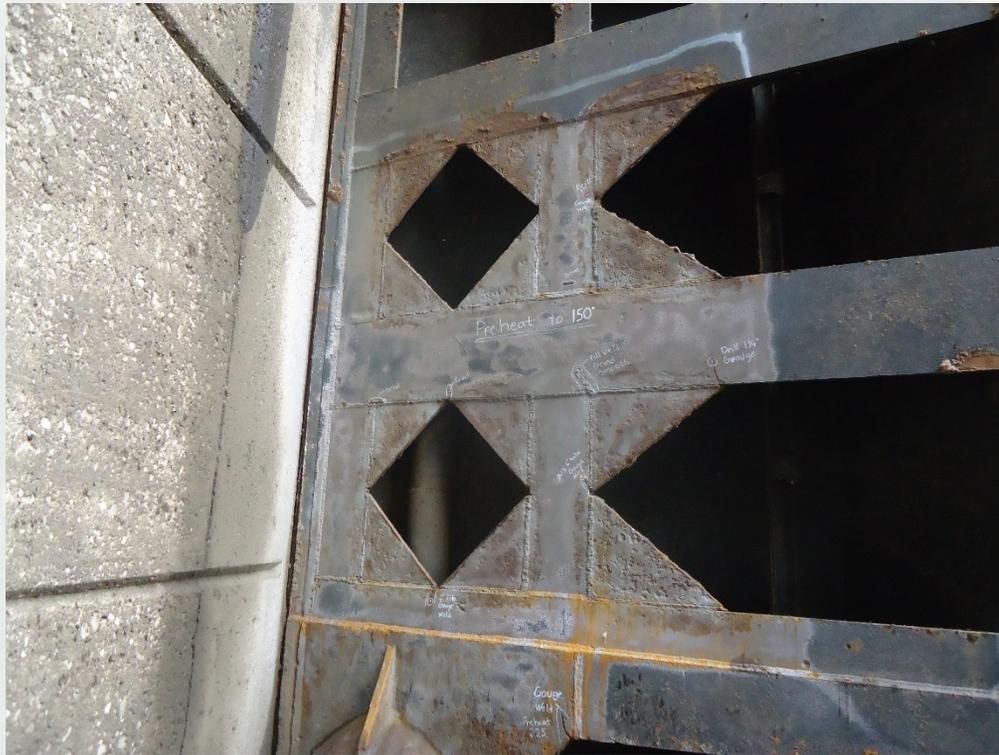
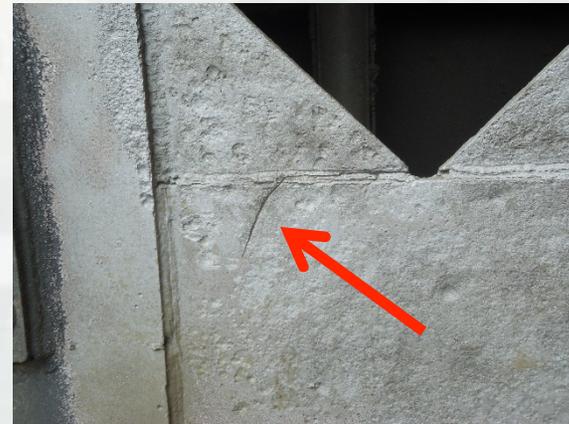
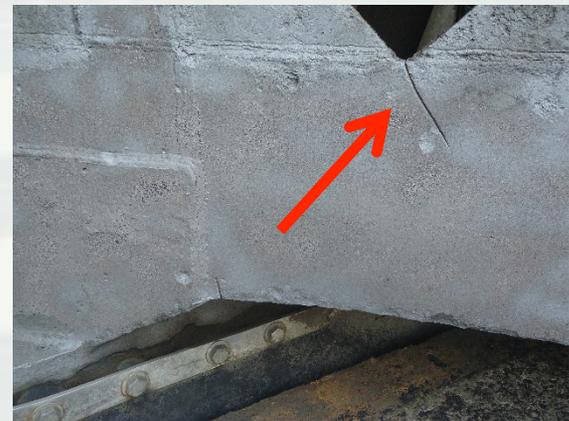
Upper End Window Stiffeners

The existing window stiffeners were creating numerous cracks due to stress concentration and weld imperfections.

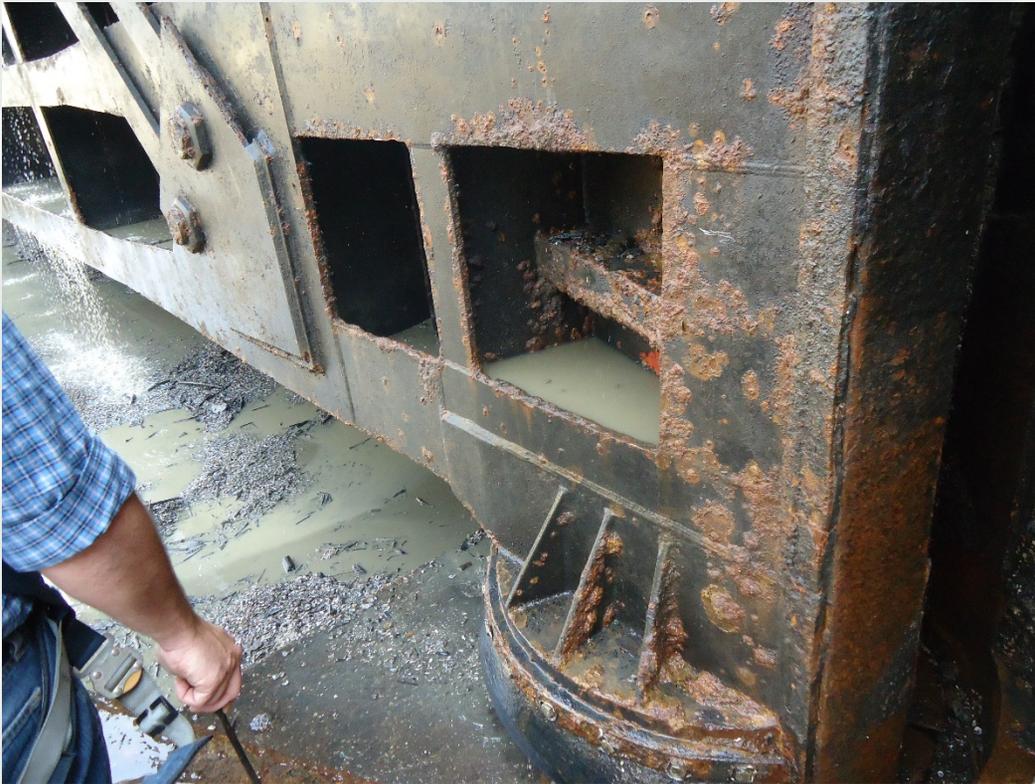
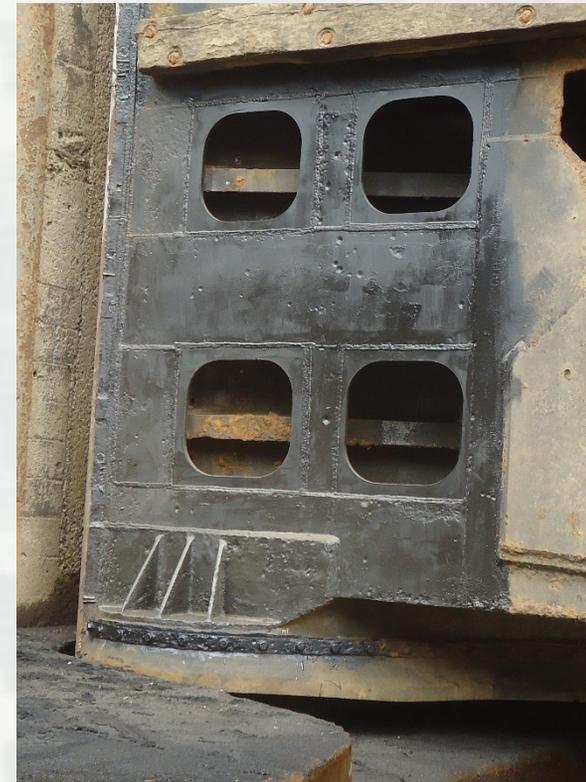
Lower End Window Stiffeners

- The Lower End did not have existing stiffeners and there were very few cracks around the windows. This saved approximately 4 days of welder work removing stiffeners and repairing cracks.

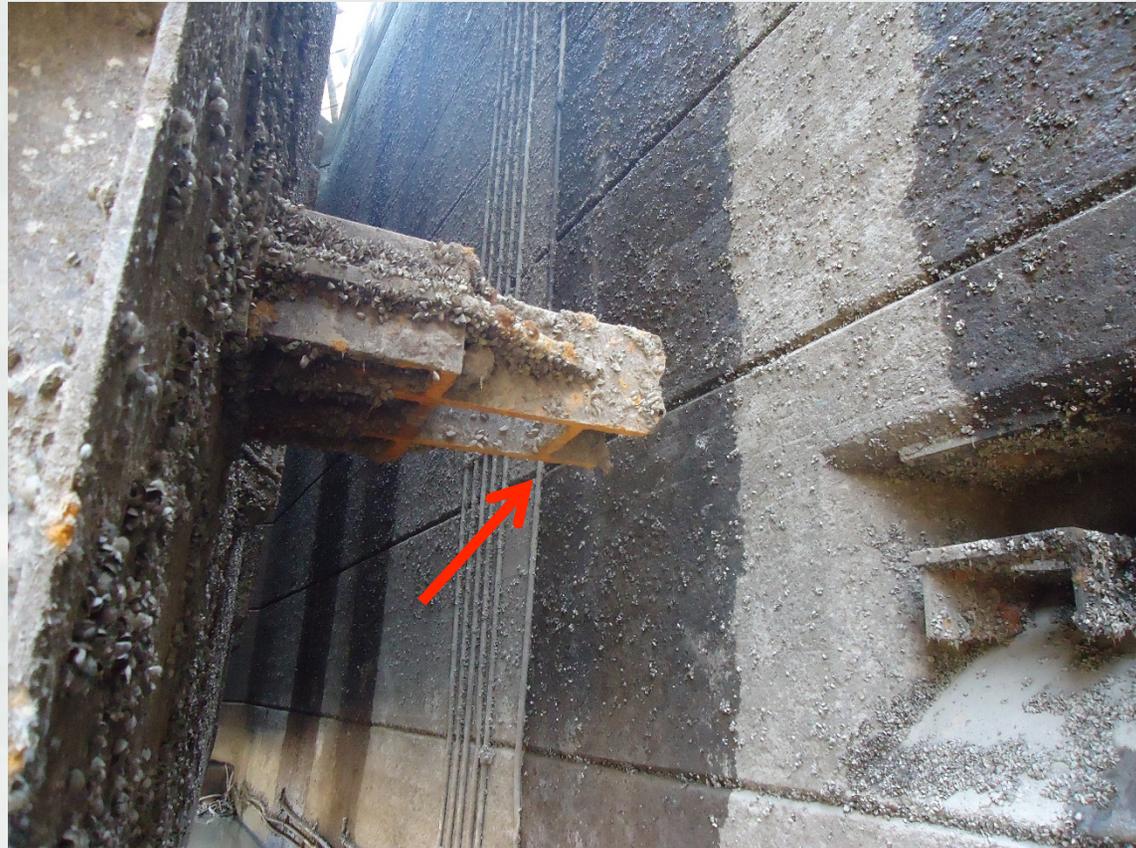
Upper End Miter/Quoin Block Replacement

- The bottom of the miter gate latching device was rubbing on the embedded latch.

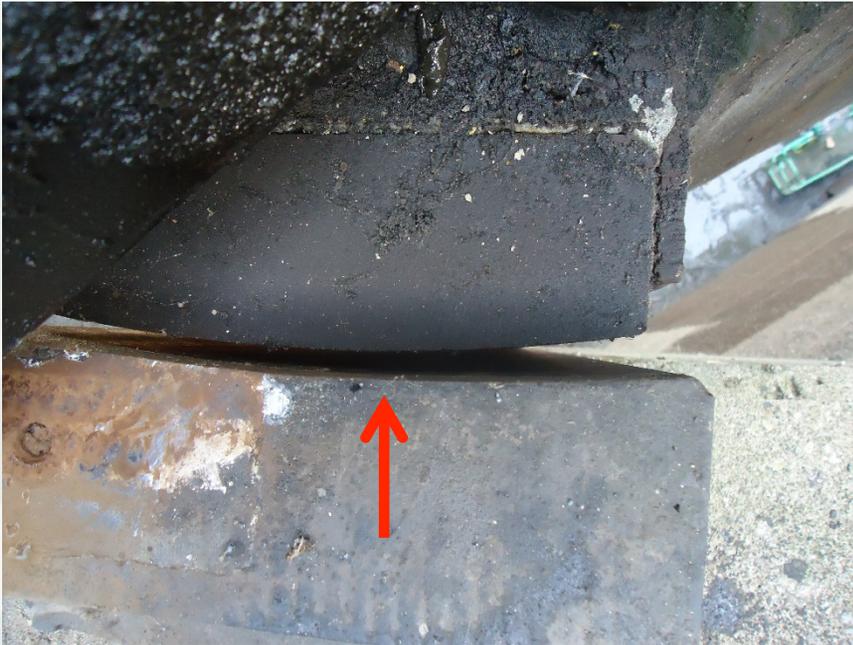
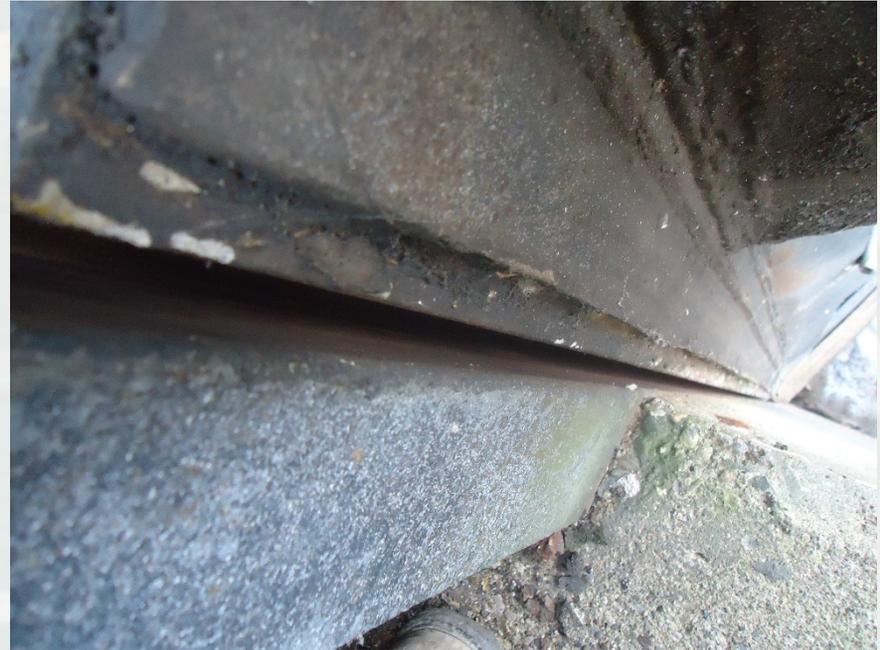
Upper End Miter/Quoin Block Replacement

- The Upper River Wall quoin block had a 3/16" to 1/4" gap at the top tapering down.

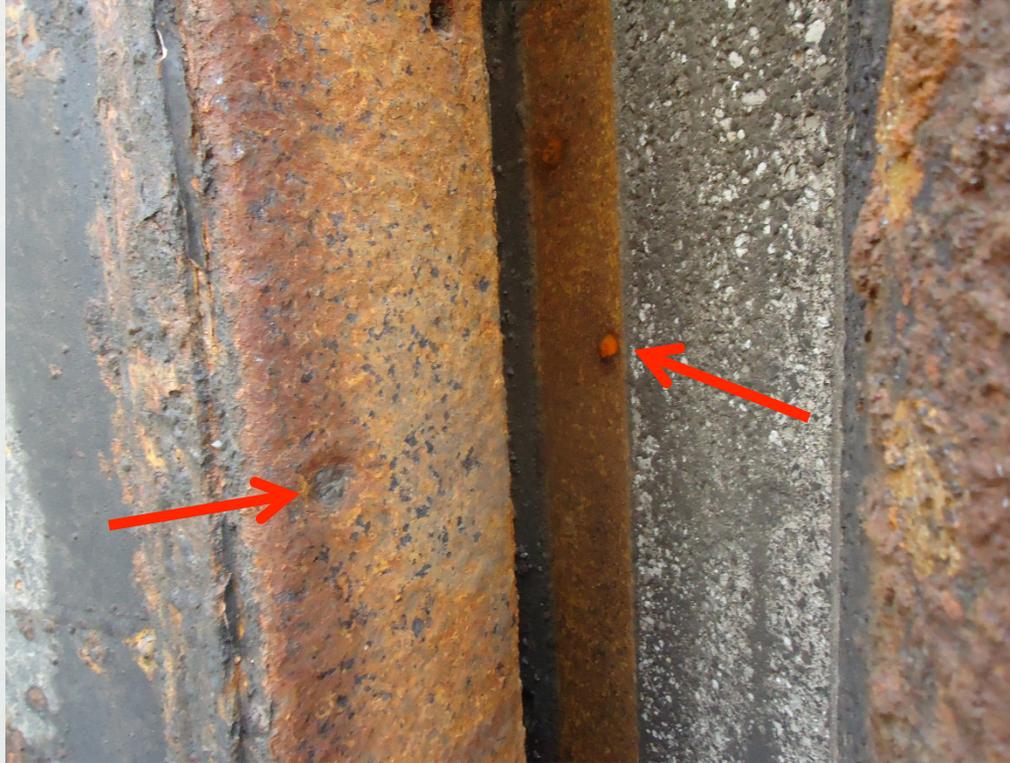
Upper End Miter/Quoin Block Replacement

- The embedded & gate quoin blocks are showing wear.

- Since the pintle bushings were not receiving grease on the loaded side, the bushings would continue to wear at a much quicker rate.
- The findings of the upper end were brought to the attention of LRD, the proposed fix was to jack the gates and change the pintle bushings.
- The schedule did not allow enough time to change pintle bushings so LRL would only change the blocks on the lower end.

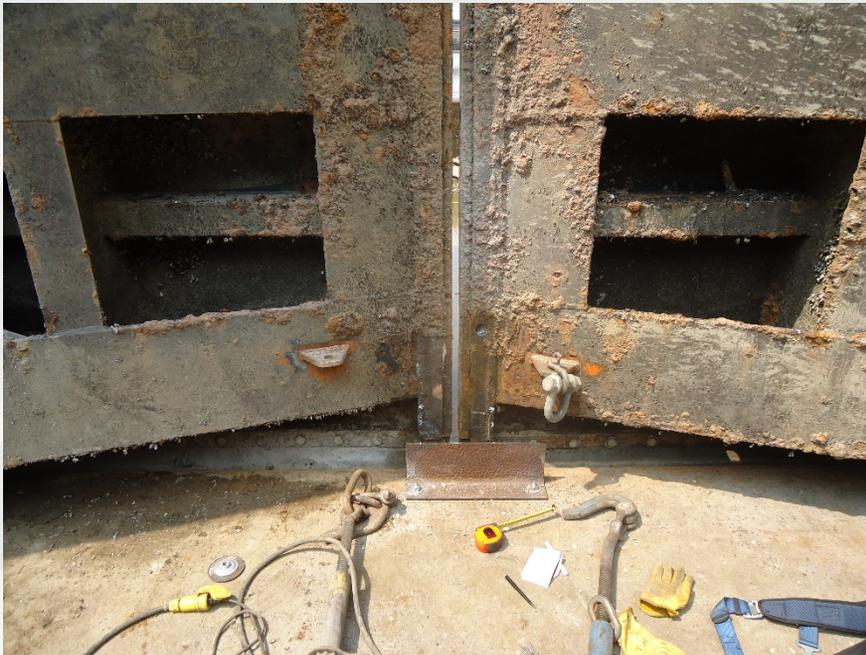
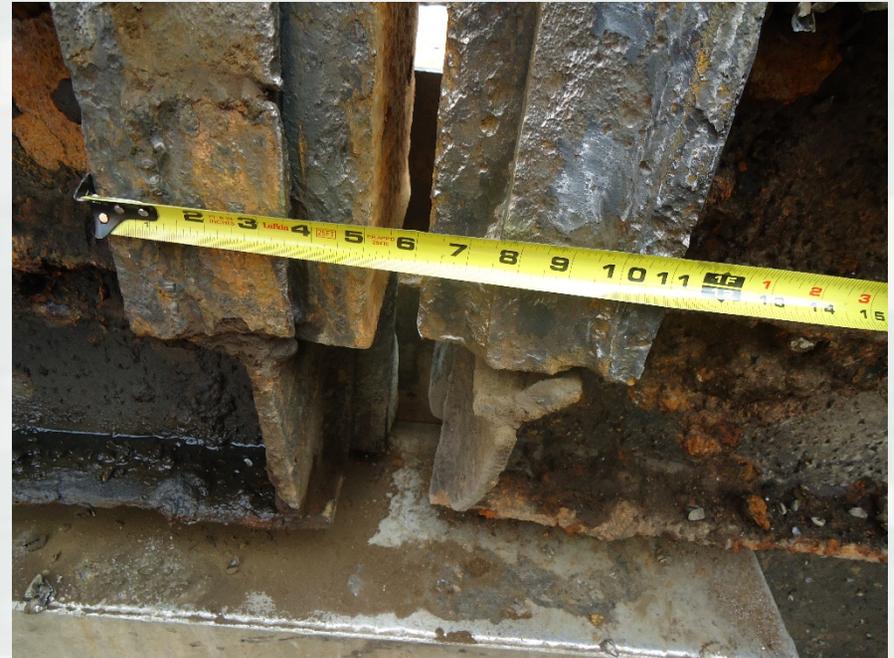
Lower End Miter/Quoin Block Replacement

- The contact blocks were out of tolerance with a large gap at the miter.
- The gates had to be adjusted further downstream to allow the gates to seal against the sill properly.

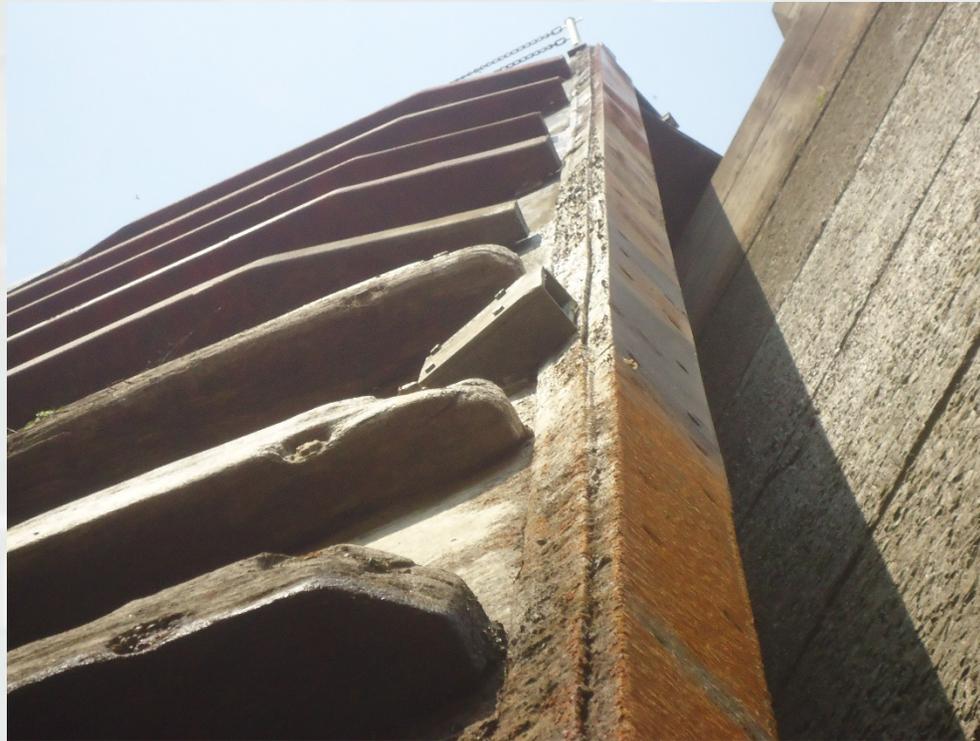
Lower End Miter/Quoin Block Replacement

- The large gap at the bottom miter was causing the gate leaves to twist under hydrostatic load causing a lack of bearing at the top.
