Markland Gate Failure

LRL / LRP

11 February 2010

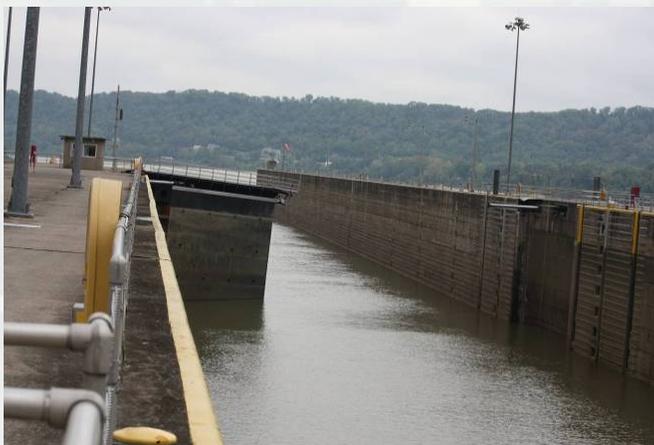
Chain of Events

- The river wall (rw) leaf breaks away and falls into the chamber.
- The middle wall (mw) leaf is pointing downstream with one anchor arm holding it in place.
- 0800 – lockmaster and operations managers notified of the incident.
- Ohio River closed at Markland L/D.

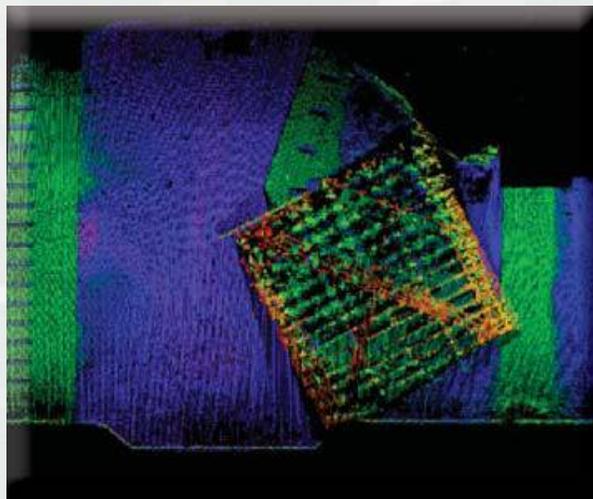
Recovery and Repair

- Survey crew finds rw leaf partially blocking the bulkhead sill. Leaf must be moved to set bulkheads.
- Corps determines hiring a contractor is most efficient method to move rw leaf.
- Towing industry requests a helper boat be supplied by the Corps.

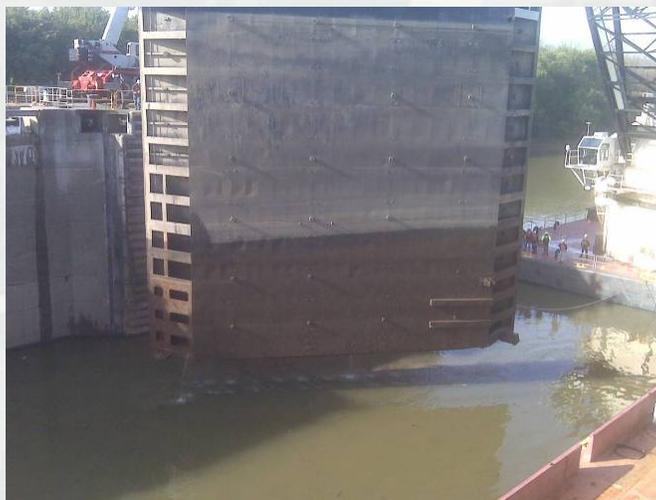
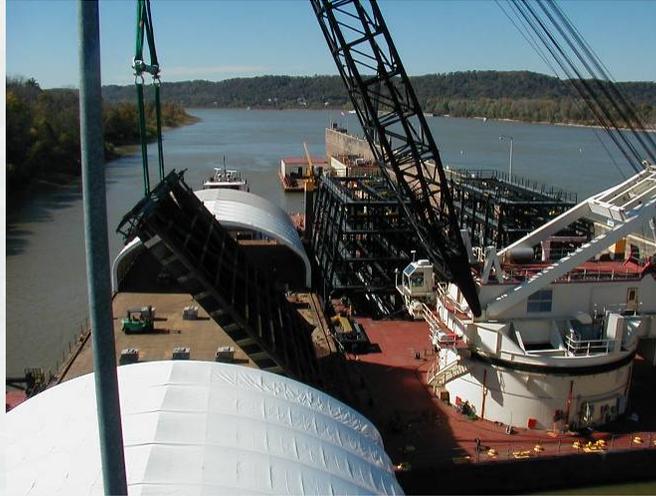
Recovery and Repair

- New miter gate leaf contract is accelerated to a mid-March 2010 delivery.
- Helper boat contract is awarded.
- Corps contracts salvor to move rw miter gate leaf.
- Lifted mw leaf on 19 October and placed on the DeLong barge.

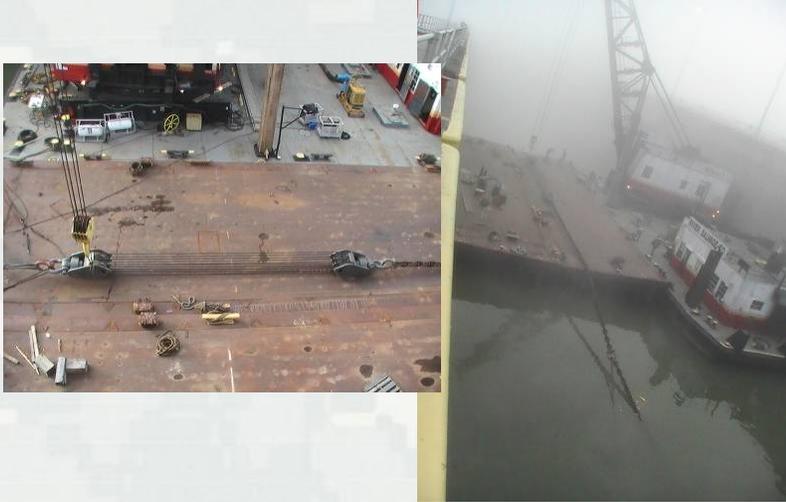
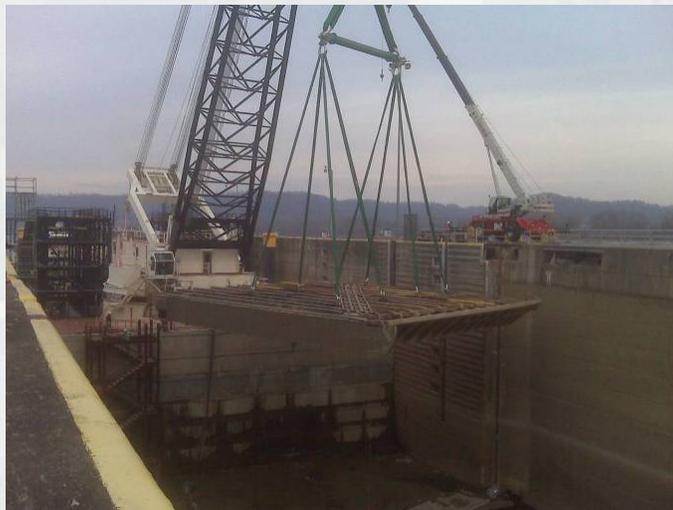
Recovery and Repair

- Salvage contractor moved rw leaf off the bulkhead sill on 25 October.
- Corps set bulkheads, dewatered chamber and installed eight point lifting system.
- Lifted rw leaf out of chamber and placed it on the DeLong barge on 10 November.

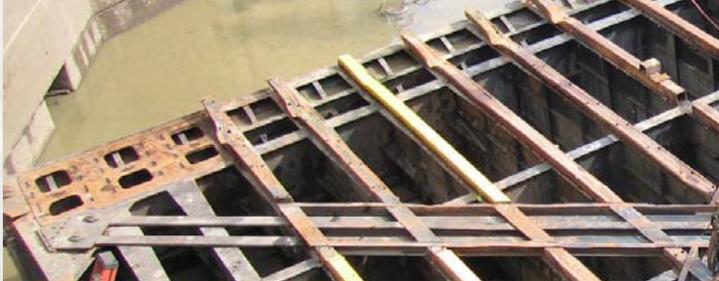
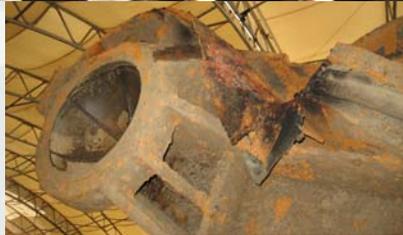
Damage to Gate

- Leaves are not properly mitered as chamber continues to fill. Operators try to close filling valve but failed solenoid is holding pilot valve in the open position.
- Mitering device buckles under the load and the gate leaves move over the sill, the strut arms break away, and three of four anchor arms fail.
