# Chickamauga Lock Gate Anchorage Replacement

2010 Lock Maintenance Workshop  
St Louis, MO  
February 11, 2010

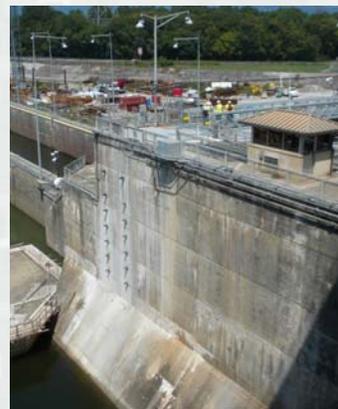
## Background - Monolith 47

- Major cracking due to Alkali-Aggregate Reaction (AAR)
- Horizontal post-tensioned anchors were installed in 1988
- Vertical post-tensioned anchors were installed in 1997

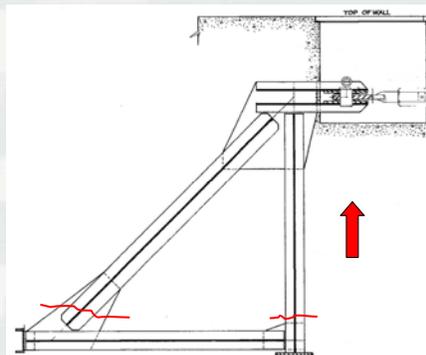
## Background - Design

- Finite element analysis determined the anchorage may have seen enough stress due to AAR to crack the embedded frame.

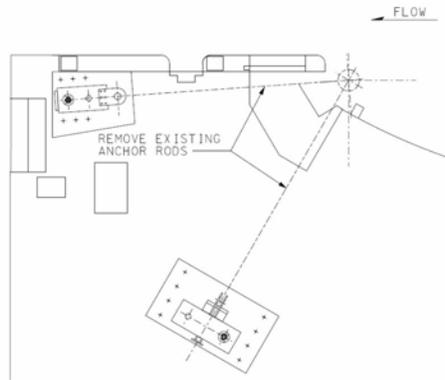
# Anchor Rod Removal

5 ANCHOR ROD REMOVAL

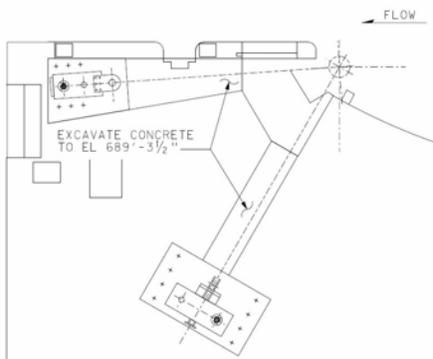
# Concrete Excavation – Phase 2

6 PHASE II - CONCRETE EXCAVATION

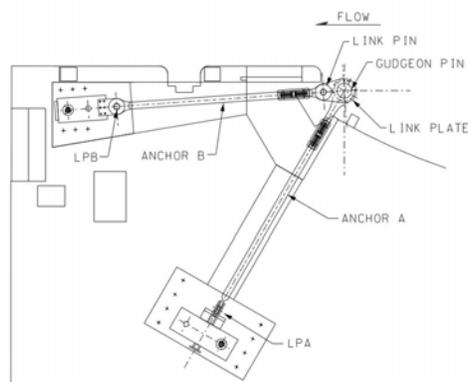
## Anchor Rod Installation

ANCHOR ROD INSTALLATION

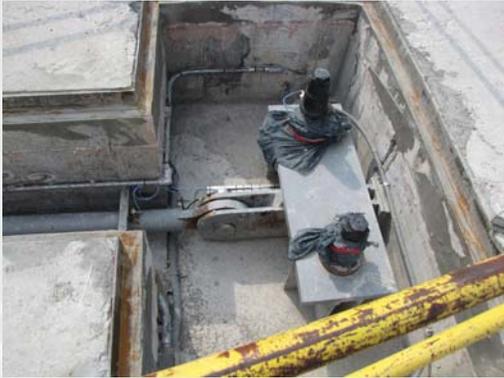
# Instrumentation

- Load Cells
- Proximity Probes
- Load Pins
