# GREENUP LOCKS AND DAM Main Lock Closure AAR

Huntington District

11 February 2010

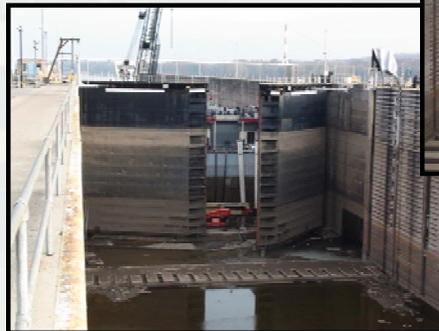
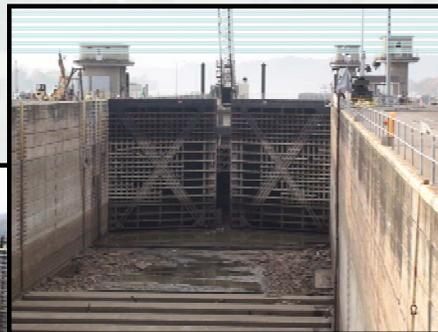
Upstream and  
Downstream Miter  
Gates

- Dewater main 110-ft. x 1200-ft. lock chamber
- Inspect / Repair Structural components to upper and lower miter gates
- Repair 6 floating mooring bitt tracks
- Repairs to trash guards on 6 mooring bitts
- Repair upstream river wall miter gate latch pin
- Repair upper river wall skin plate crack

- ▶ Crack repairs to lower miter gates
    - 3 cracks on each leaf at the pintle casting
    - 6 flange welds on G-15
    - Major crack repair on G-9, middle wall leaf

- 35 various other crack repairs
  - ▶ Crack repairs to upper miter gates
    - Major crack on each leaf in pintle area
    - 7 large cracks on river wall leaf

- Multiple cracks upstream and downstream on both leaves
  - ▶ Repaired 8 mooring bitt tracks
  - ▶ Repaired 8 mooring bits
    - Fabricated and installed new trash screens

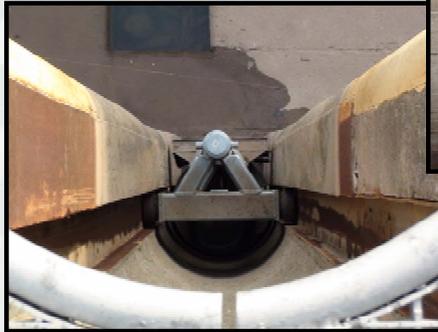
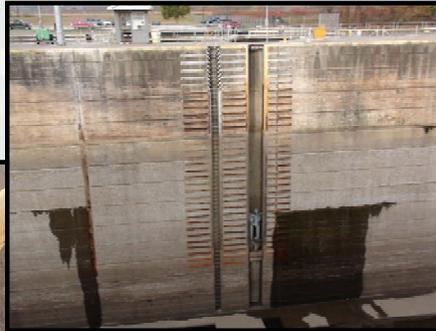
Mooring Bitt Tracks

- 50% of the mooring bitt tracks were out of service
- The average locking time went from 45 mins to approximately 2.0 hrs. The average delay time for the duration of the outage was 8.8 hours. This was a significant drop from previous year's dewaterings.

- Installed new bushings on rollers and chamfer roller edge
    - Replaced guide shoes
  - ▶ Removed, fabricated and installed new gate fenders
  - ▶ Repaired diagonal gate protection
