McAlpine Bushing Failures by Richard Nichols, LRL

# McAlpine Greaseless Bushing Failures

Louisville District

1 November 2010

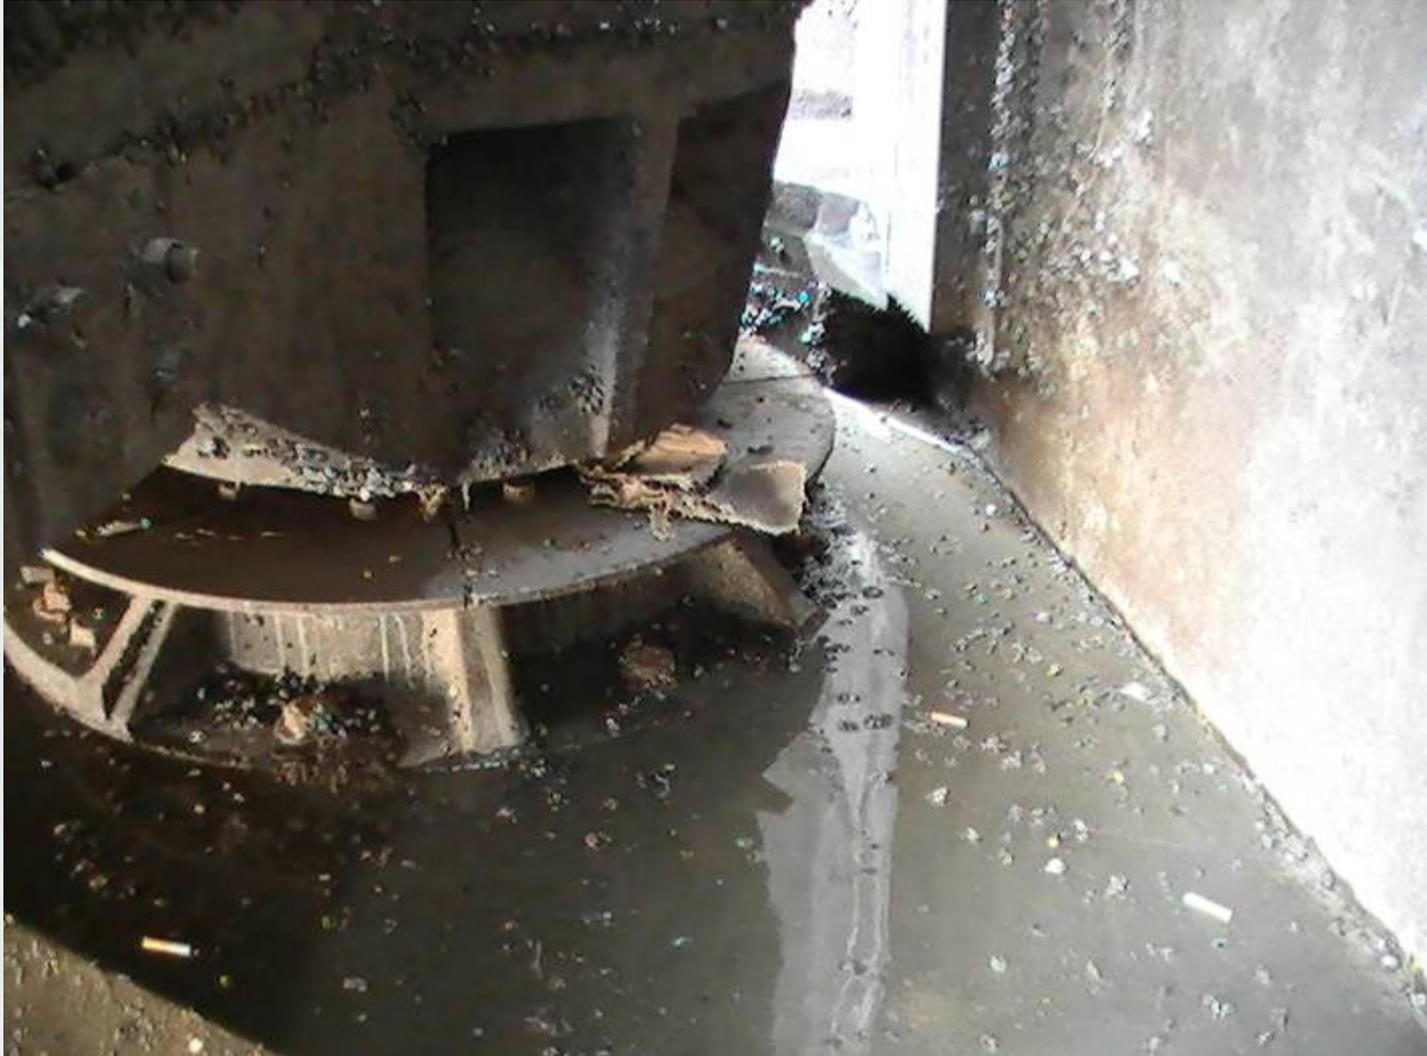
# Pintle Bushings

- Material – Tenmat T814

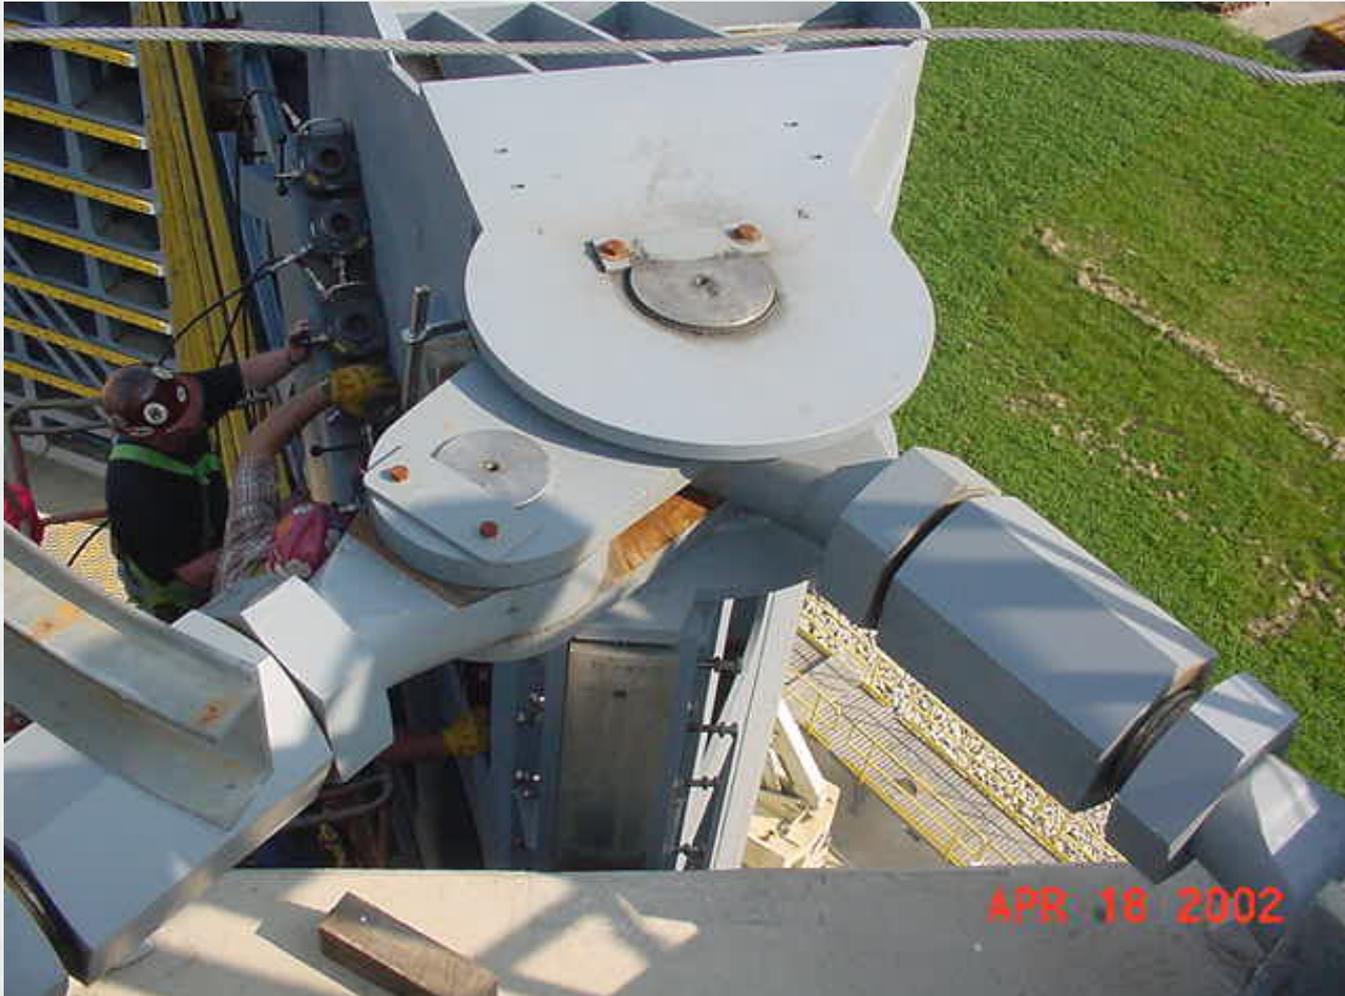
# Gudgeon Pin Bushings

- Material – Tenmat T814

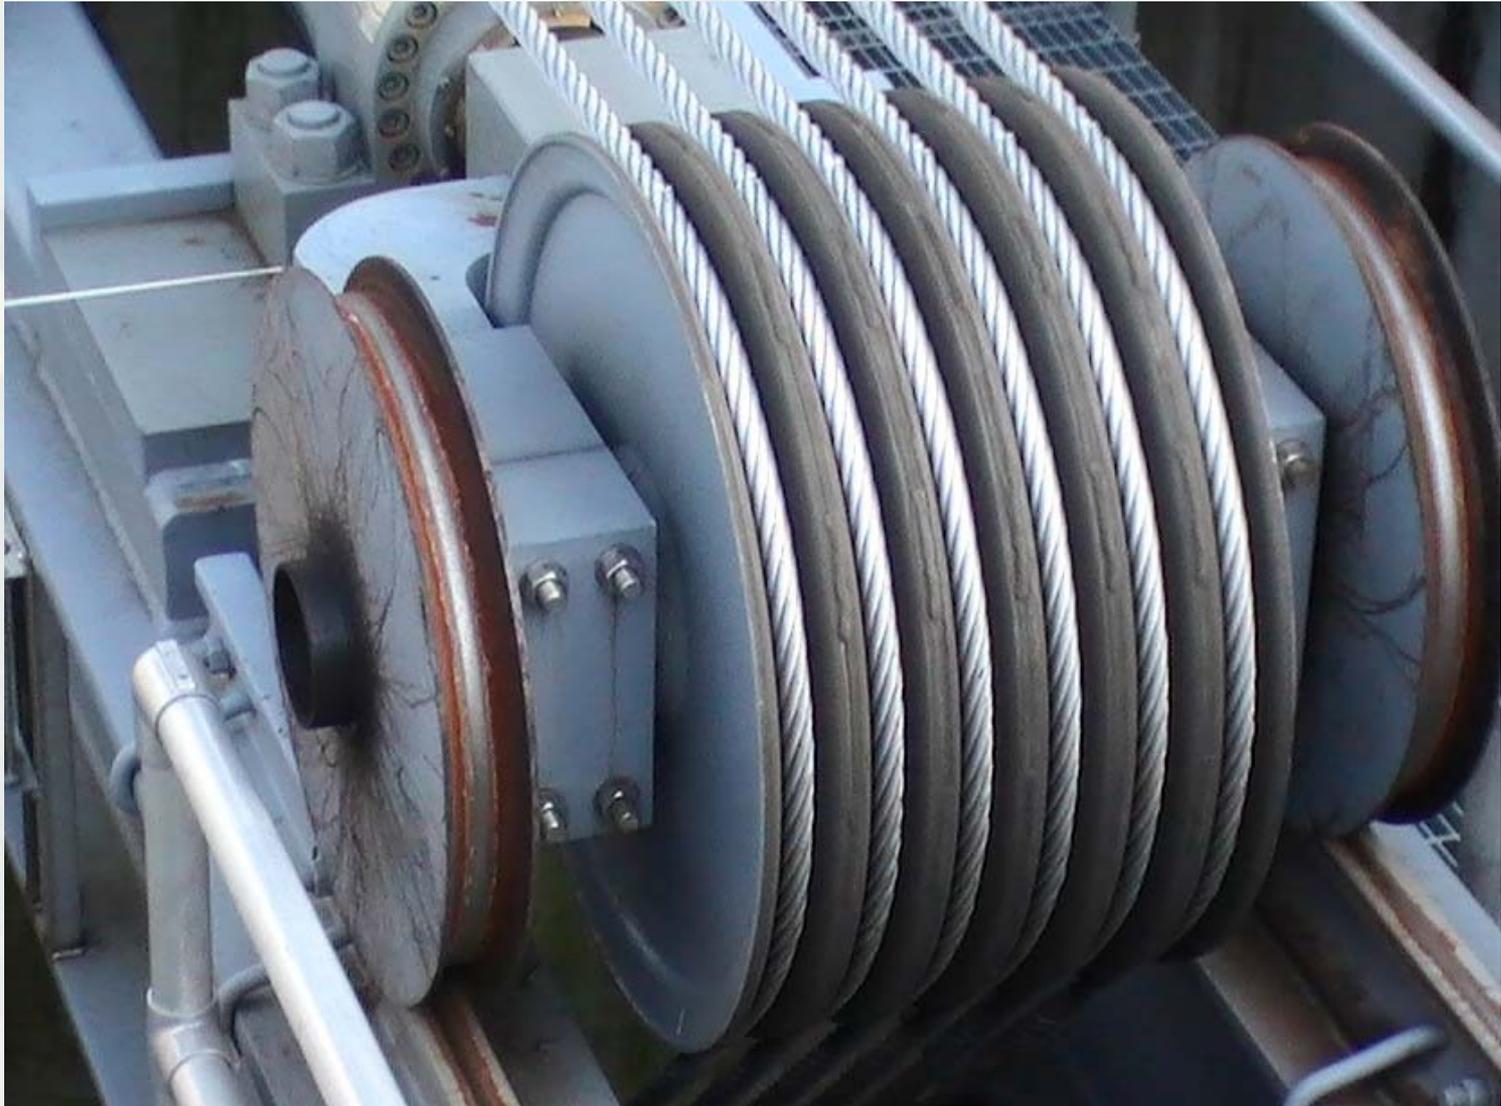
# Valve Sheave Pin Bushings

- Original Material – CIP 121
- Noise Noticed During Construction
- Replacement Material – CIP 151

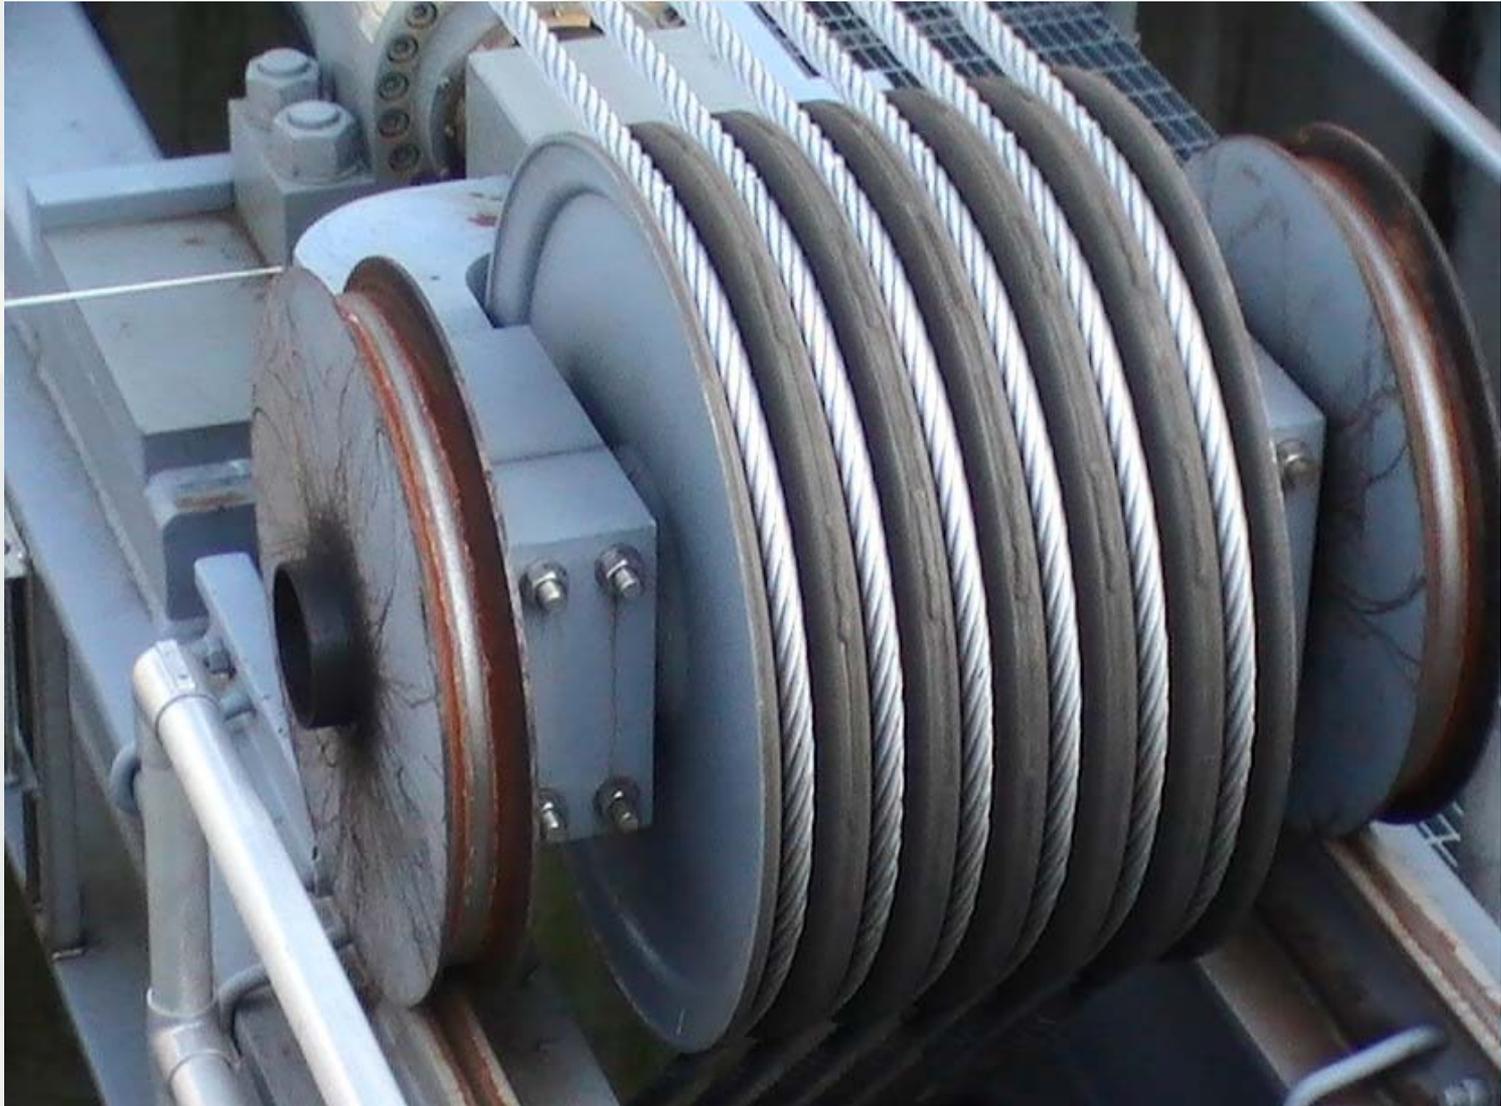
# Valve Machinery Wheels

- Material – CIP 121
- Displacement at Very Cold Temperatures
- Bushing Thermal Contraction Very Different from Metal Wheels
- Actual Temperature Range?
