# Polymer Composite Materials for the Repair and Maintenance of Navigation Structures

2013 Locks Maintenance Workshop  
Huntington, WV

Richard Lampo

ERDC / CERL, Champaign, IL

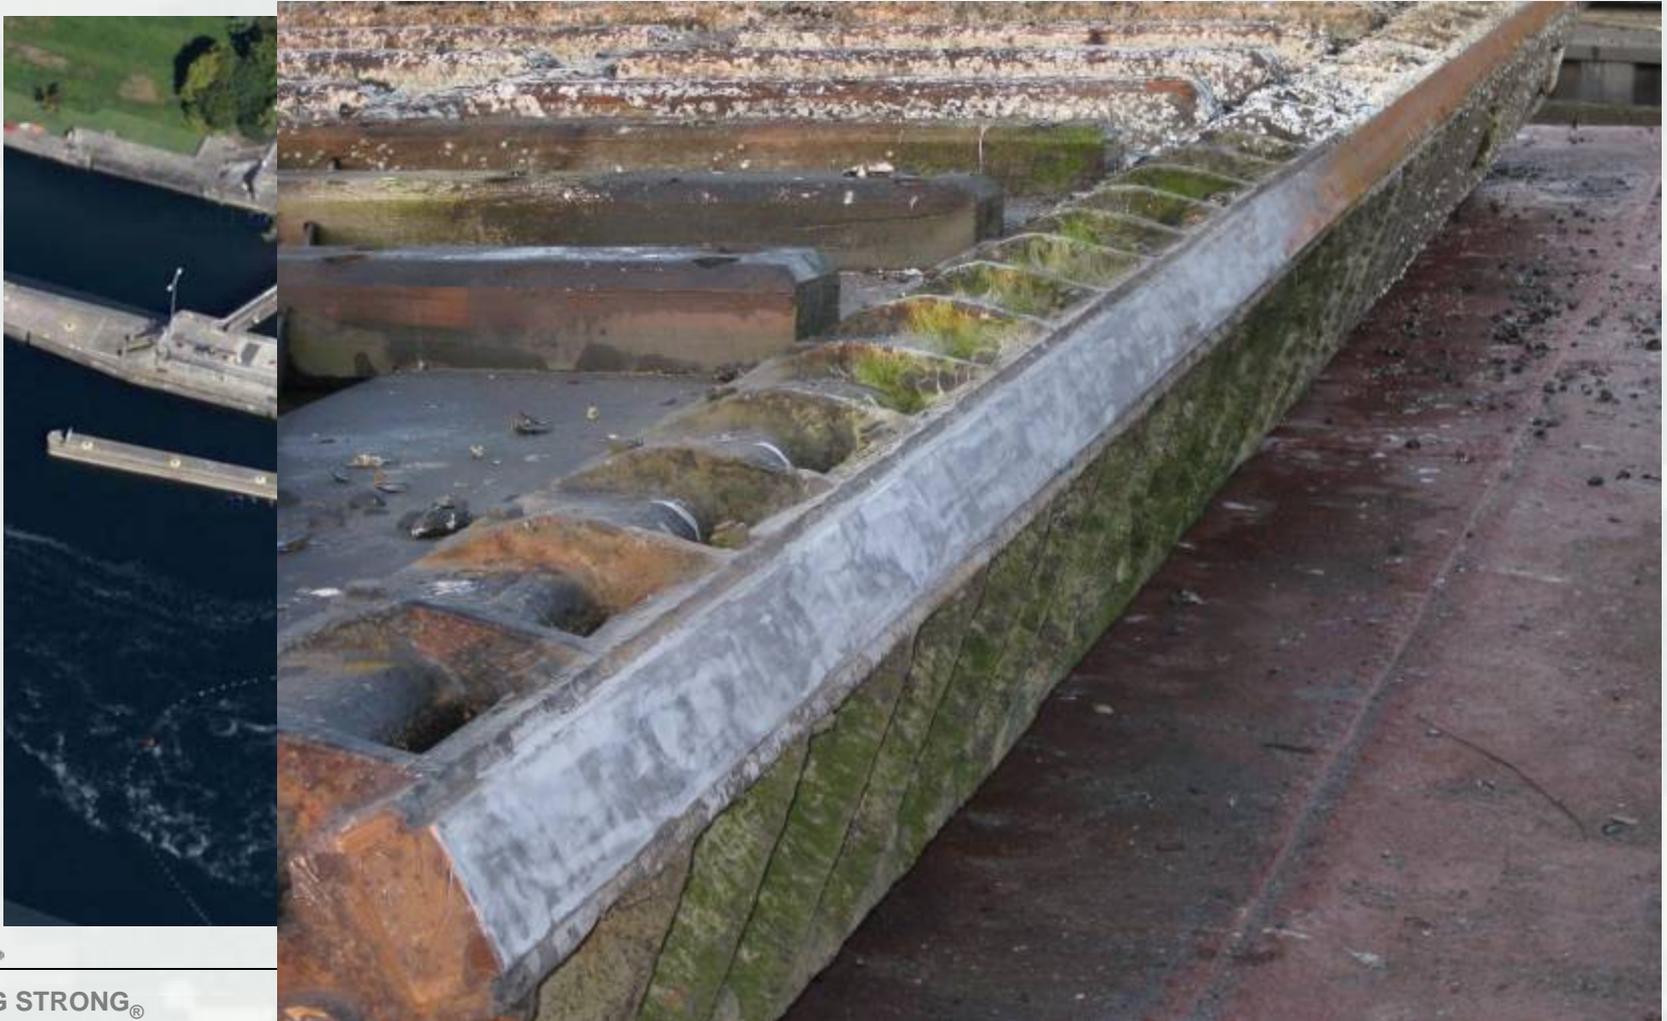
- **FRP Composite Miter Blocks for small lock on Washington Lake Canal, WA.** Blocks are 39 feet long on upper service gate and 19 feet long on lower service gate.

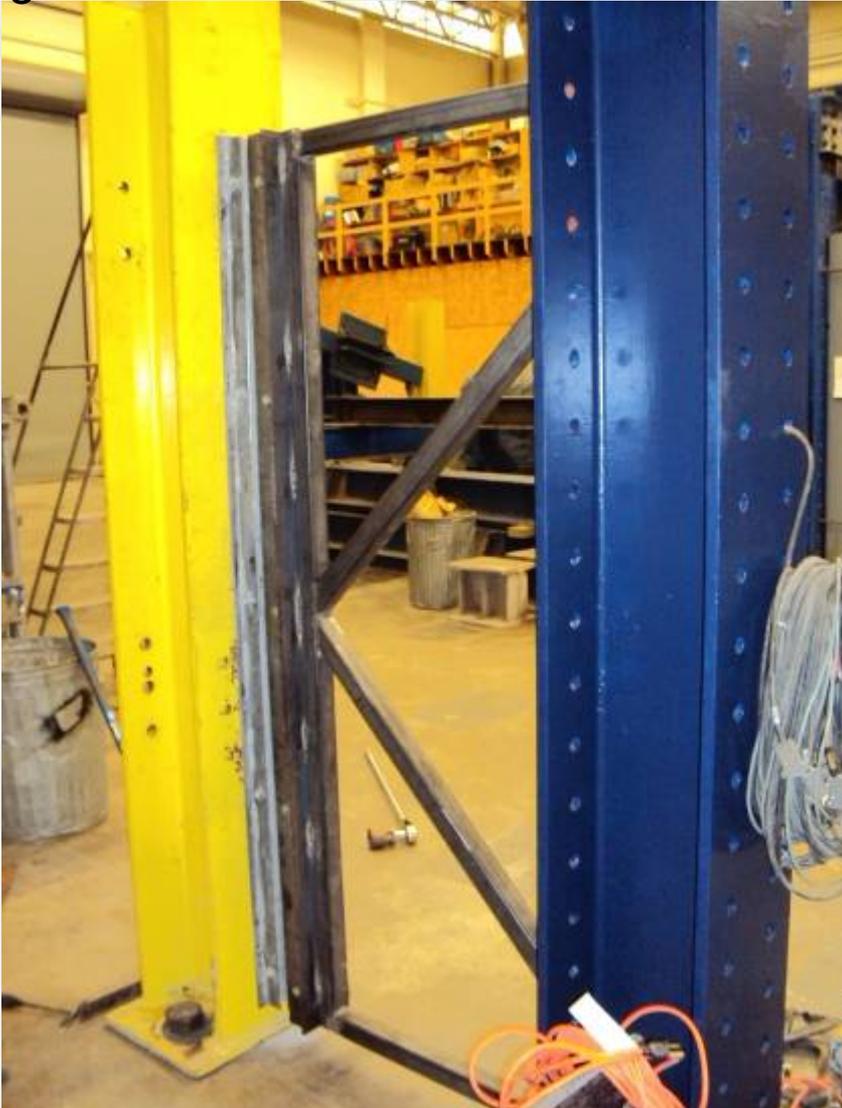
Miter gate FRP blocks (left-hand side) mounted on revolving and stationary gates

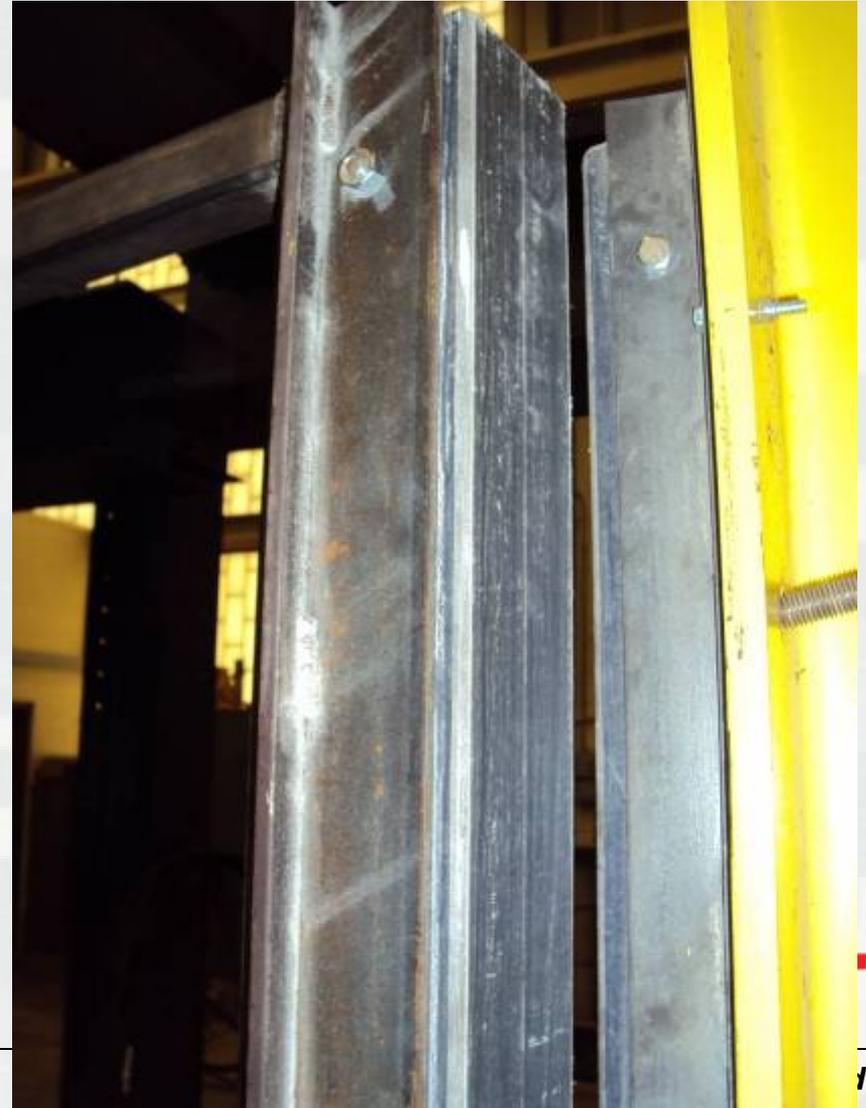
FRP miter block on rotating door on left and stationary FRP block on right gates

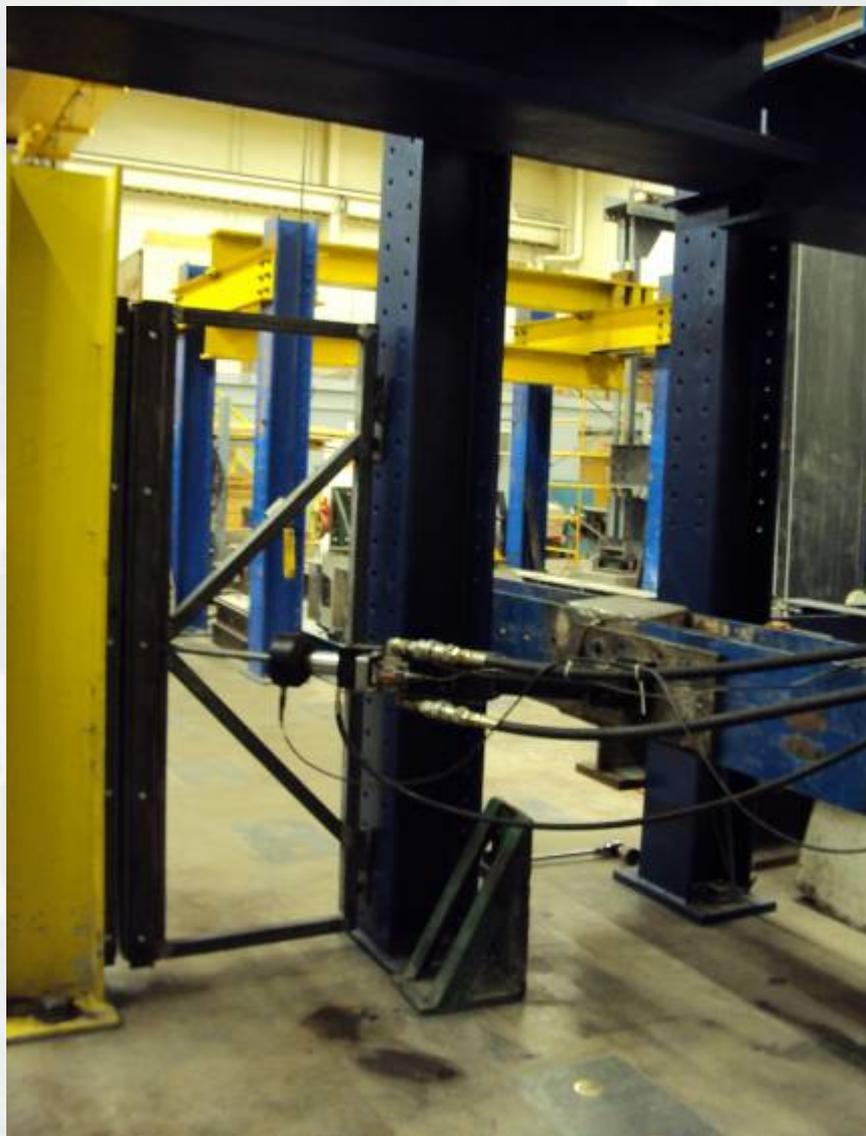
Miter gate FRP blocks (left hand side) on revolving and stationary door segments

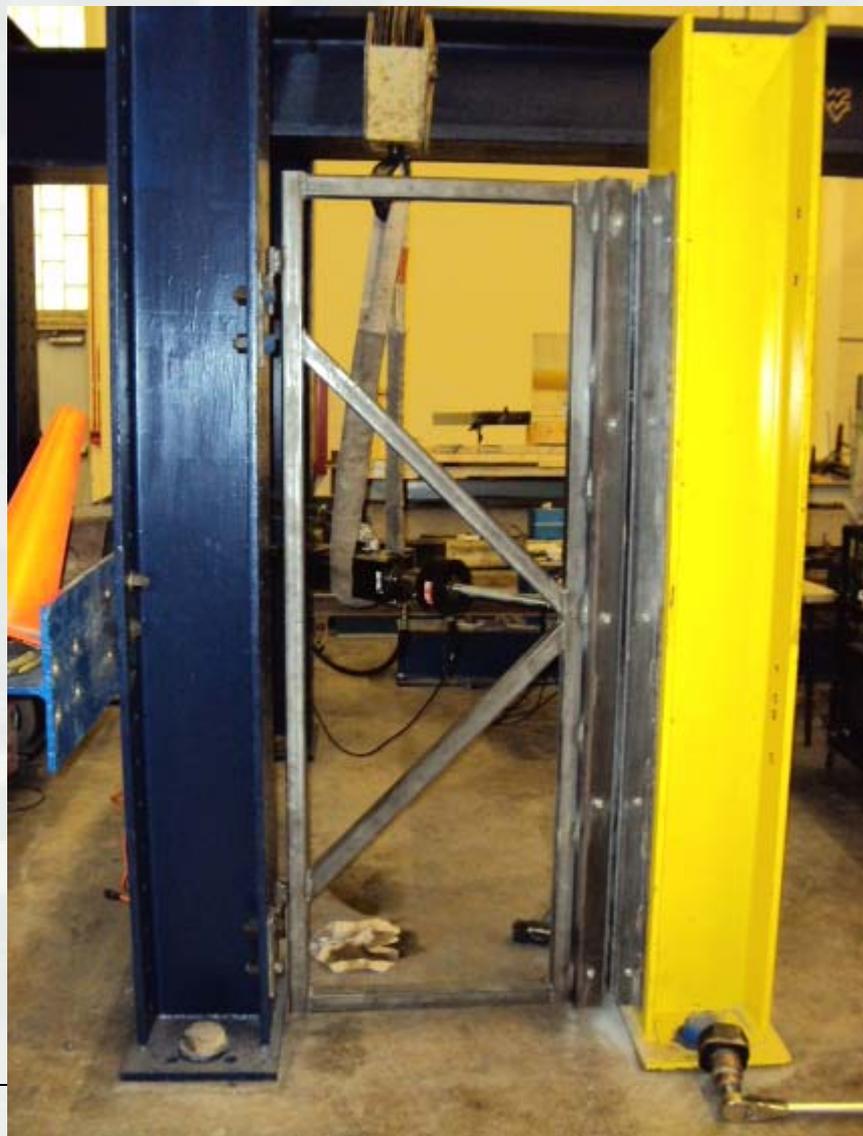
Miter gate FRP blocks (right side) on revolving (left) and stationary (right) door segments

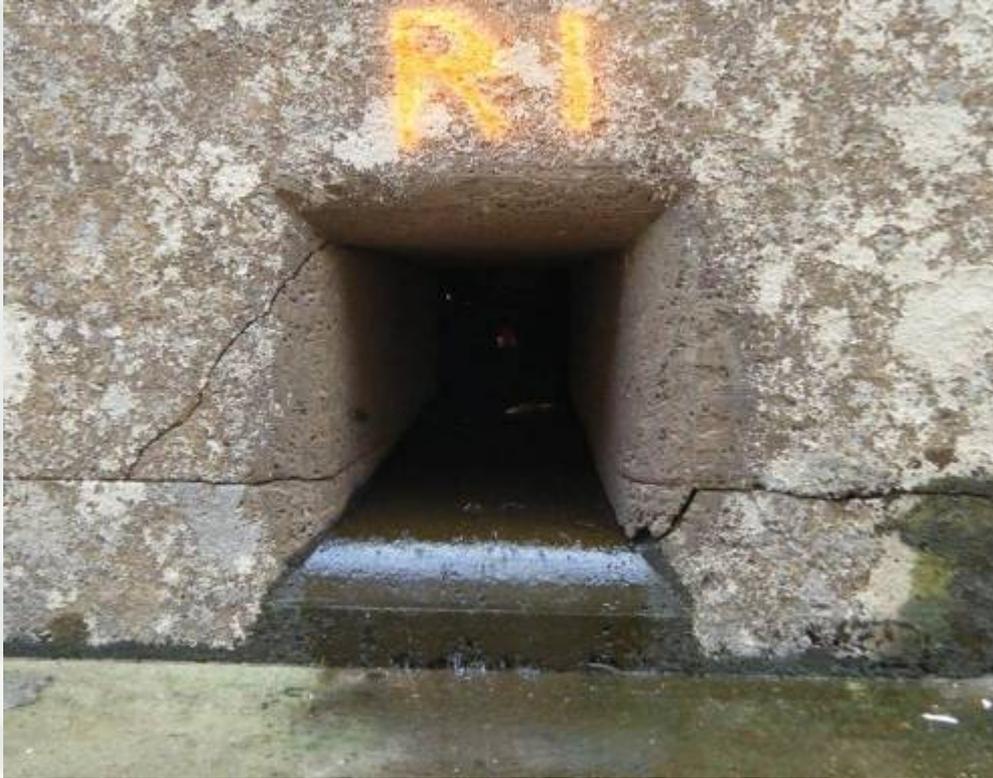
Example cracking at exit ports.

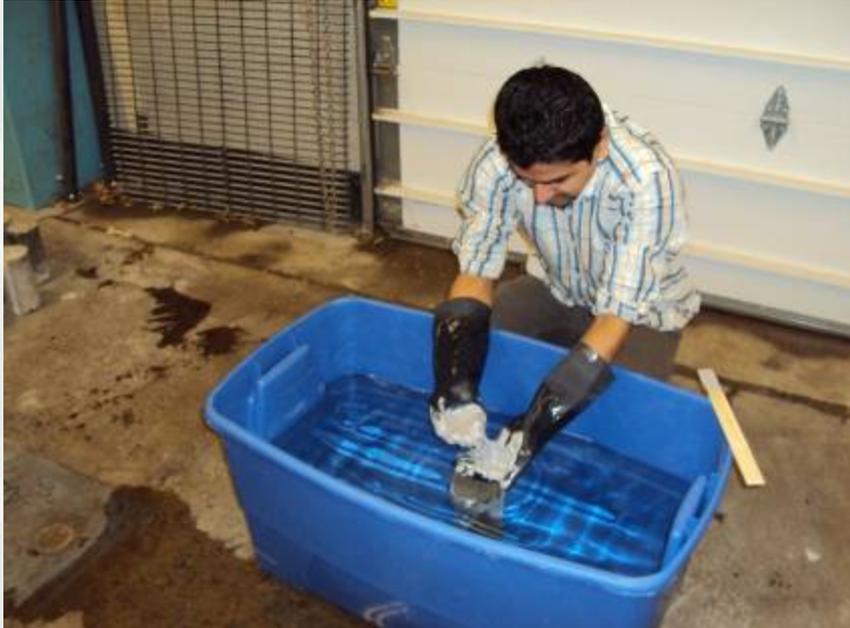
Underwater Primer Application

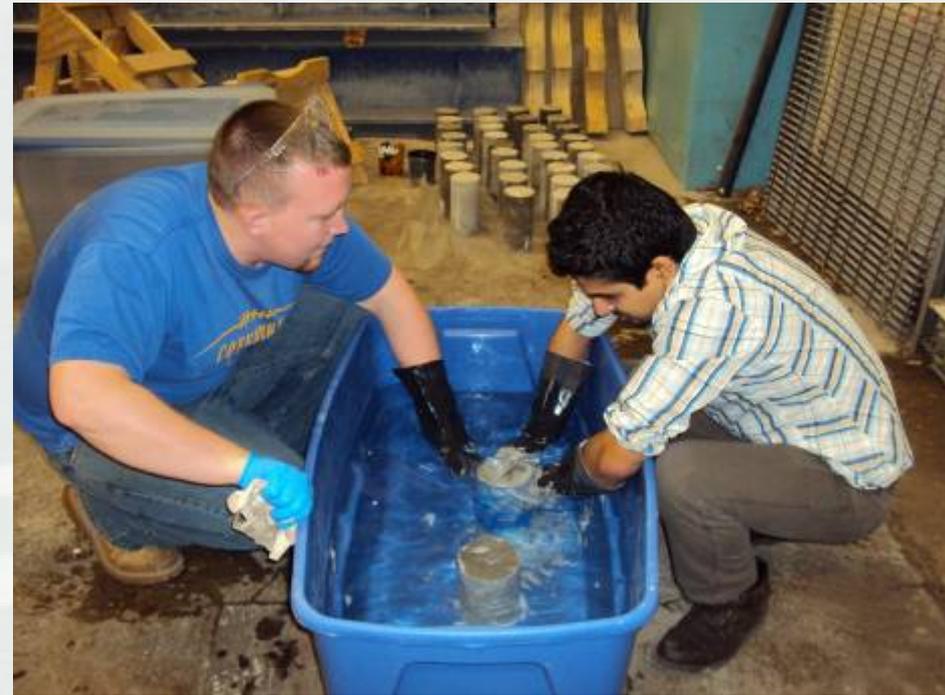
Underwater Circumferential  
Banding (pressure application) over  
GFRP Wrap

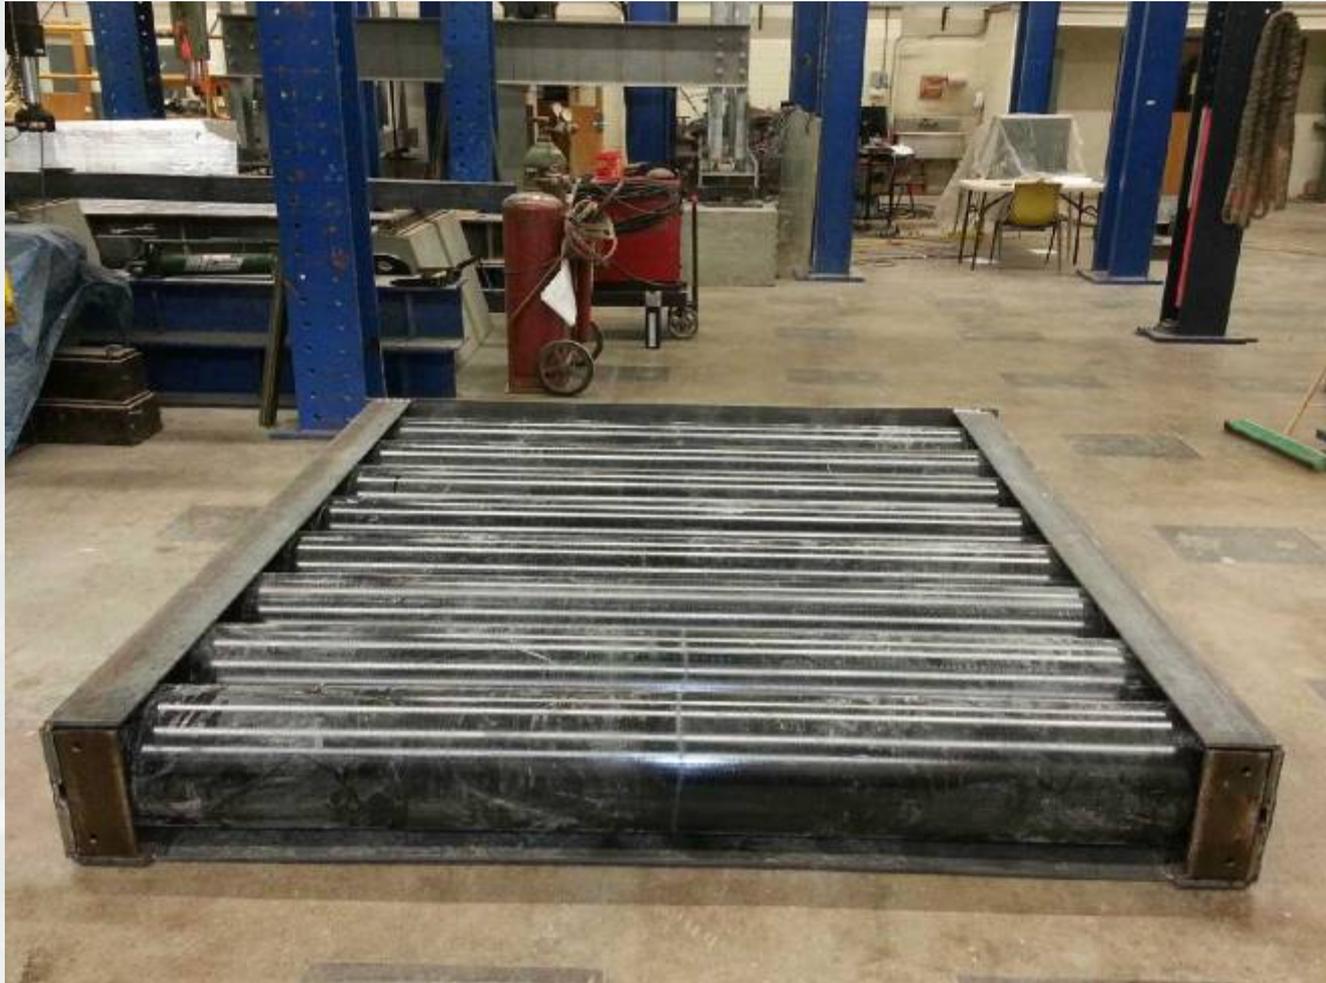
### FRP Pipes in Steel Casing

((Note: End plates are bolted & any FRP pipes/Sheets can be slid out or replaced, if there is local damage during service)

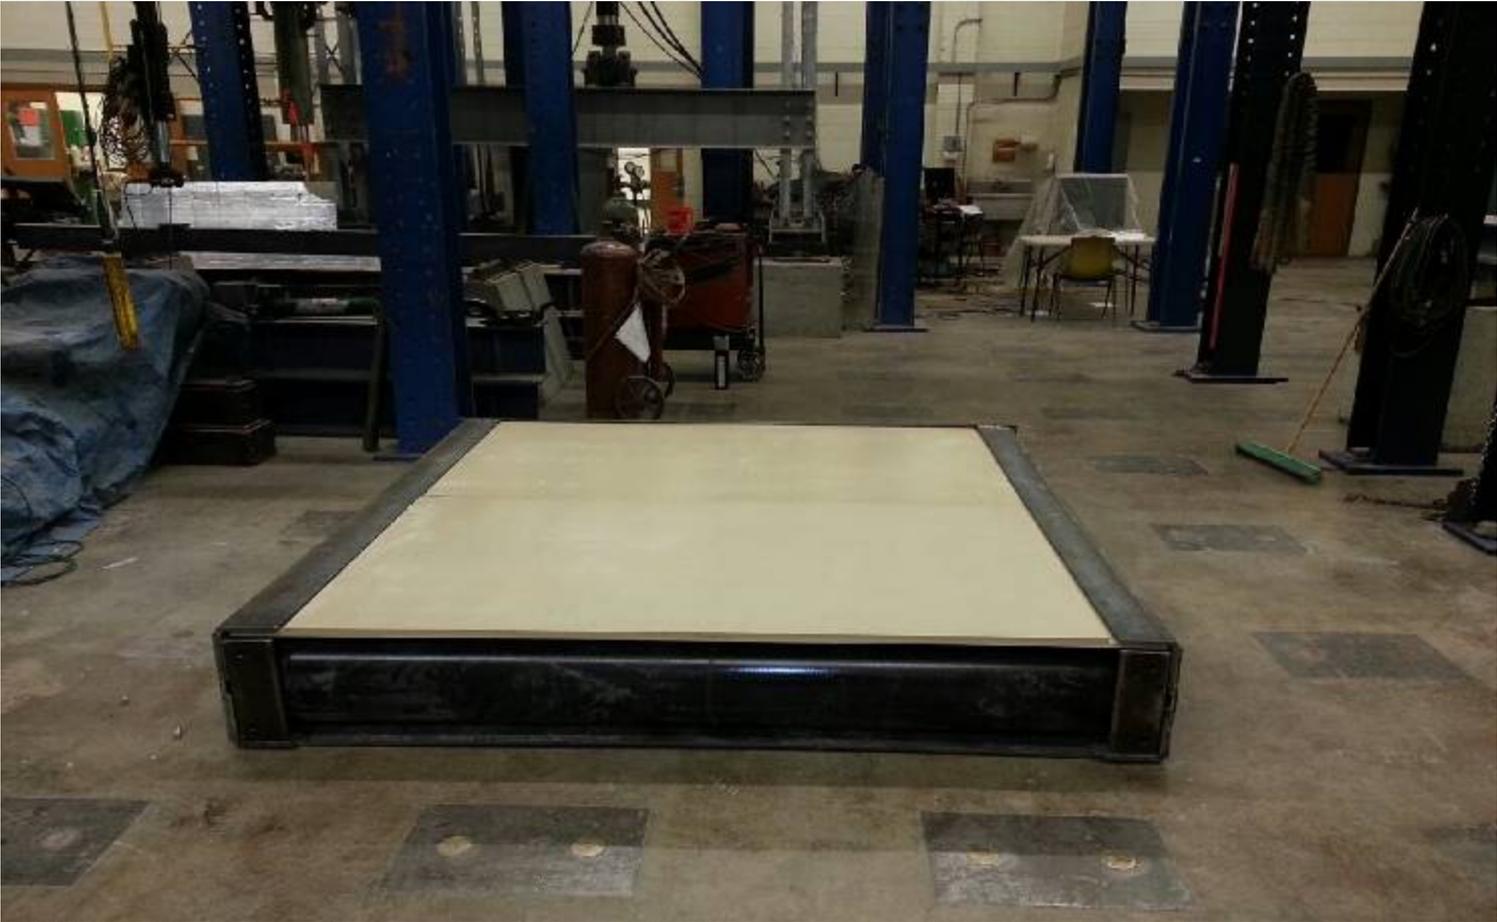
## FRP Pipes and Top sheet in Steel Casing

(Note: End plates are bolted & any FRP pipes/Sheets can be slid out or replaced, if there is local damage during service)

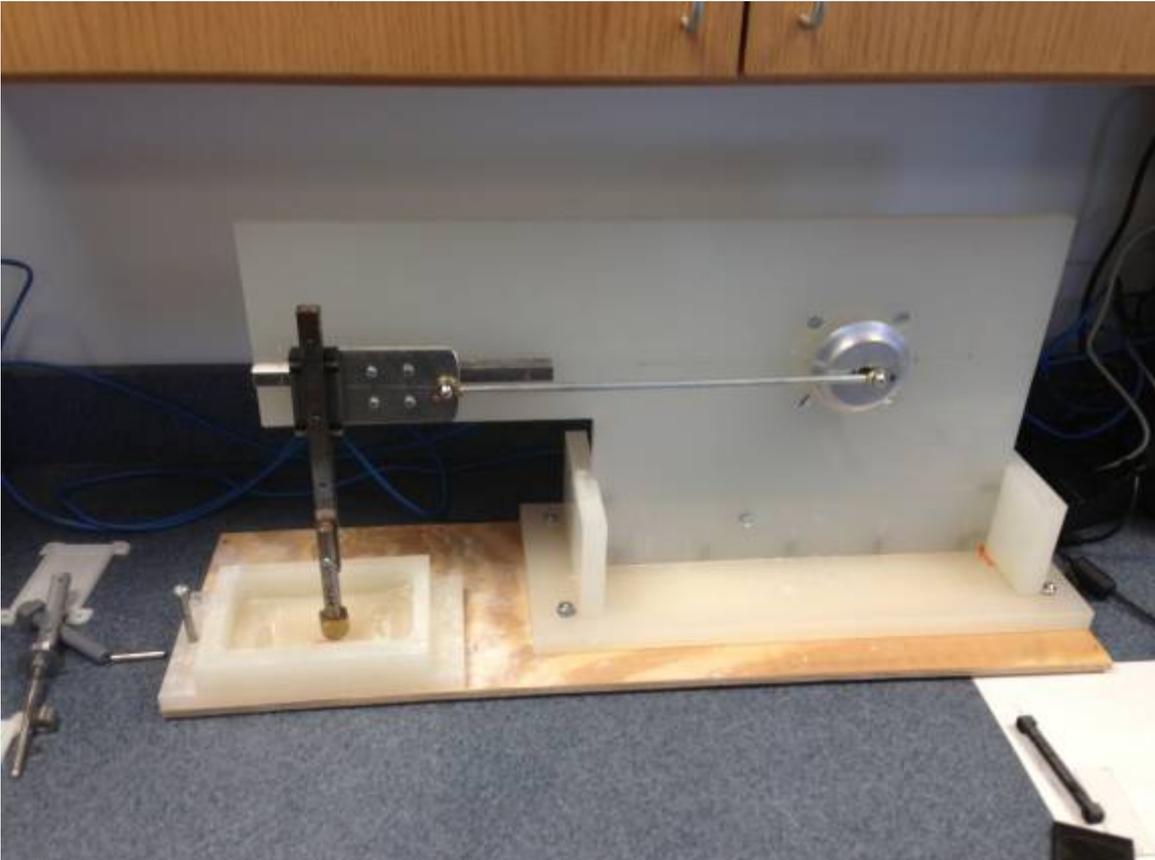
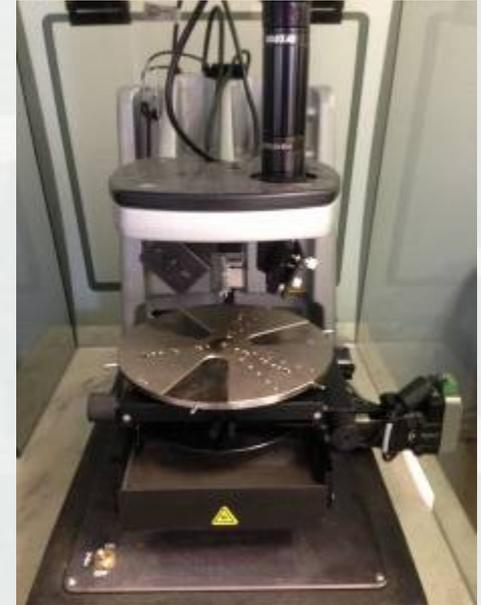
Reciprocating Abrading Steel Ball System (L) with Computerized Control & Profilometer (R)  
(Note: the tank will accommodate both securing of specimen and conditioning with liquid)

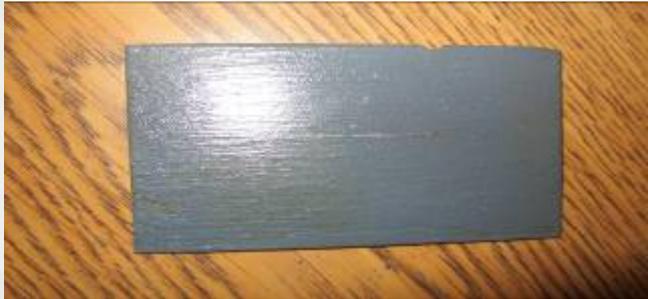
ARC 855 (Ceramic Composite)

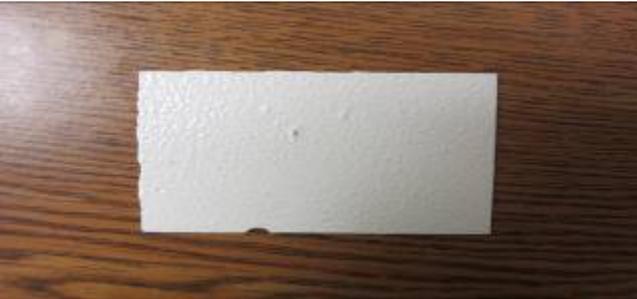
Dura Plate

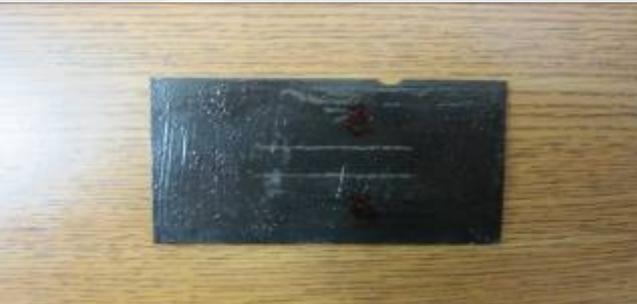
Tar Guard

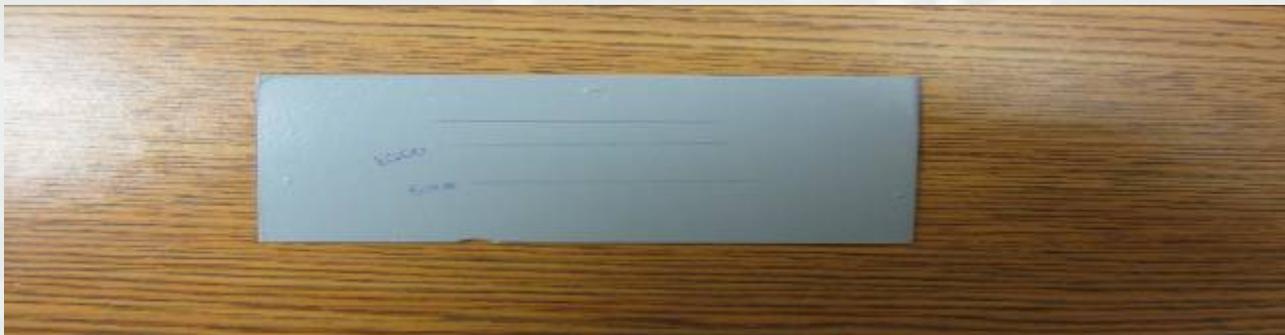
CoE Vinyl 5-e-z

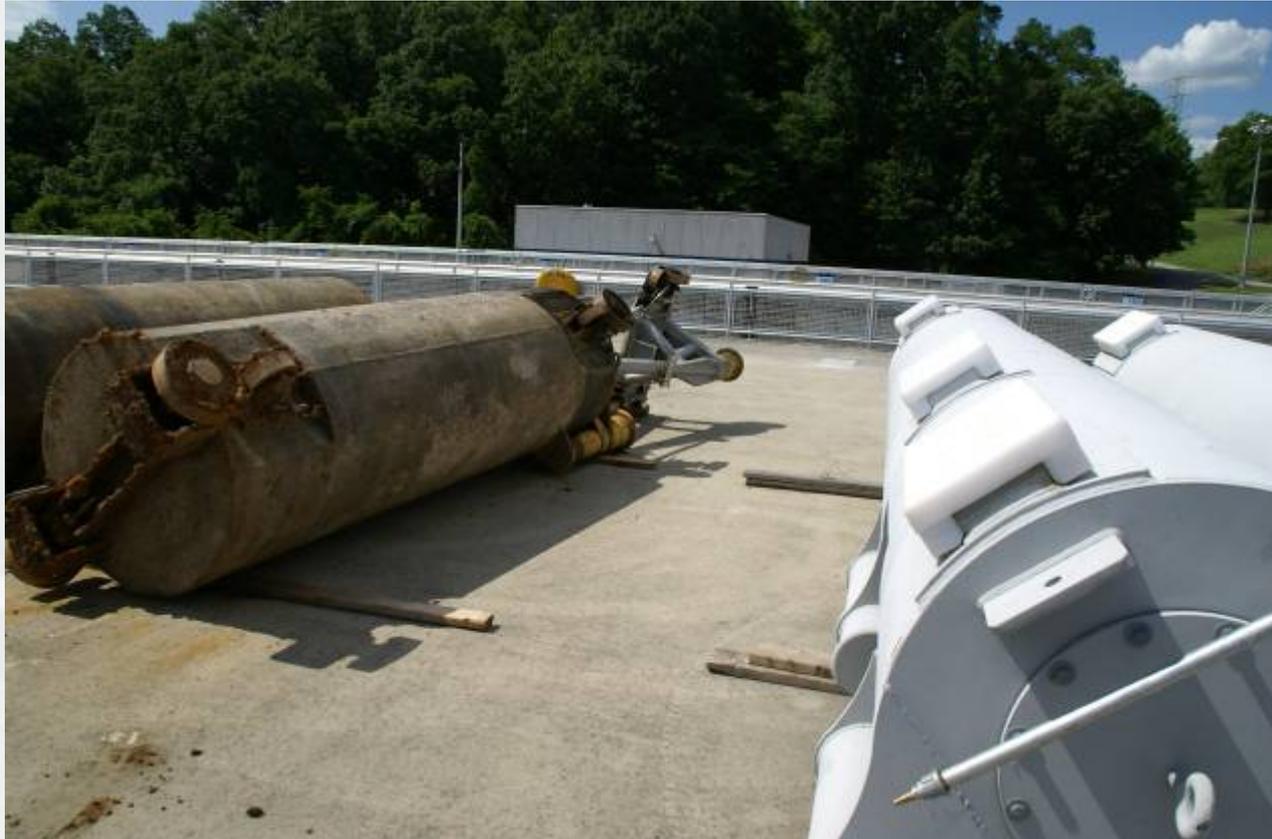
Replacing wheels on floating mooring bits with polymer slides.

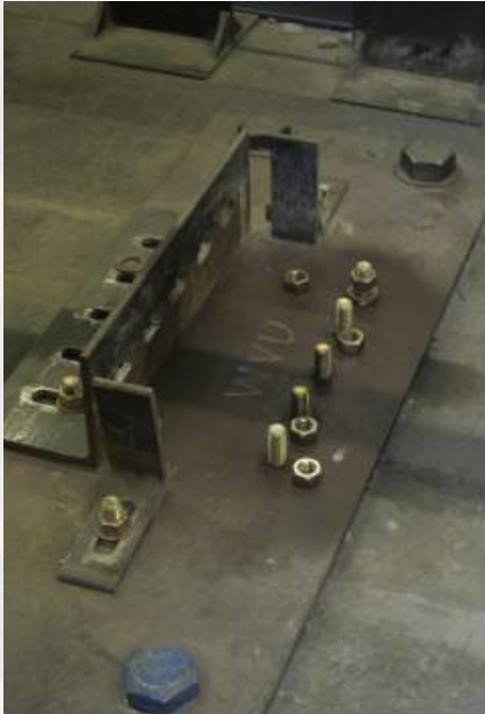
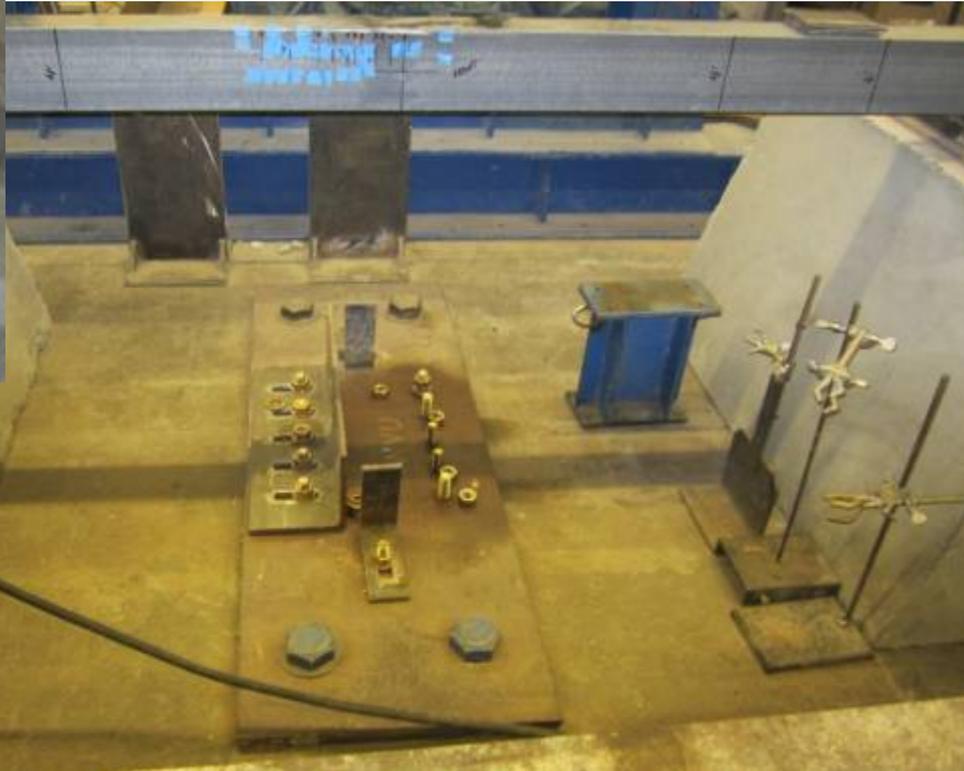
Steel Blocks and Adjustable Angle System bolted to Load Frame for testing 2'x10' wicket gate (in excess of 600 kip load frame capacity over 4 bolts)

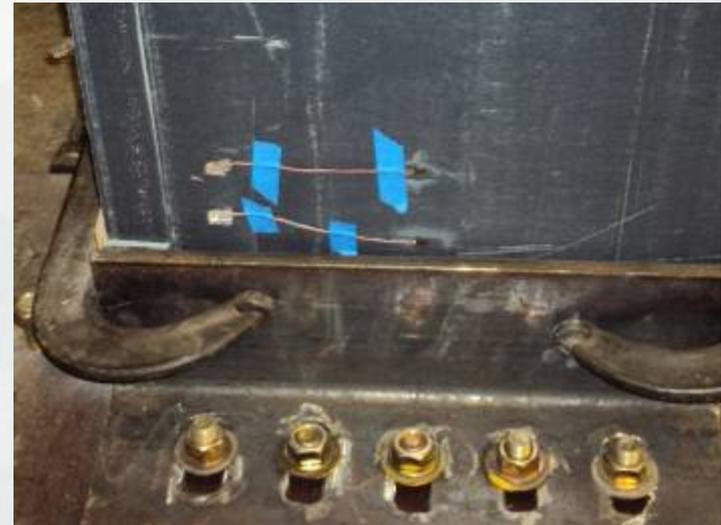
Strain gages on flange (near support)

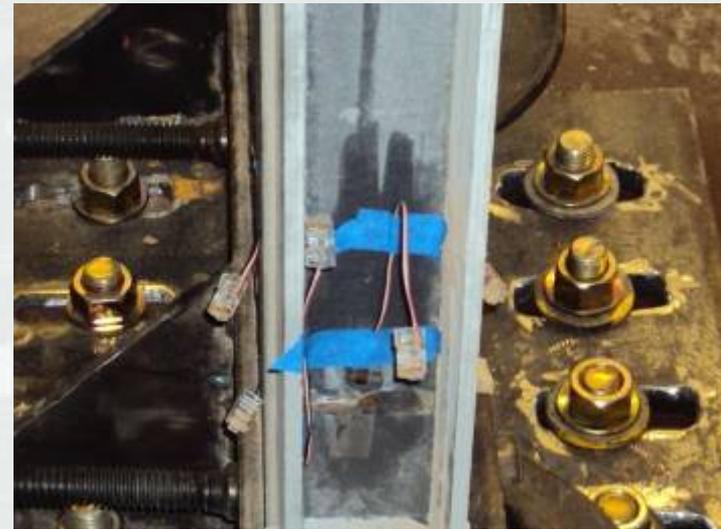
Strain gages on web (near support)
