# Evaluation of Embedded Wall Quoin Rehabilitation Methods

**Ross W. Woodbury, P.E.**

Louisville District

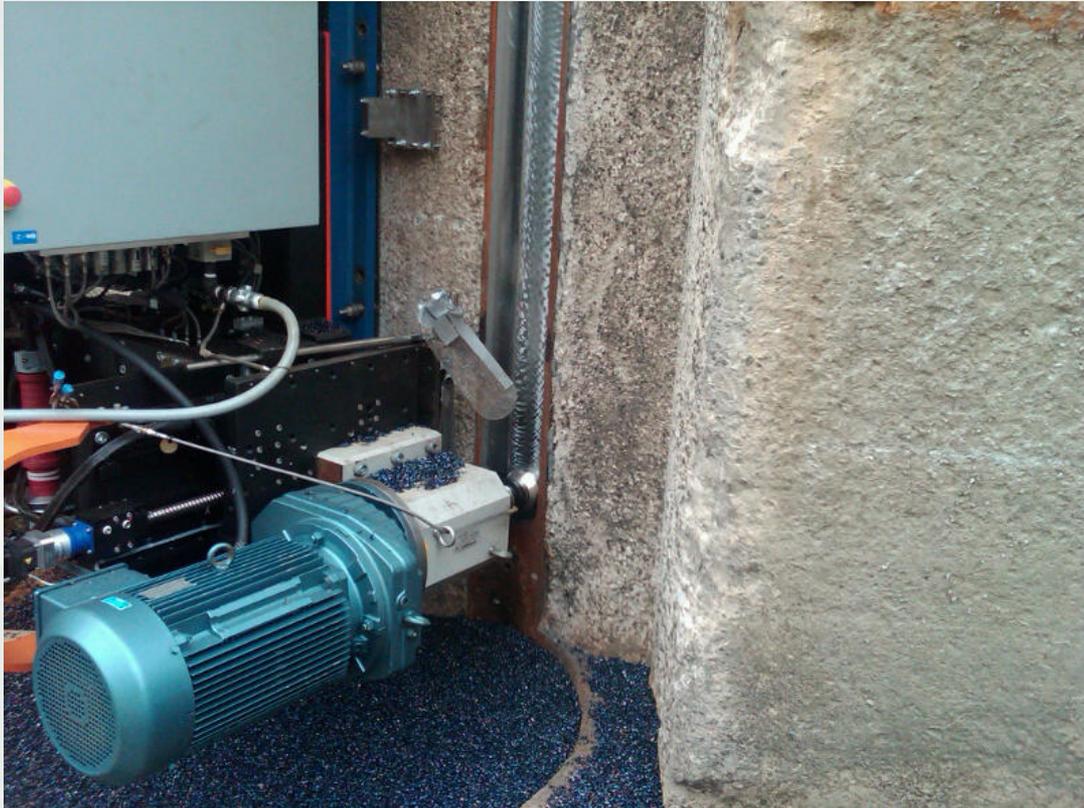
# Markland Milling

- At Markland the wall quoins were milled down for new removable replacement blocks. This required the purchase of two milling machines and replacement blocks.
- At Meldahl the second pour concrete was removed along with all the embedded steel. This required a contract for a large amount of concrete removal and the purchase of new embedded steel framing and new replaceable blocks.

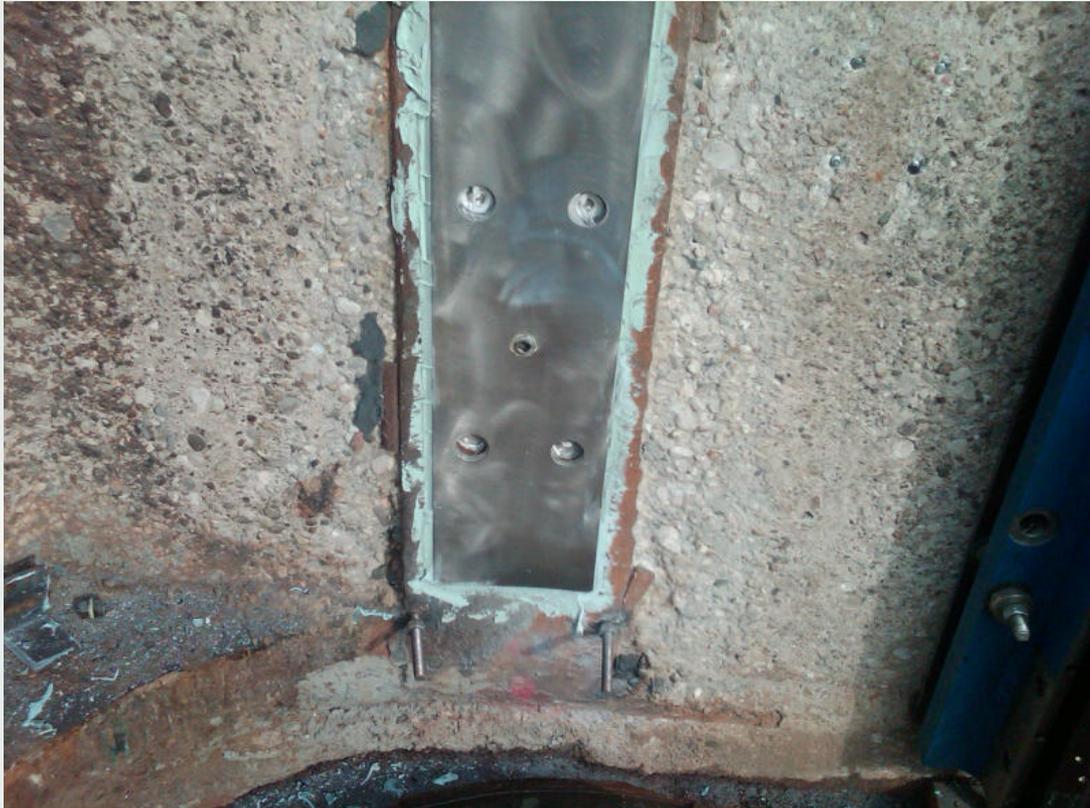
# Finished Wall Quoin

- Both projects will have wall quoin blocks that are adjustable and replaceable in the future
- Markland's are stainless steel clad on the bearing surface and backed with epoxy
- Meldahl's are carbon steel and backed with zinc
- Both projects will have new miter gates
- Both projects will have new or refurbished anchorages
- Meldahl will now have horizontal seals

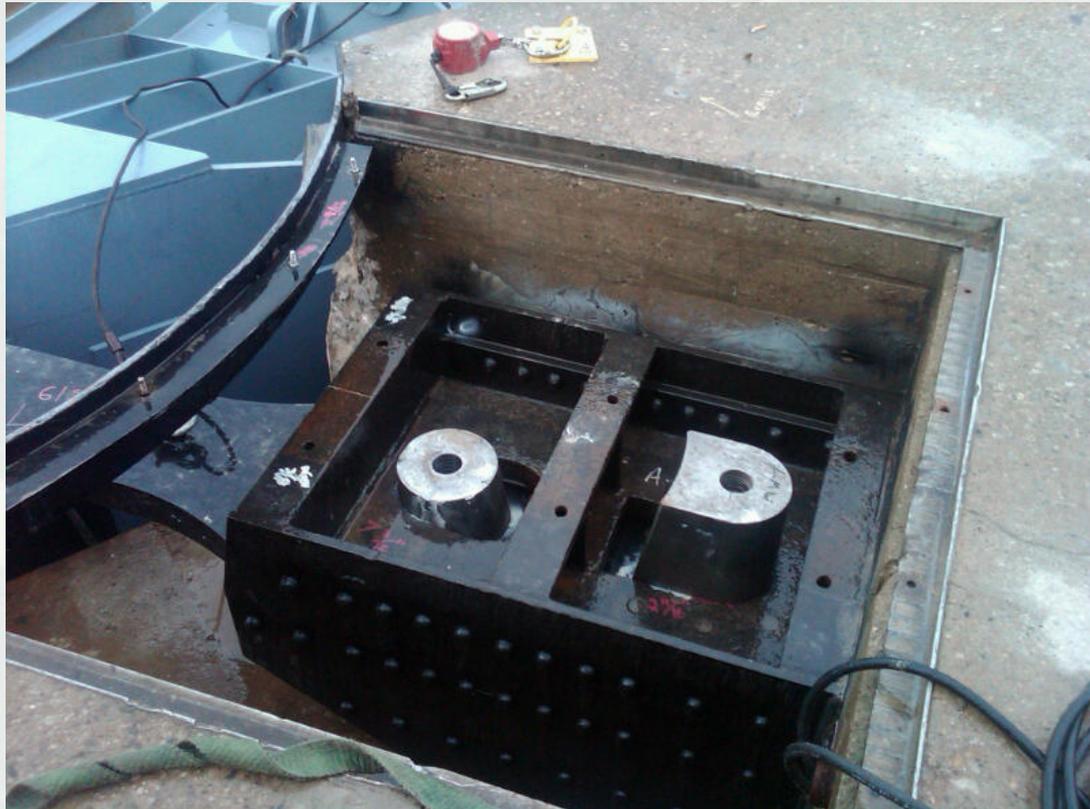
# Refurbished Markland Anchorage

- Existing embedded anchorage reused
- Heavy riveted structure analyzed for fatigue by Louisville Engineering Division. No concerns or problems found.
- Anchorages were sandblasted, inspected for cracks and defects by NDT methods. Anchorages were painted and assembled using original style components but with improved material properties and inspection during fabrication.

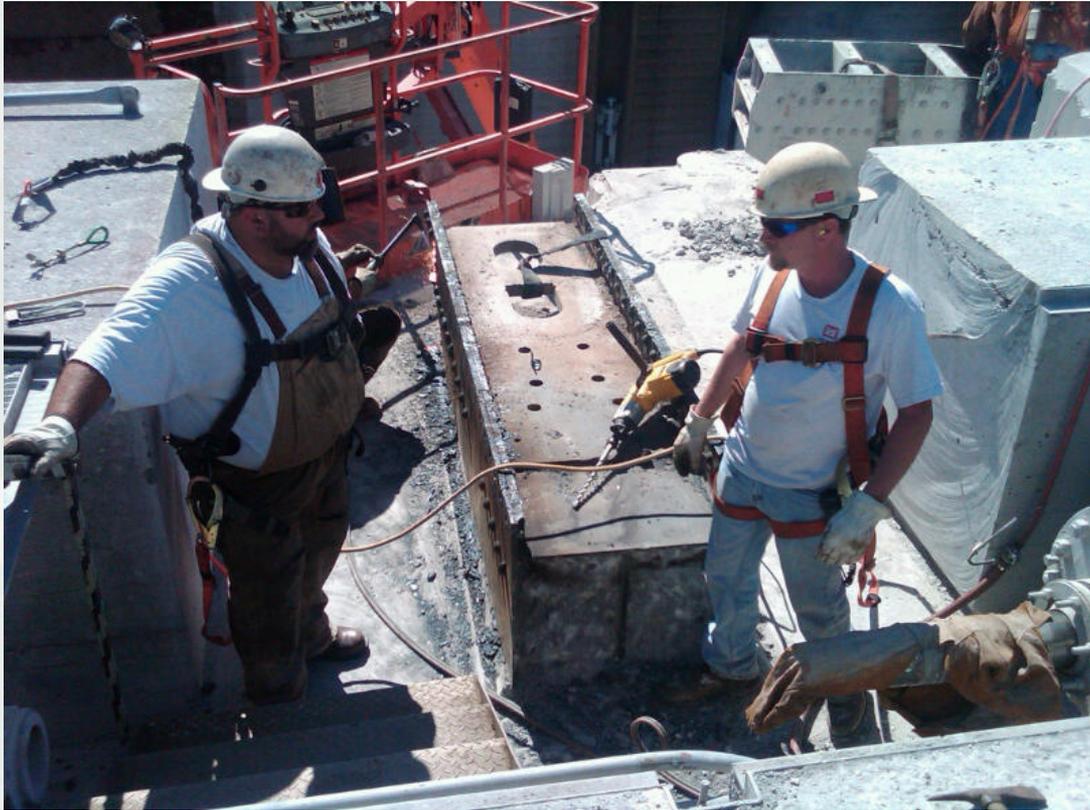
# Meldahl Anchorage

- The existing concrete around the anchorage was removed and the existing structure was modified to accept a new style anchorage per Huntington District Engineering Division. This was in response to the anchor arm failure at Greenup lock.
- The anchorage at Meldahl was the same as Markland.

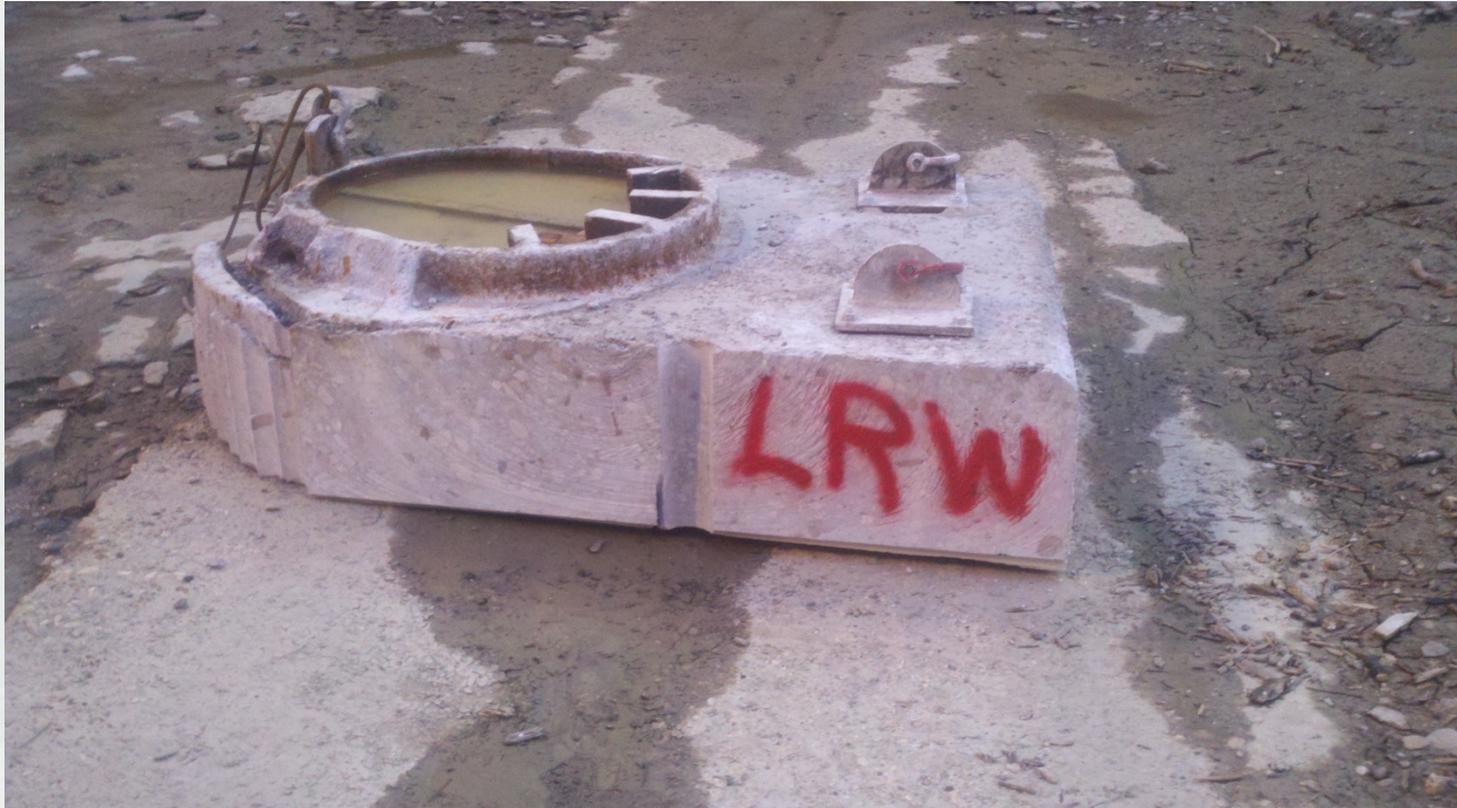
# Markland Pintle Base

- Markland pintle bases were replaced to change to a fixed pintle and the existing bases were damaged when the gates fell.
- Meldahl bases were modified to make the pintles fixed.

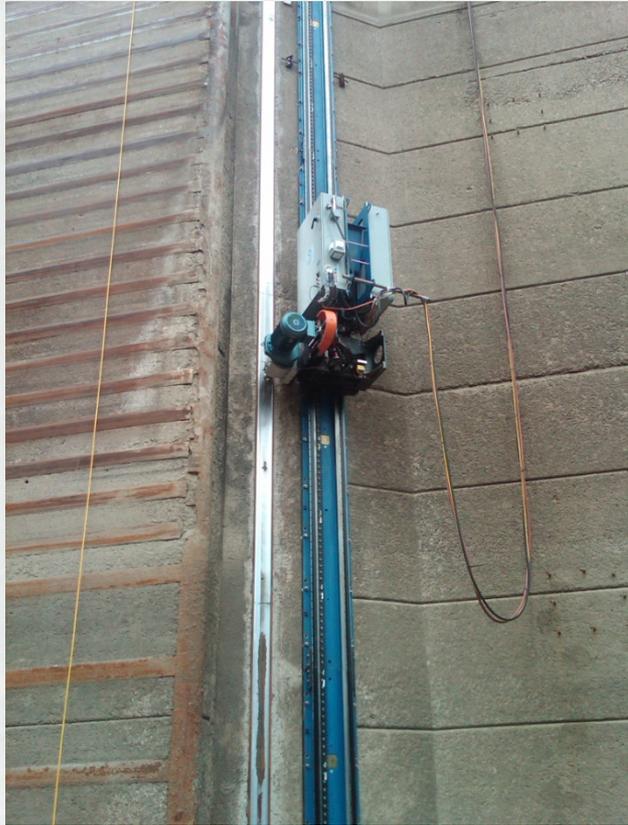
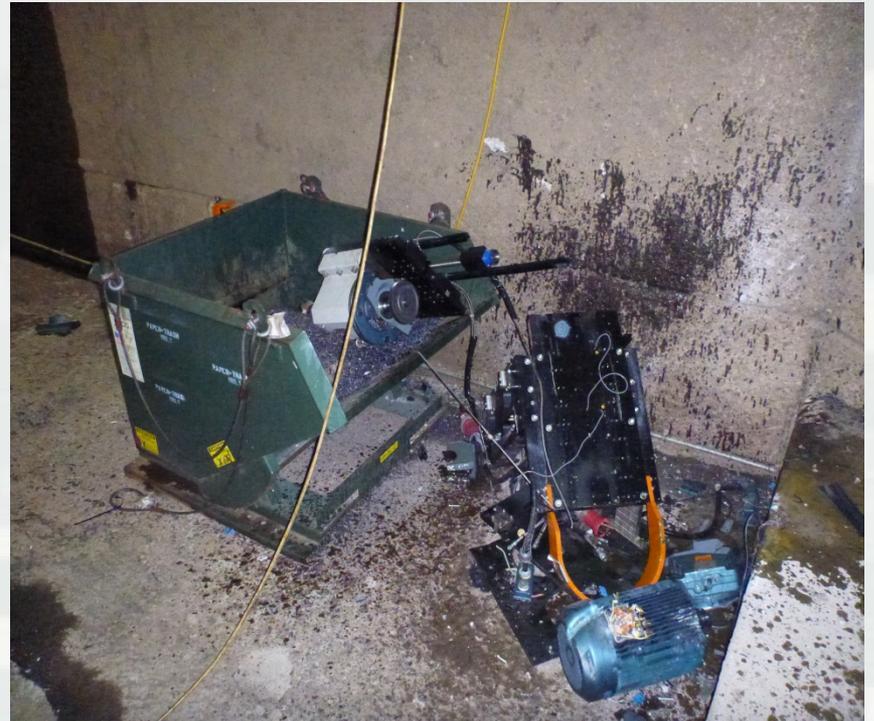
# Milling machine “problem”

- At about 1 am the bolts attaching the milling machine to the vertical track broke and the machining head fell 60 ft to the bottom of the chamber and was destroyed. This resulted in a delay for investigating and to move the machine from the river wall to the middle wall.
