Miter Gate Anchorages

**Maintenance Meeting
February 13, 2013**

**Structural Engineer
Huntington District
US Army Corps of Engineers**

Miter Gate Anchorage Failure

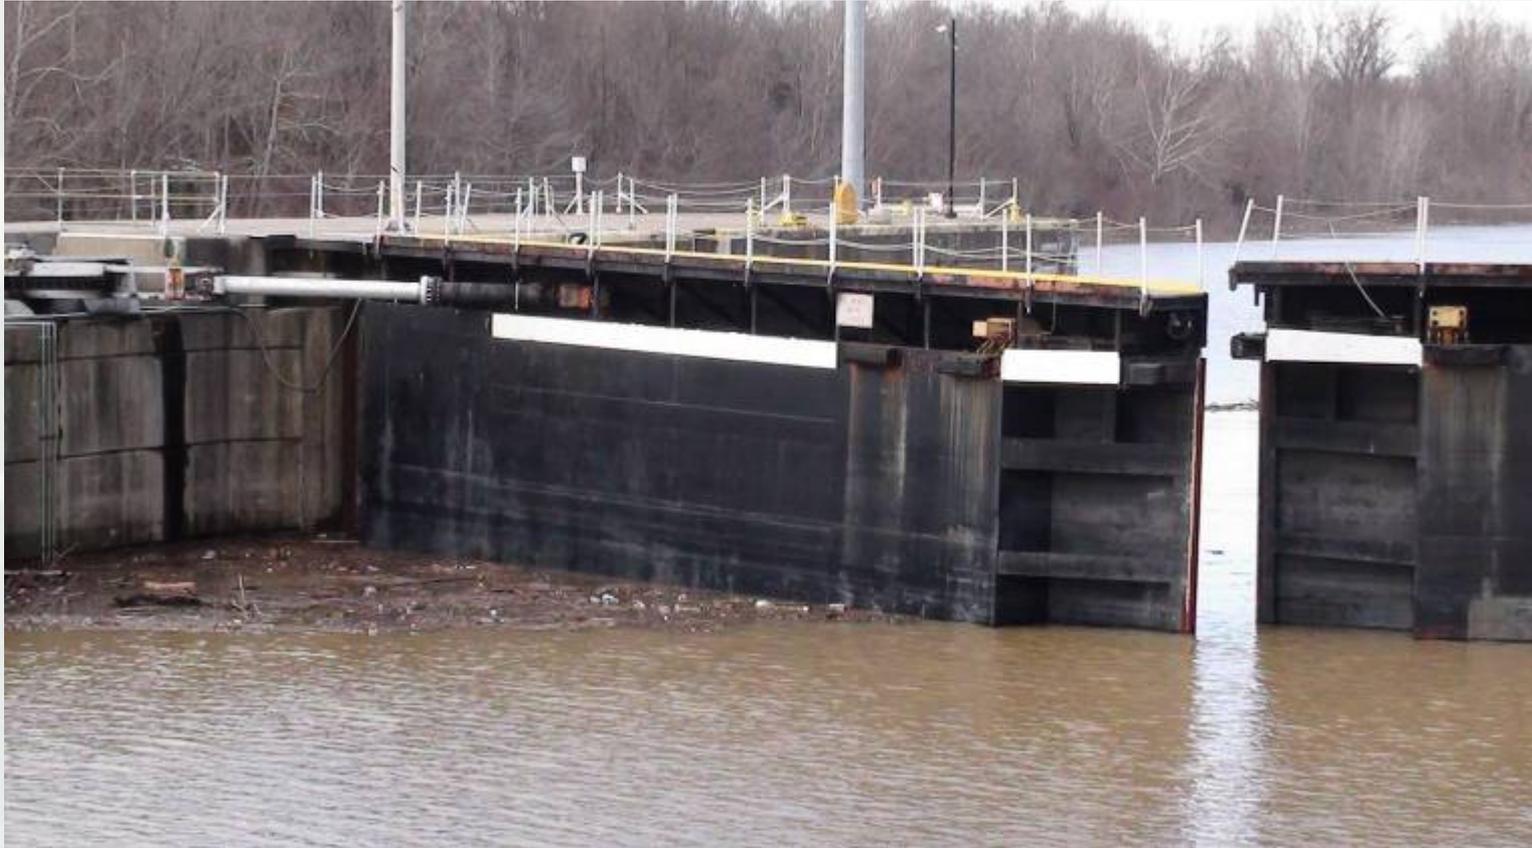
27 Jan 2010, 2:43 pm

Looking downstream – toe of gate dropped 1.2 ft

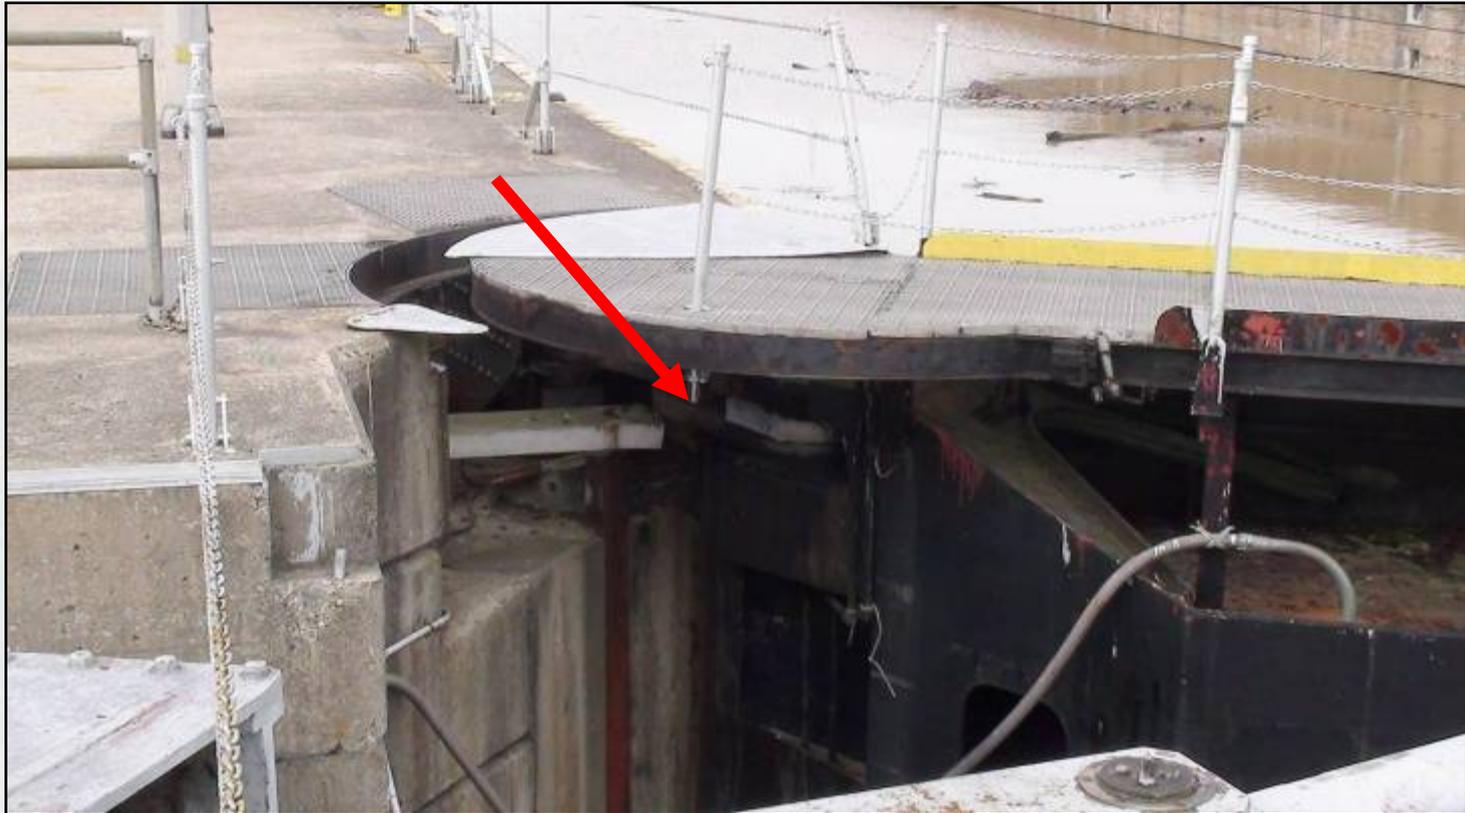
Broken Anchor Arm

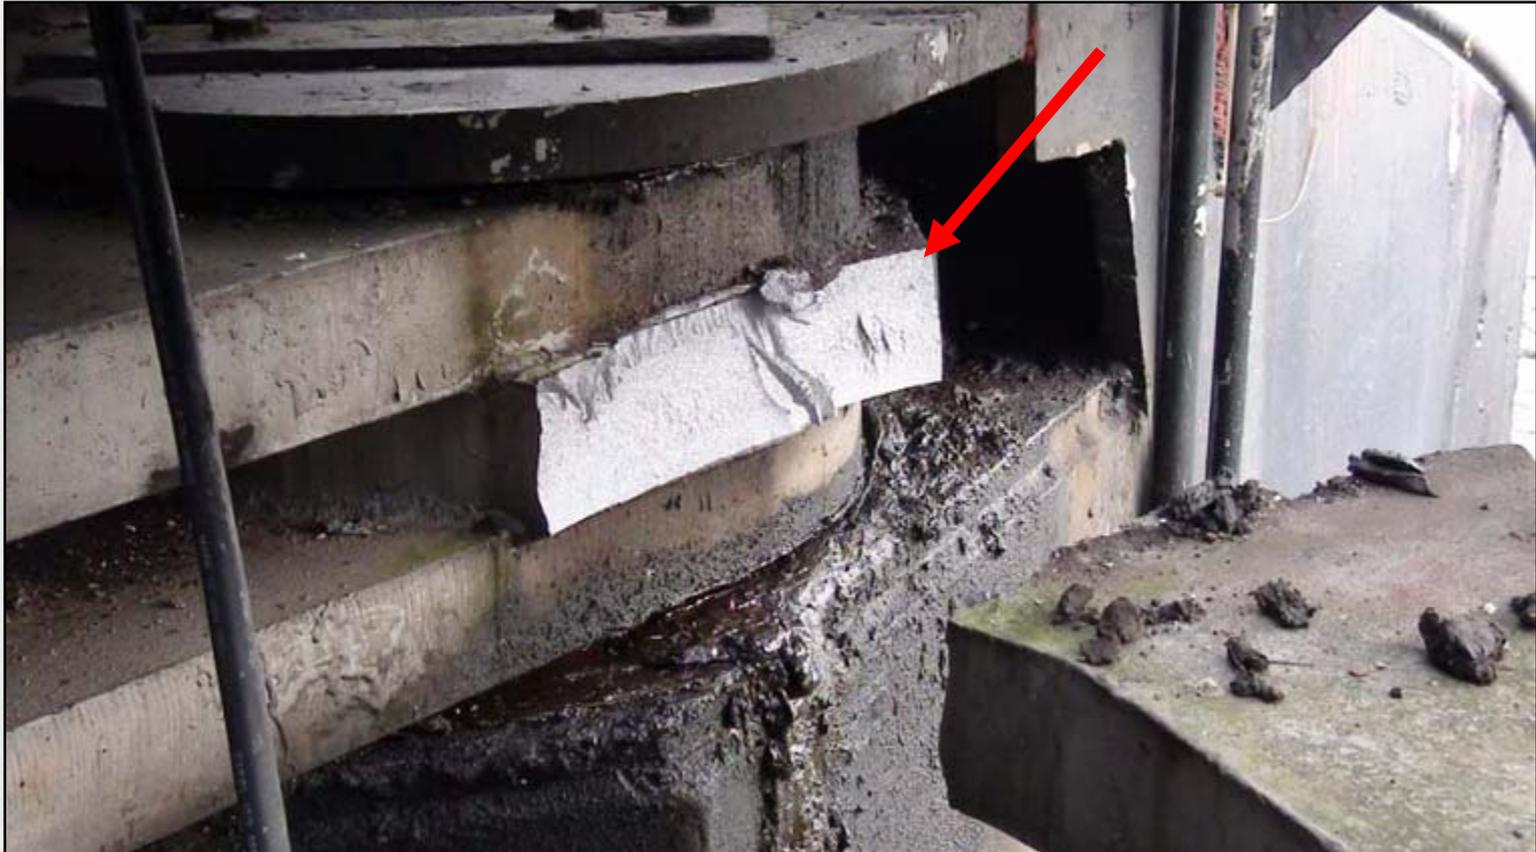
27 Jan 1416 hours

Broken Anchor Arm

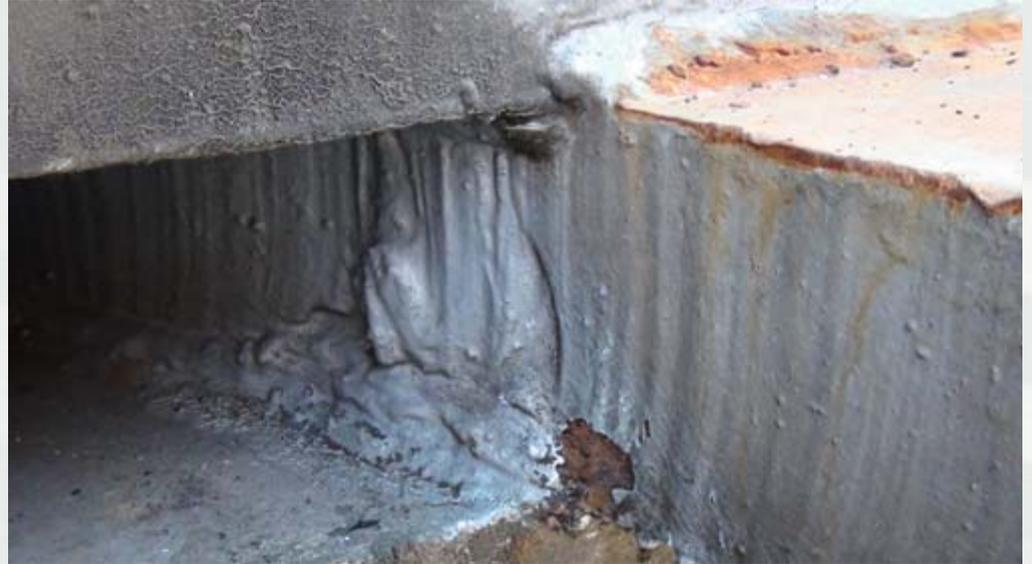
Periodic Inspection 2008

- 2008 PI this type of weld was identified as a potential problem.
- Shown as detail in EM 1110-2-2703

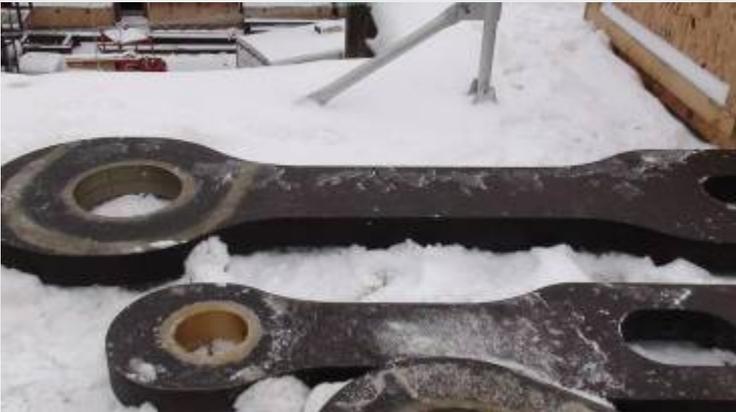
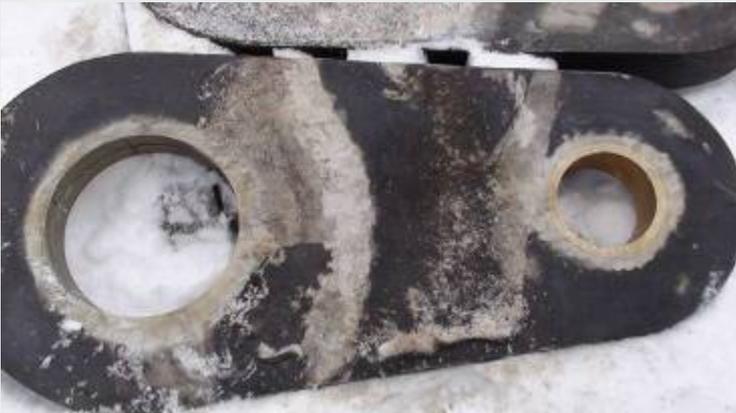
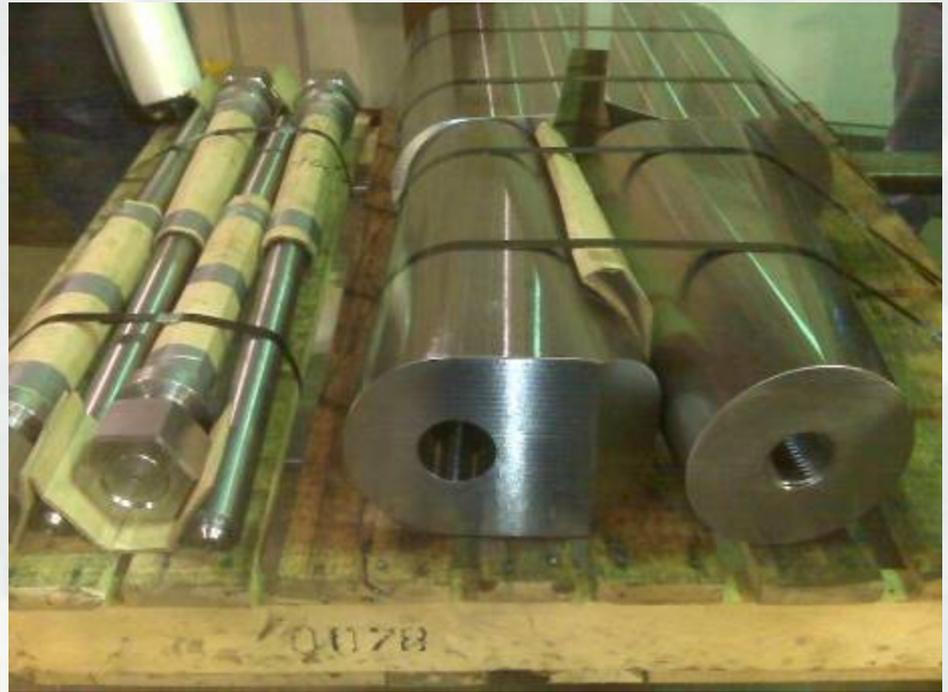
Replacement Gate Anchorages

Repair parts

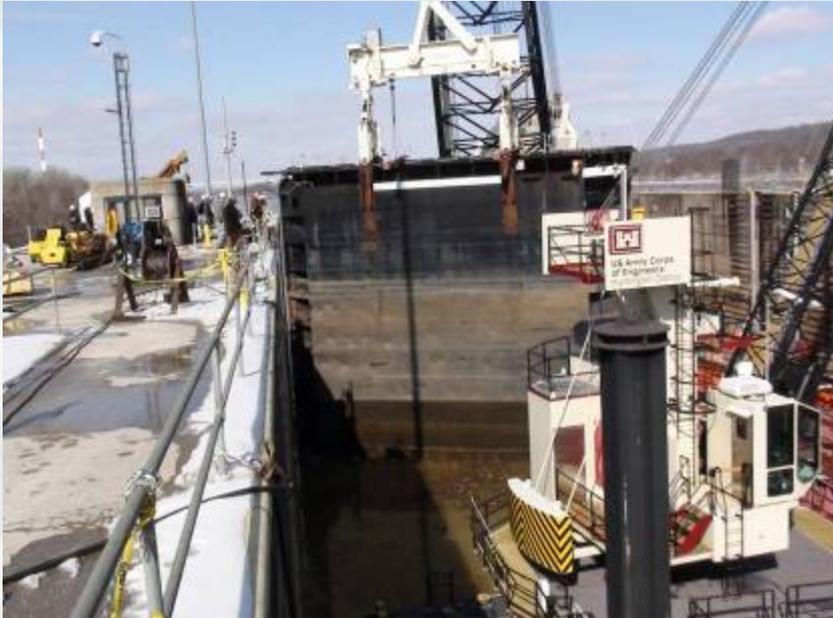
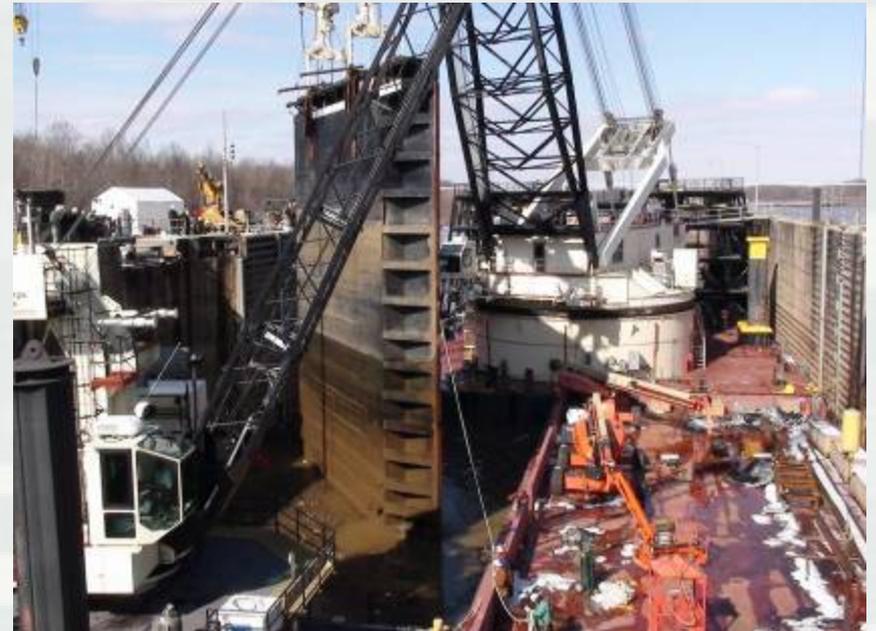
Lifting of Miter Gate

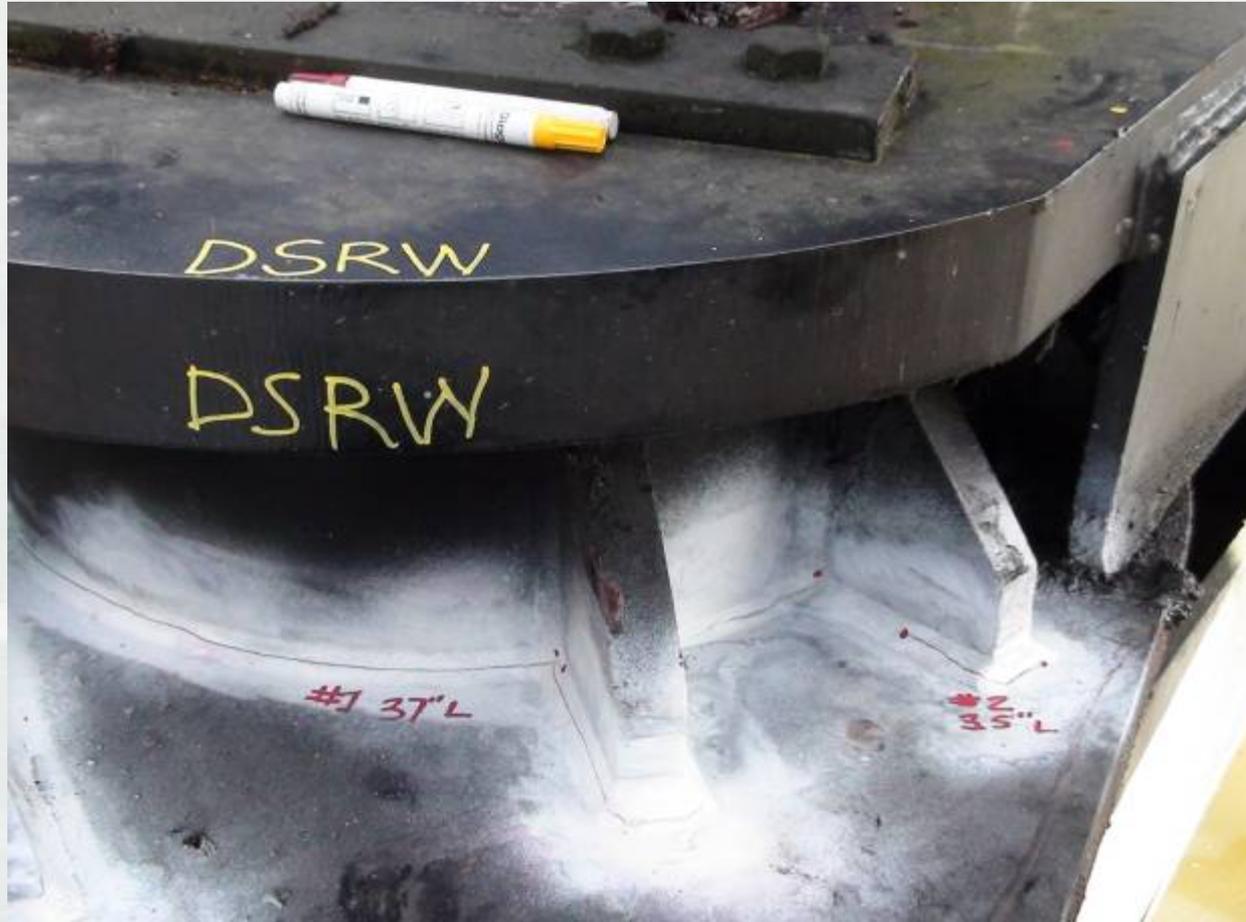
Winfield Locks & Dam

Cracks in Original Gudgeon Barrel

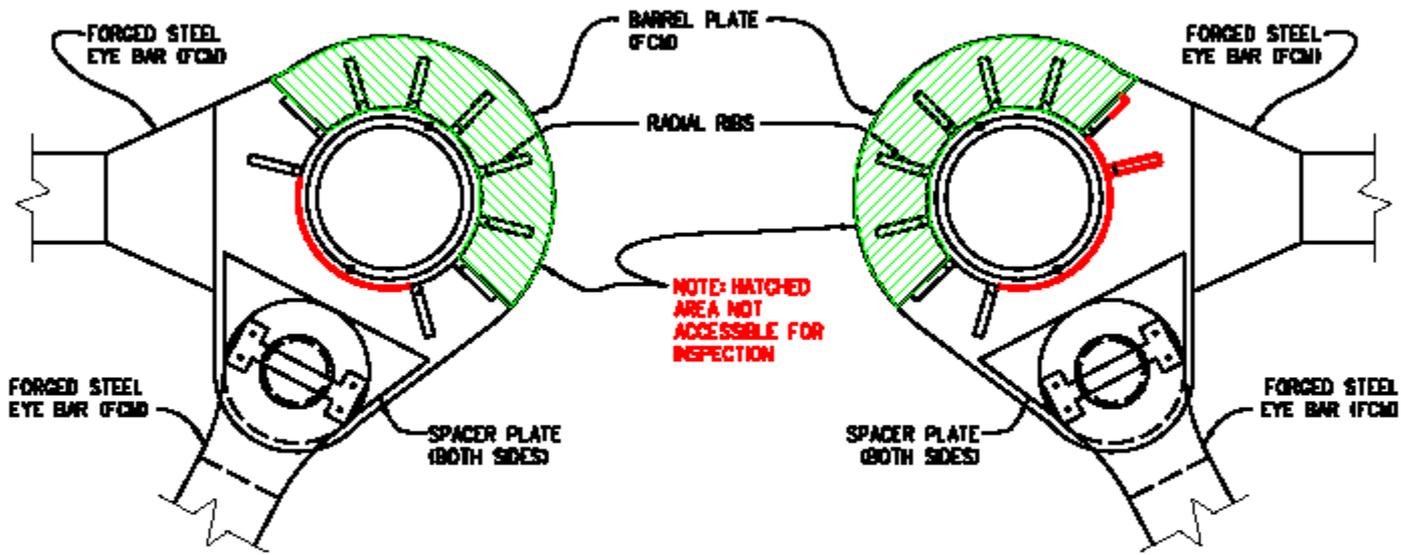
WINFIELD MAIN CHAMBER DOWNSTREAM GATE

LAND WALL LEAF

RIVER WALL LEAF

NOTE: RED LINES INDICATE CRACK LOCATIONS

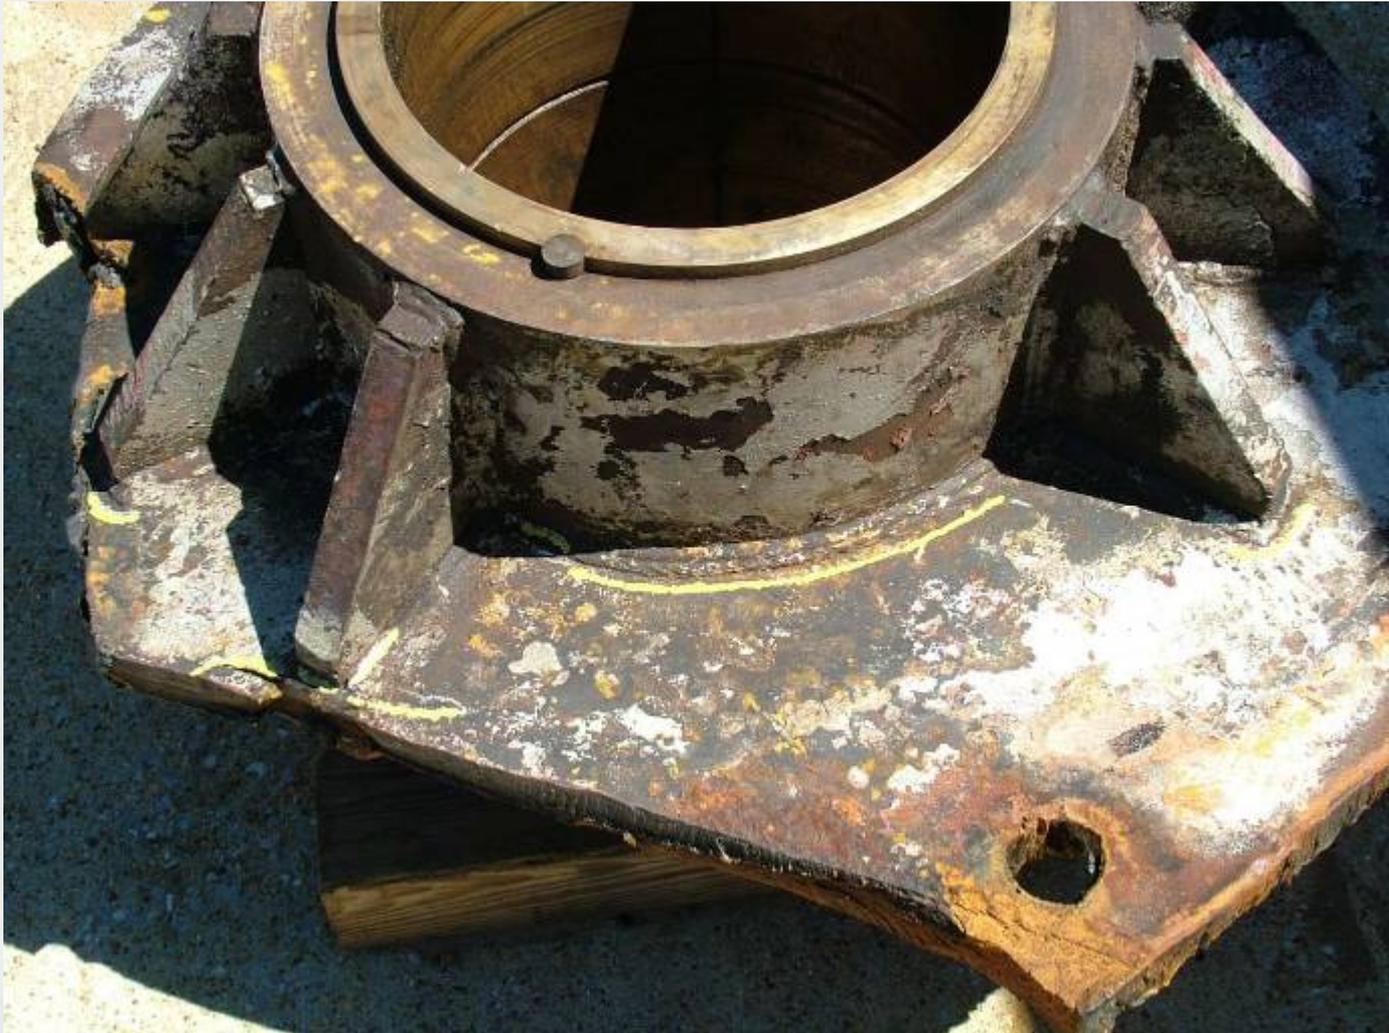
Holt Lock Anchorage Failure, 2006

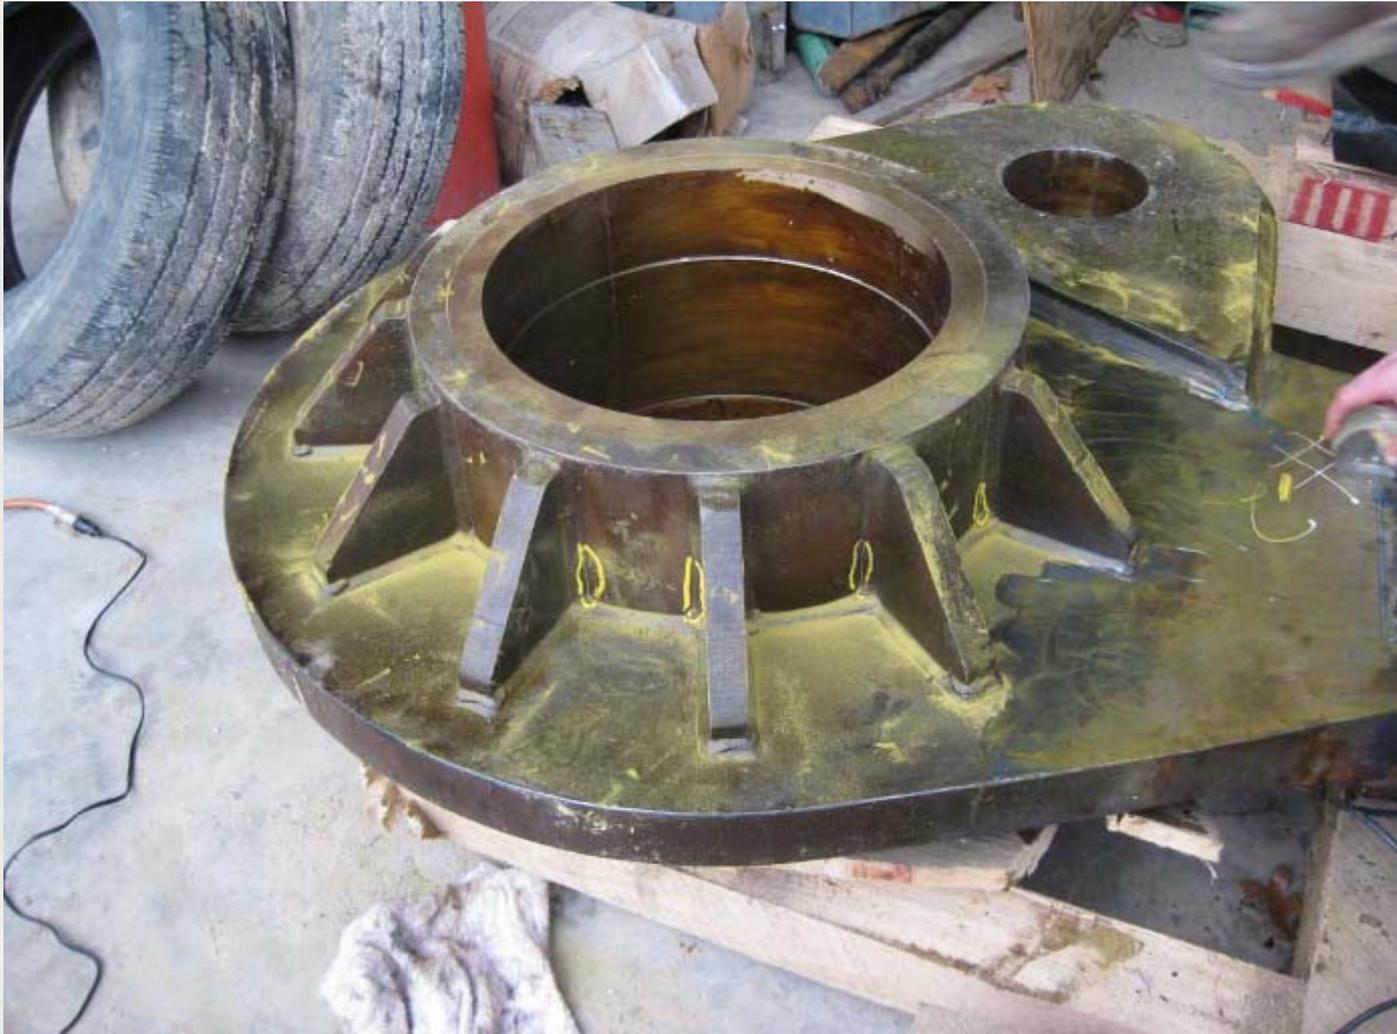
Unused spare. Cracked during fabrication.

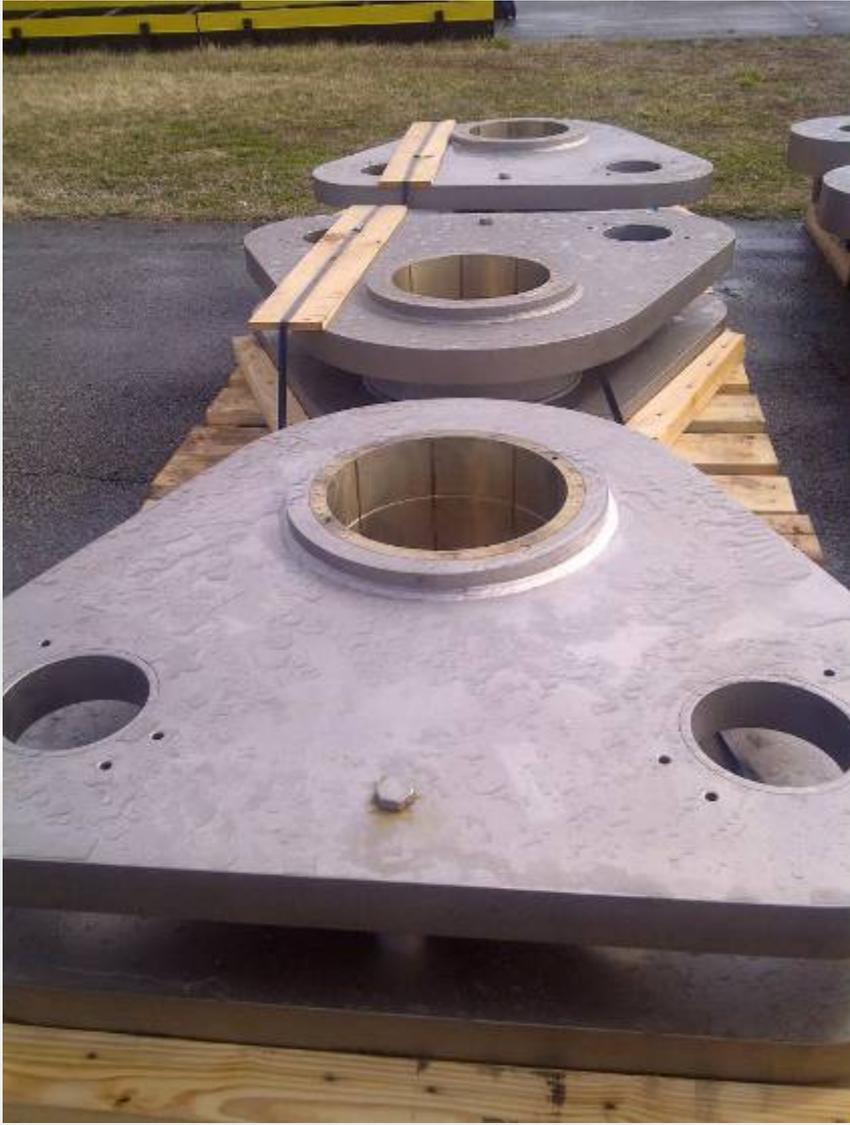
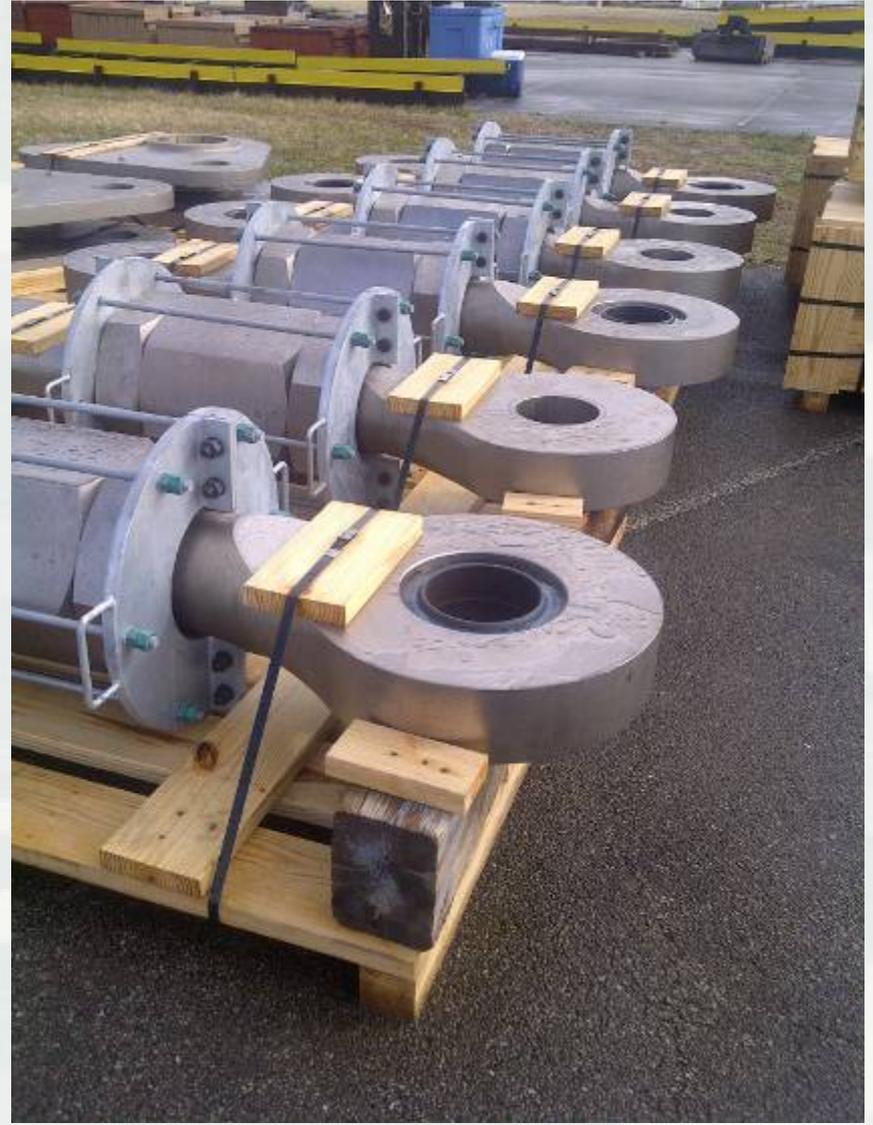
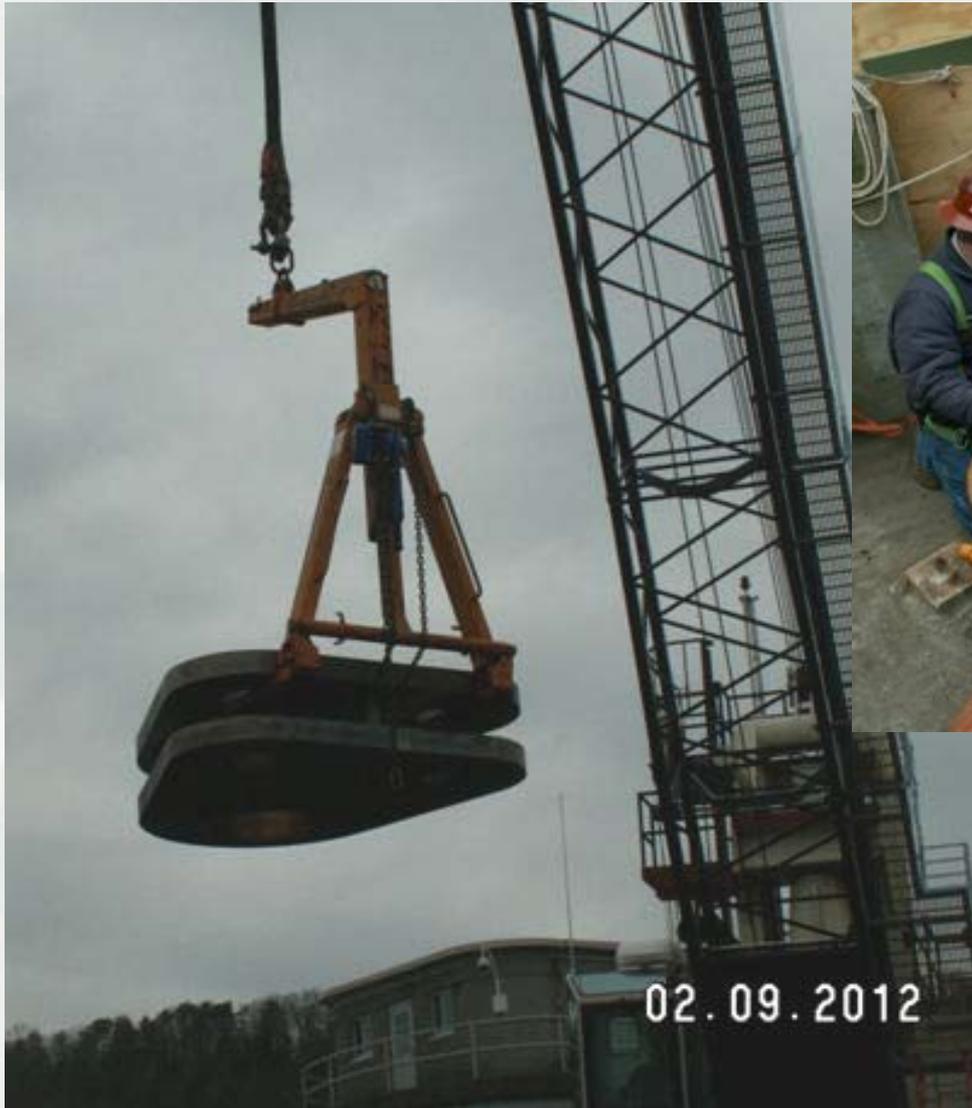
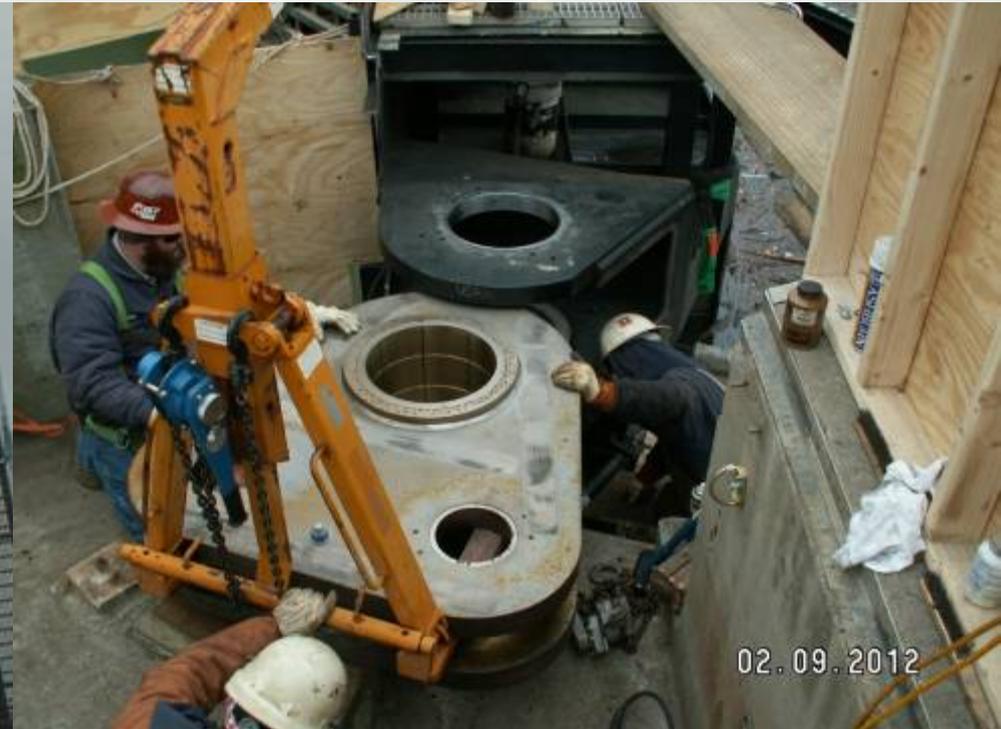
New Design

- Improvements:
 - ▶ Meets AISC Design Requirements for Eye Bar Tension Members
 - ▶ Meets Fracture Critical Requirements (toughness both A709 and A668 material)
 - ▶ Only welds in system are welds to seal around the gudgeon barrel
 - ▶ Uses Spherical Bearings to eliminate bending forces in the arms
 - ▶ They are interchangeable between projects
 - ▶ Easy to install

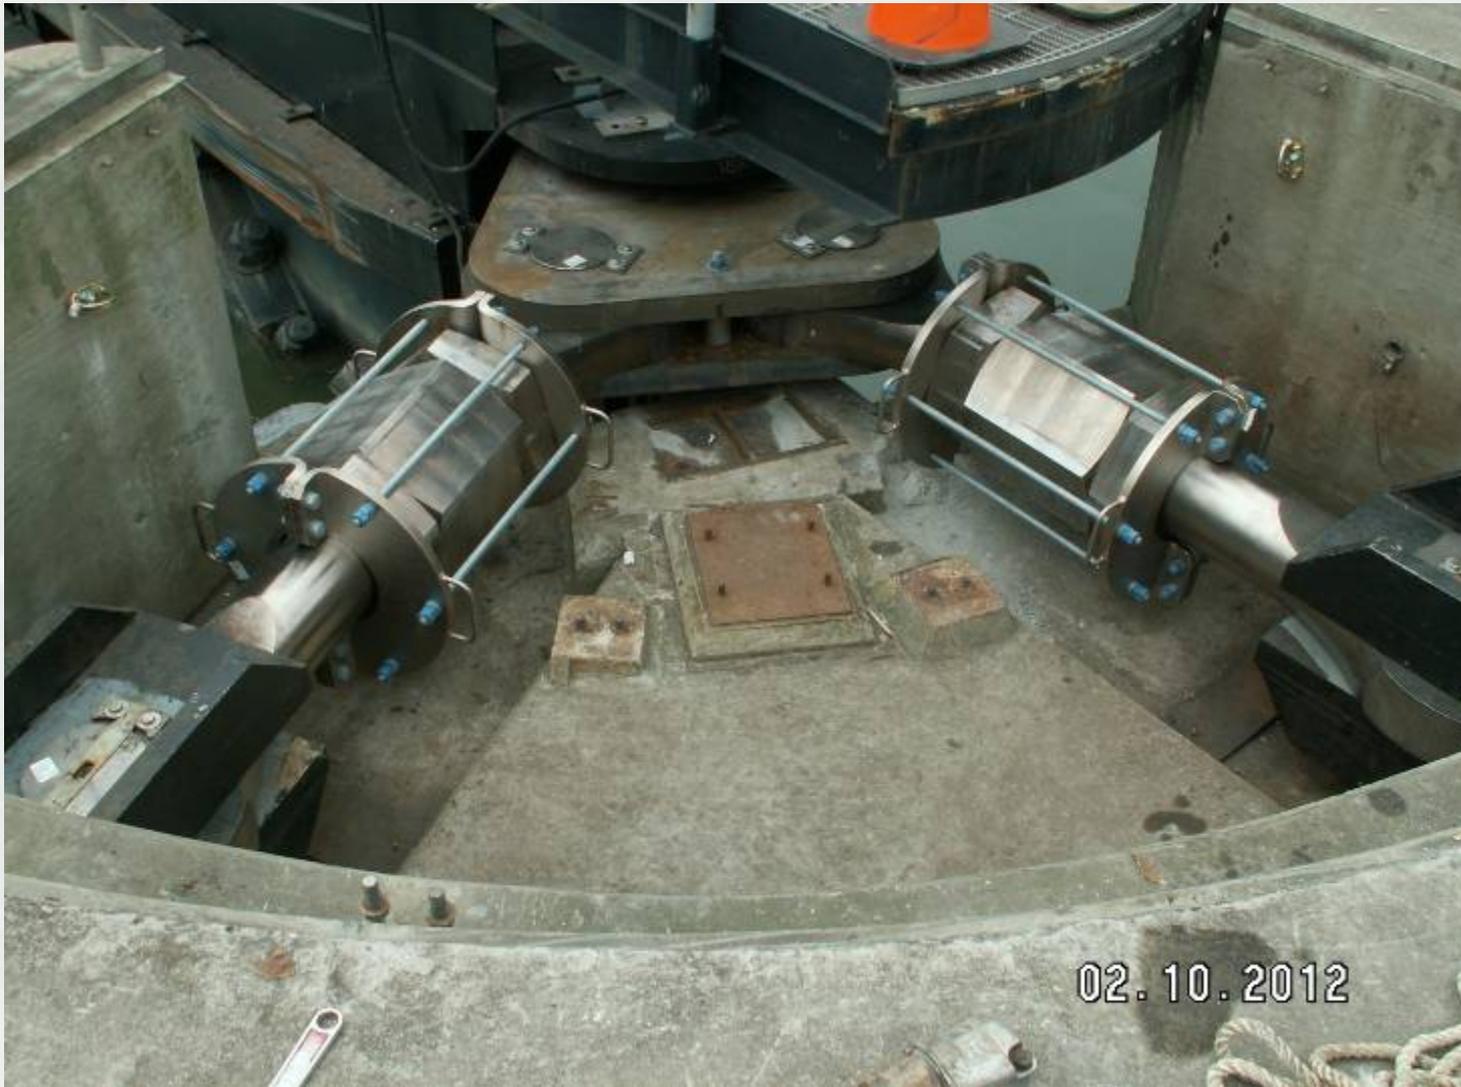
Winfield, 2012

Winfield Locks, 2012
Used existing embedded
anchorage w/ no change.

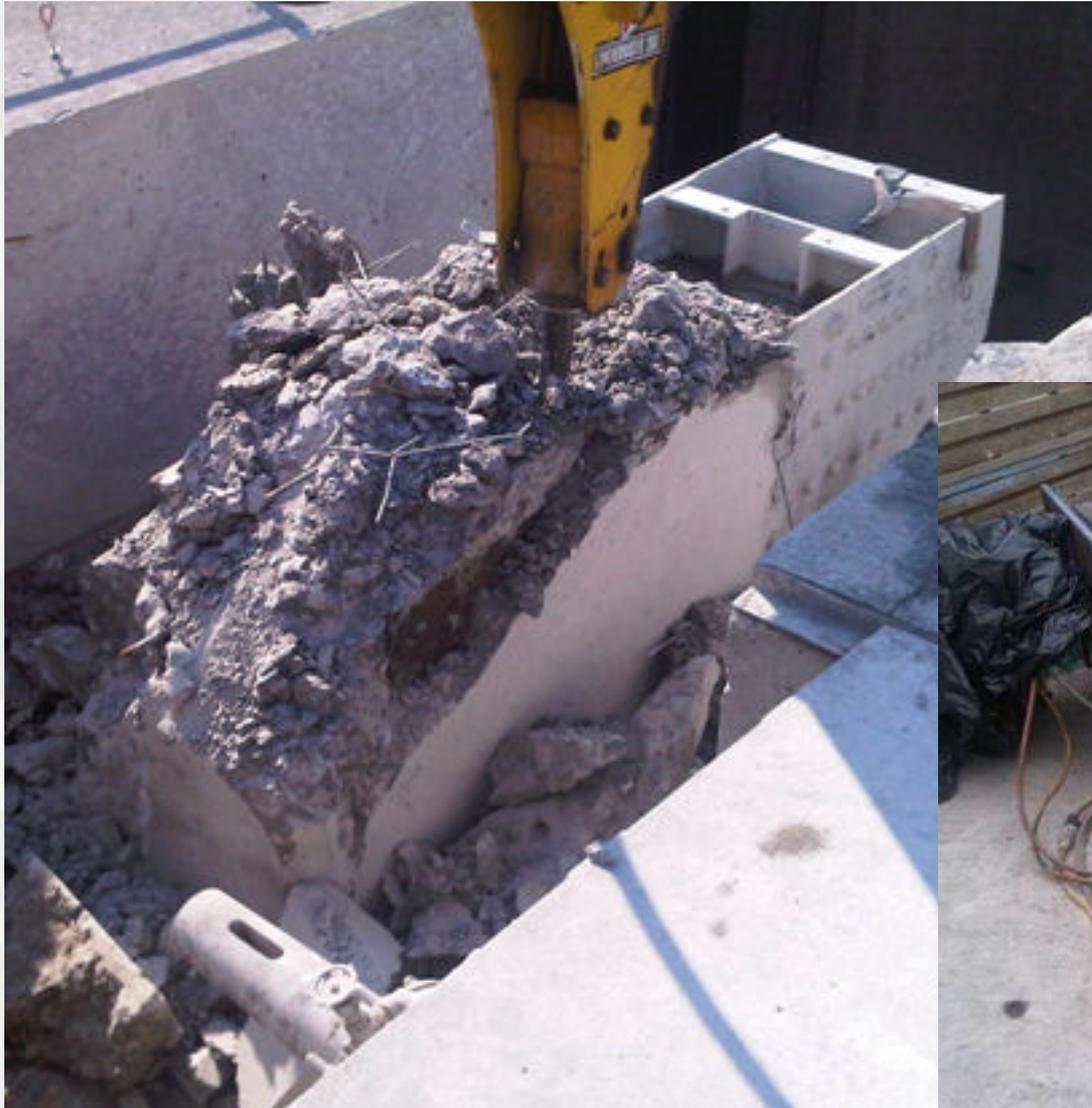
Meldahl and Greenup, 2012

Existing wedge system was exposed and modified.

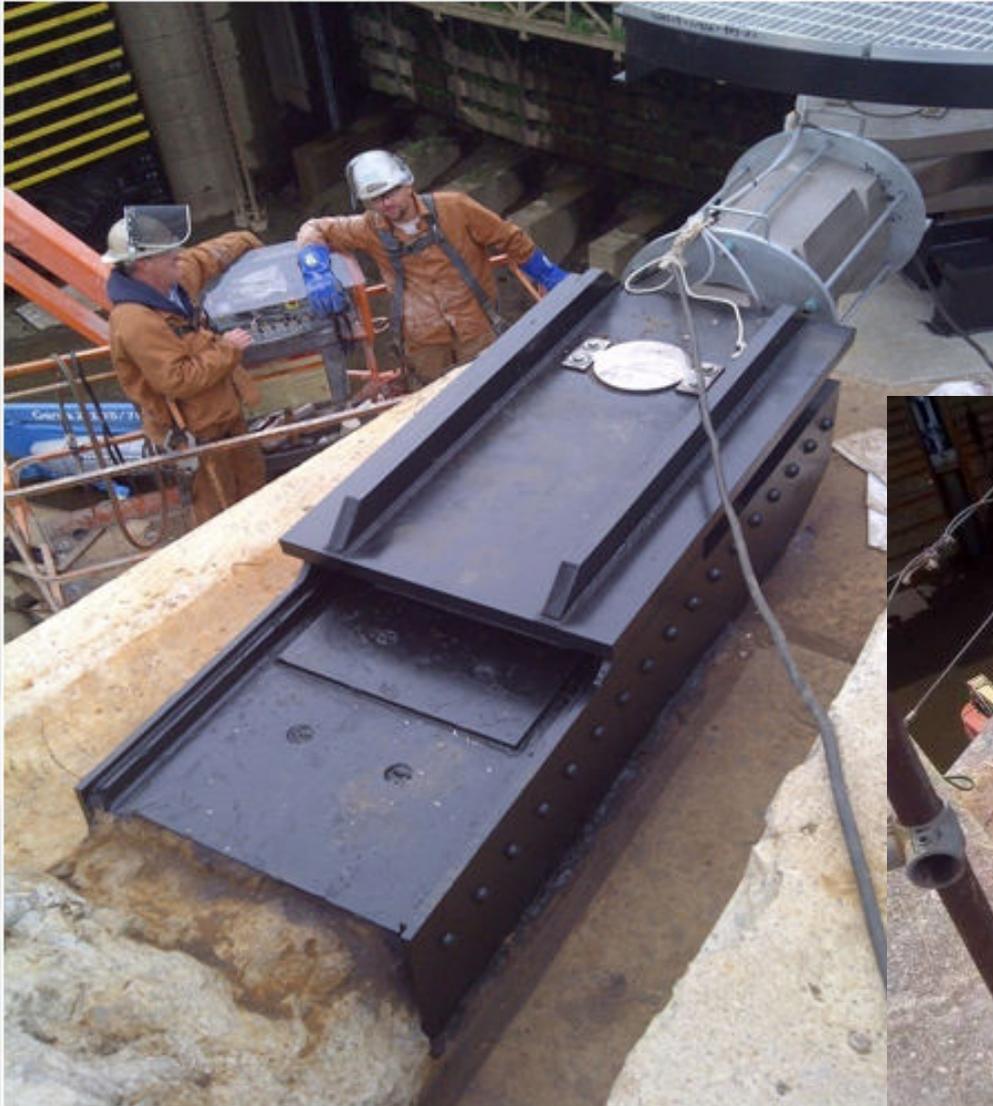
Meldahl and Greenup, 2012

Modified for new anchor bars and pins.
