# RECENT MAINTENANCE ACTIVITIES – SLSMC

## The Great Lakes St. Lawrence Seaway System

Ana Claudia Oliveira, P. Eng., M.Eng

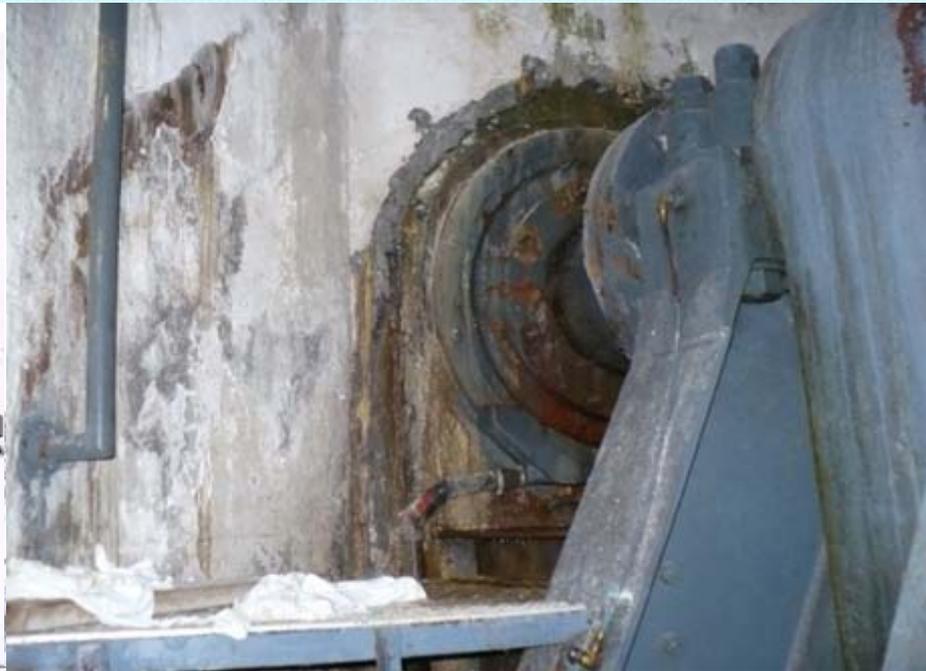
Before

# Realignment of valve level arm After first project – 1995 (3 first valves in the lock) Diagnostic for next project 2010

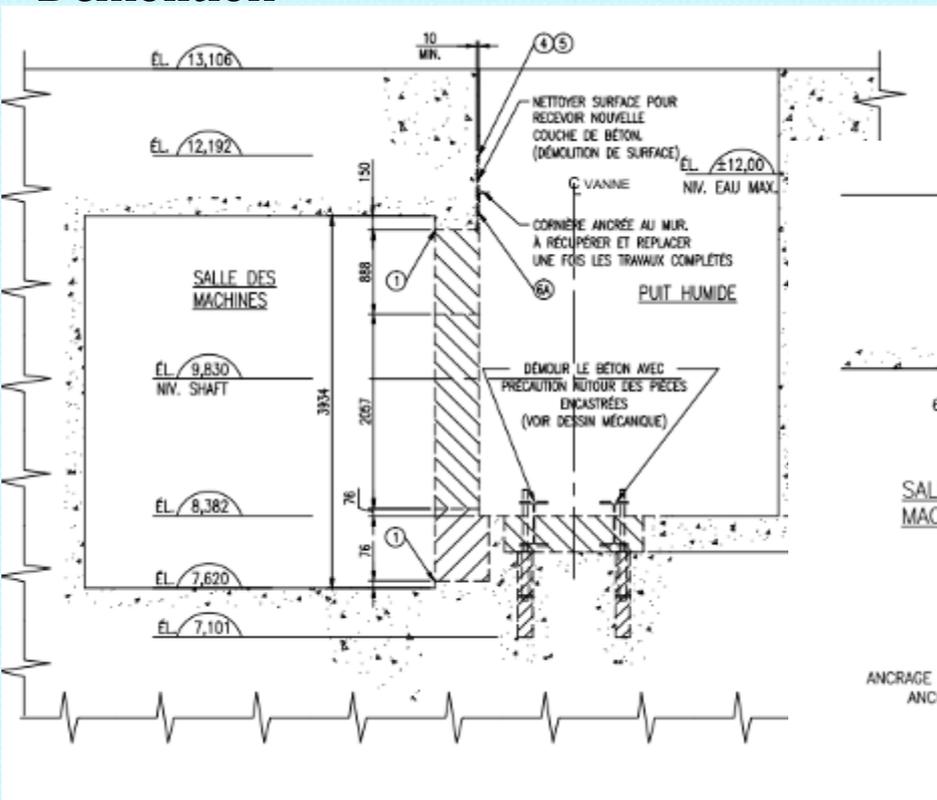
## Demolition

Water infiltration

# New approach

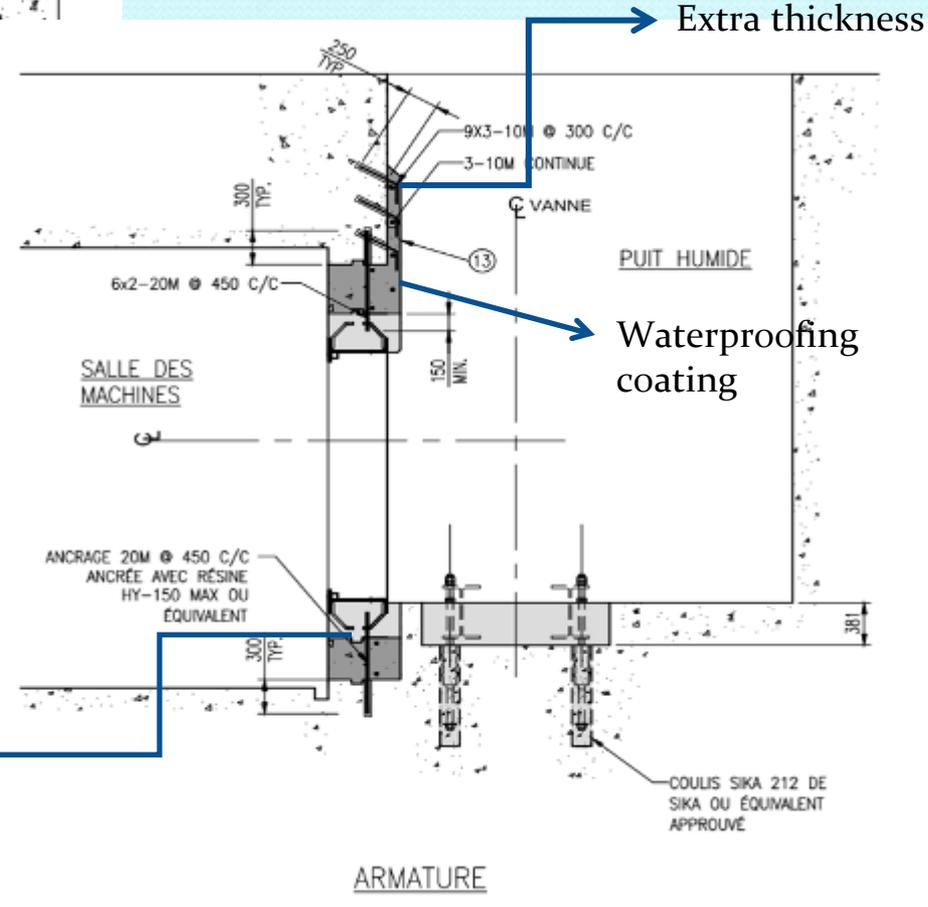
## Reconstruction

Extra thickness

Waterproofing coating

Mastix sealing

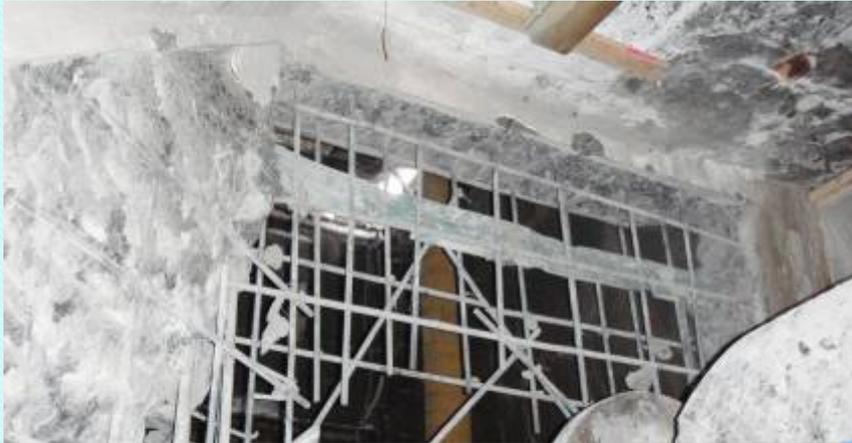
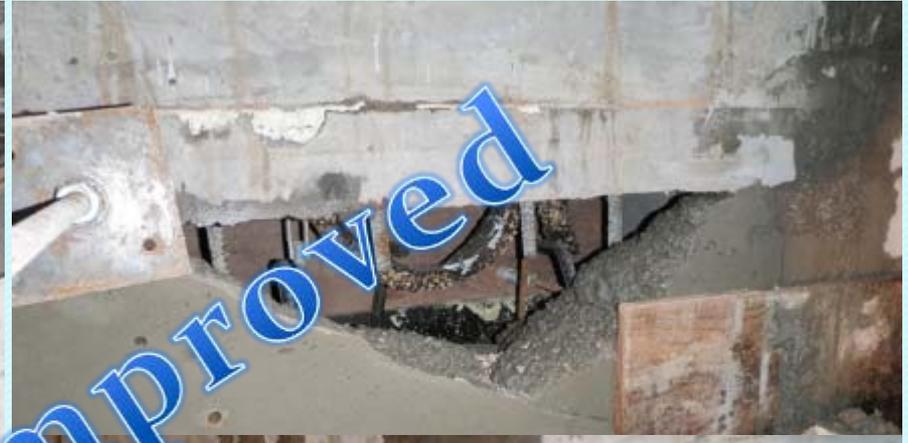
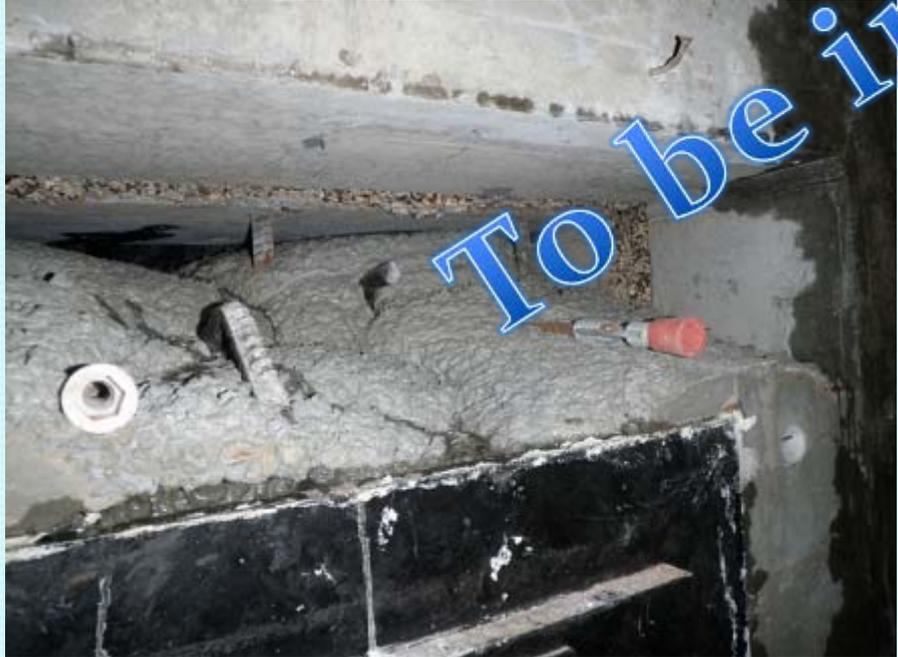
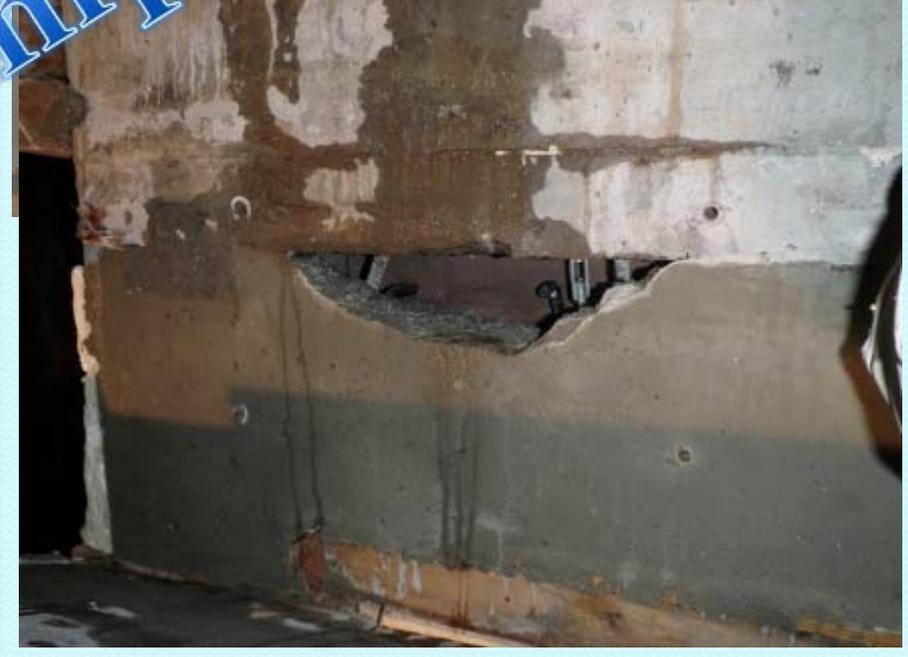
# New approach Execution (winter 2011)

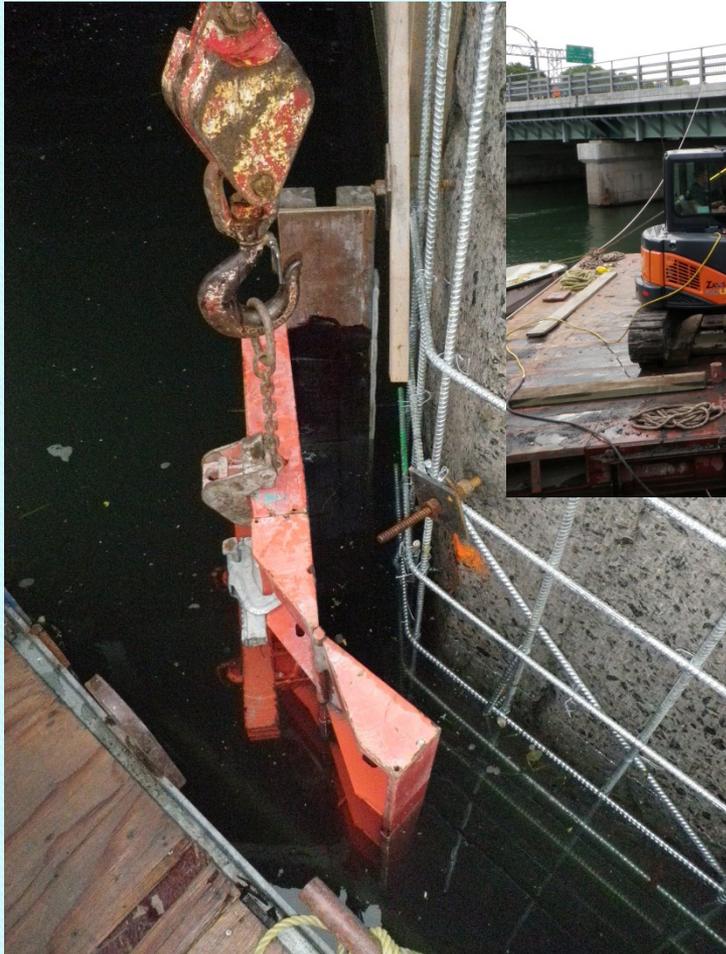
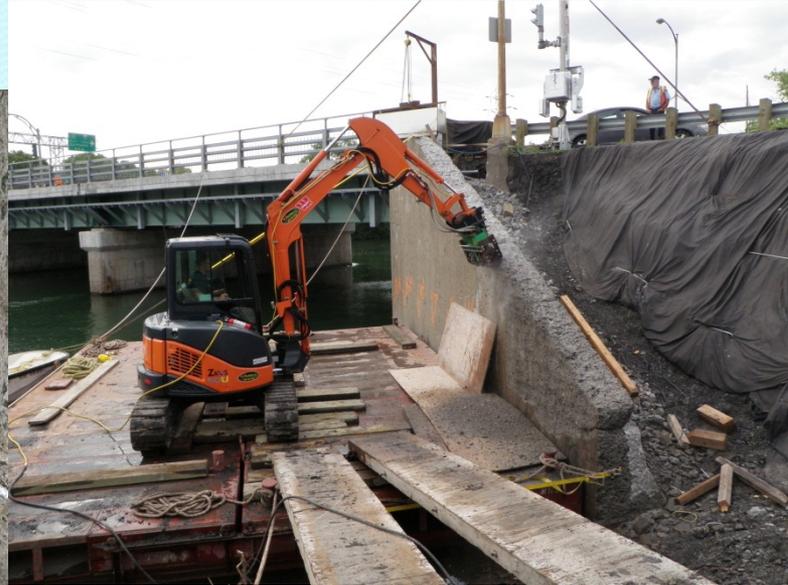
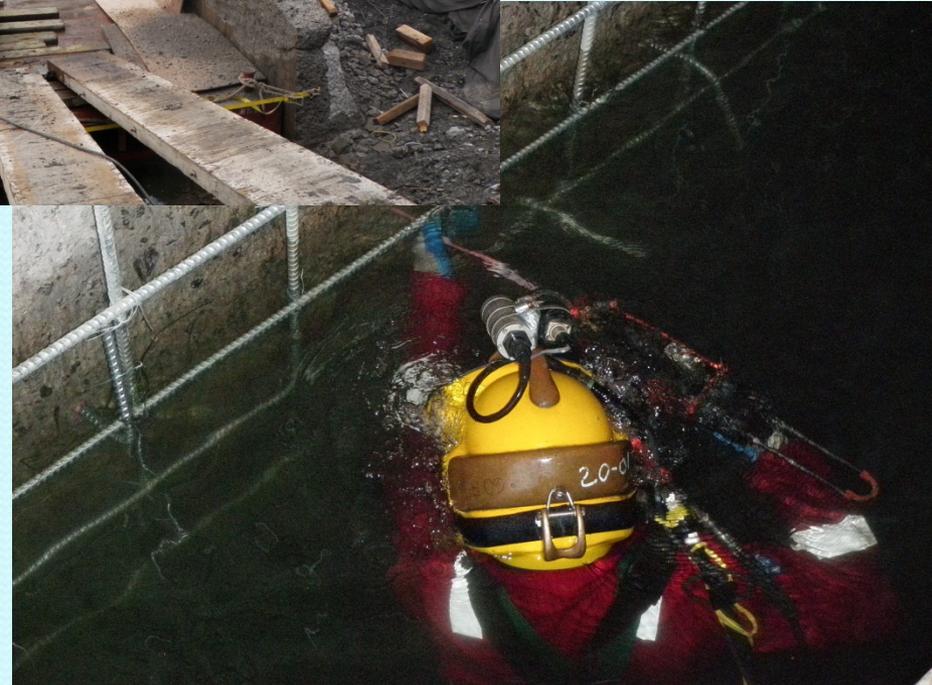
# Underwater works

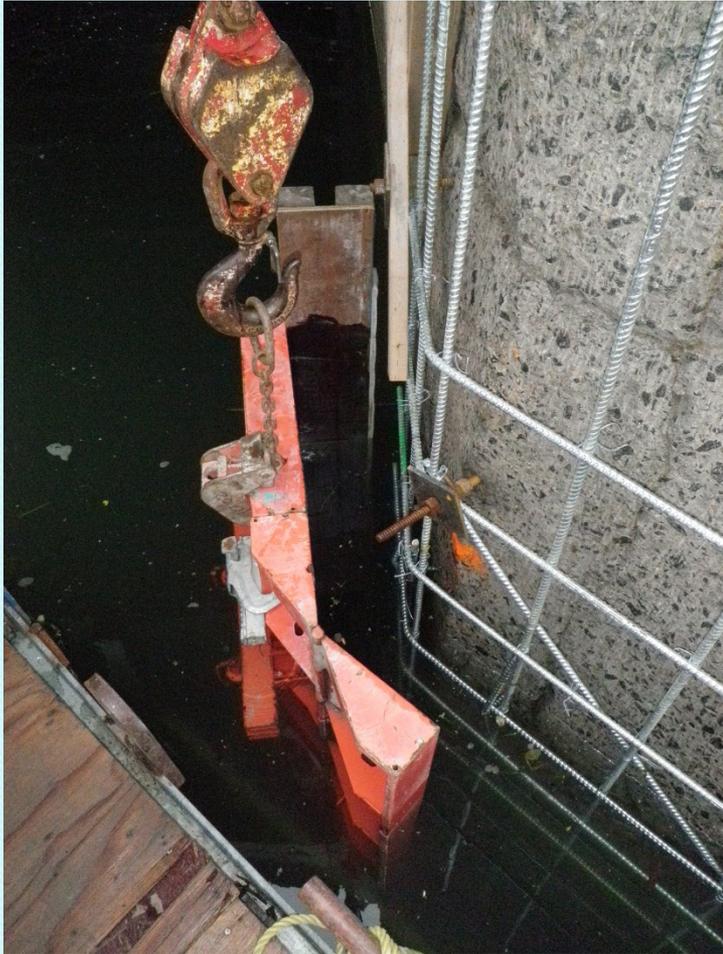
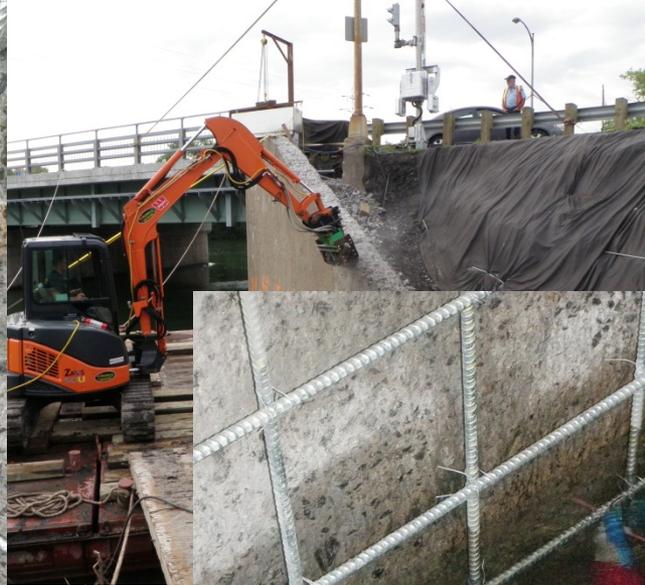
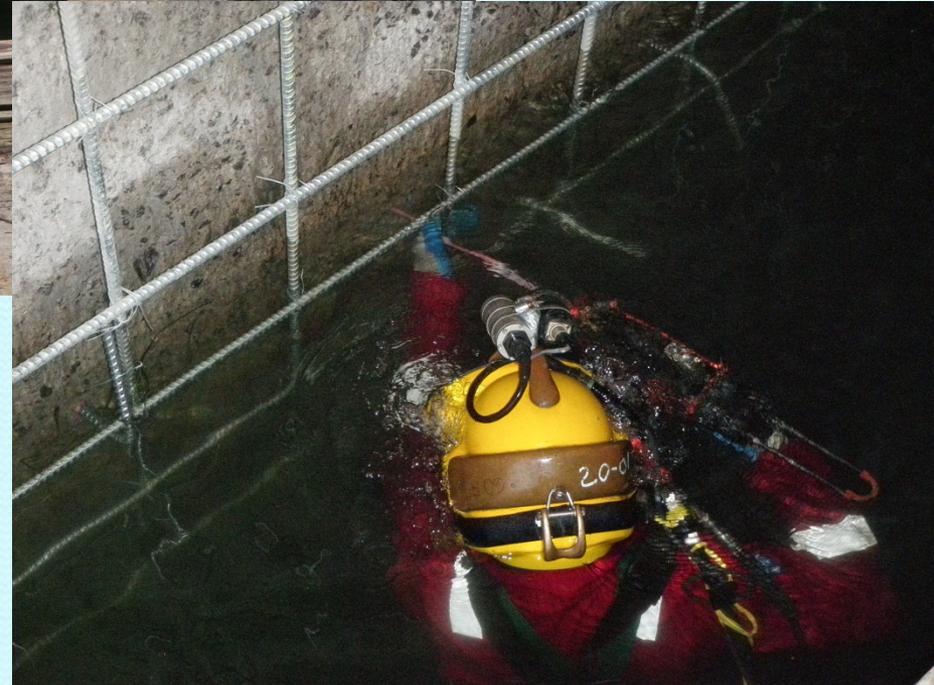
## Underwater Concrete Repairs

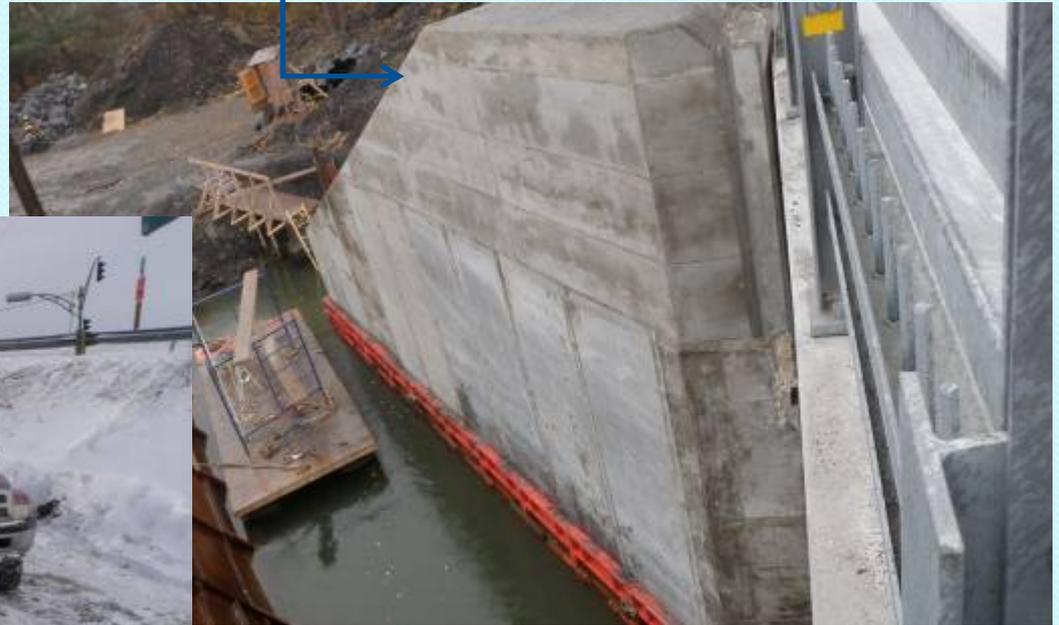
Extra thickness

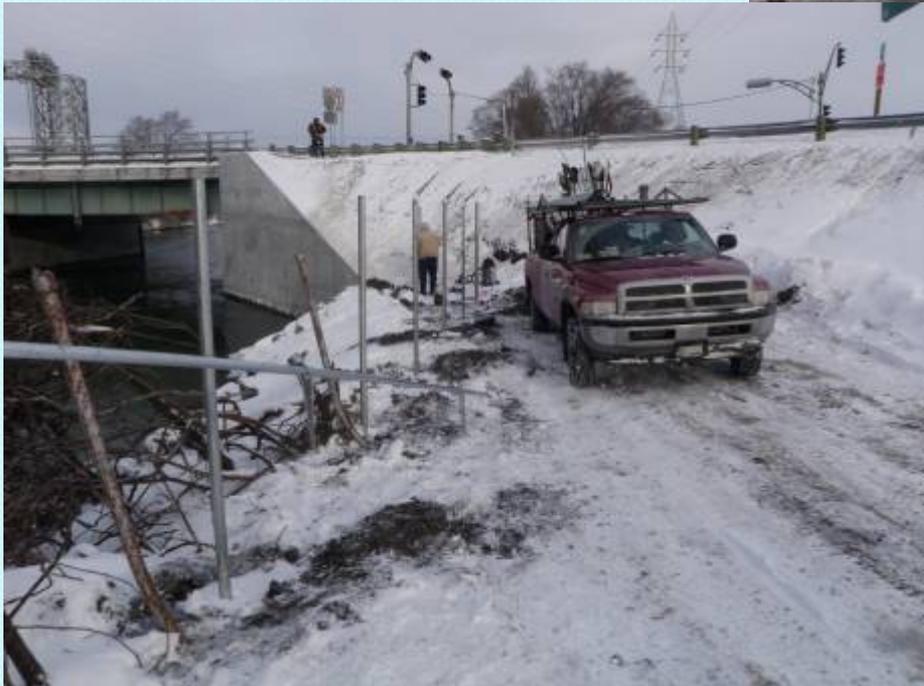
Extended time  
realisation

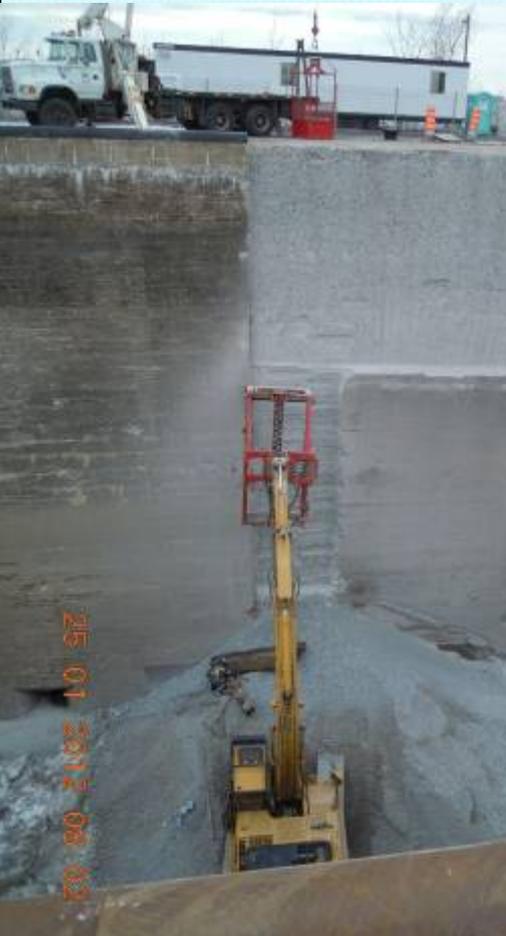
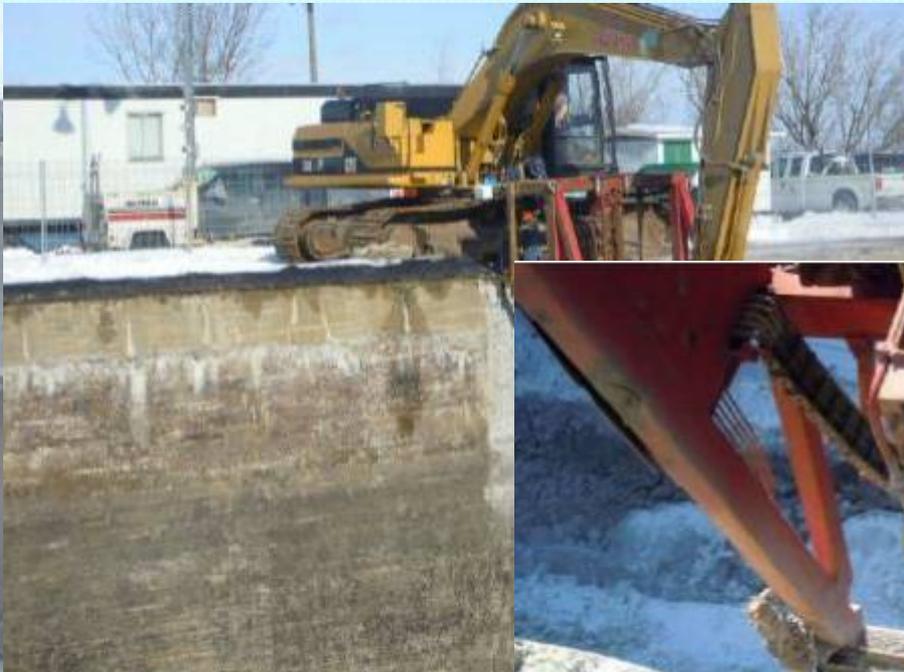
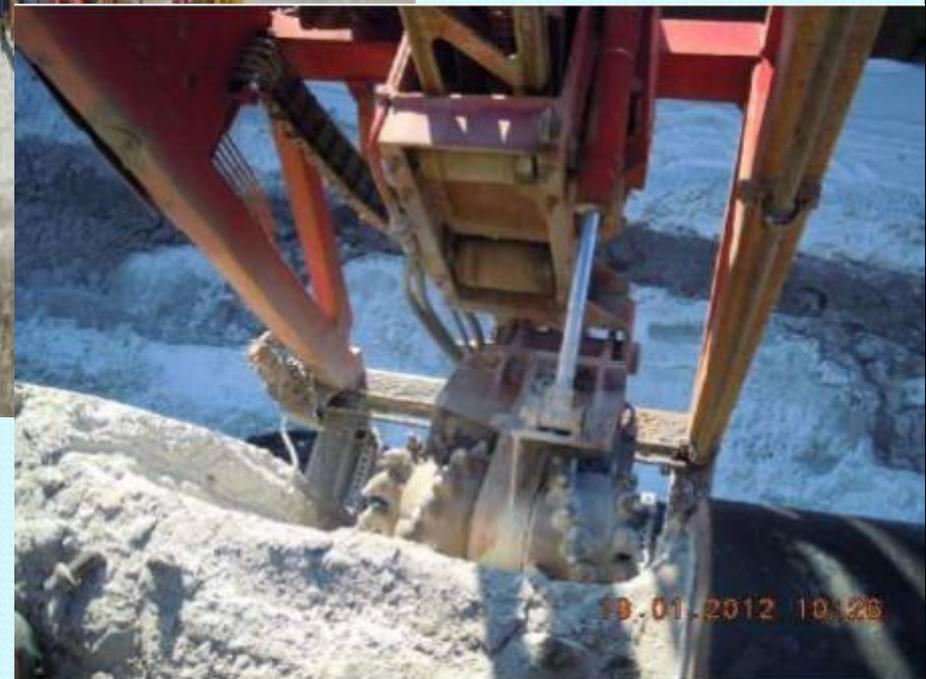
# Partial Demolition of Two Monolithes - January 2012

Demolition using rotomilling method  
rate: 2 m<sup>2</sup>/hour for the removal of 350 mm

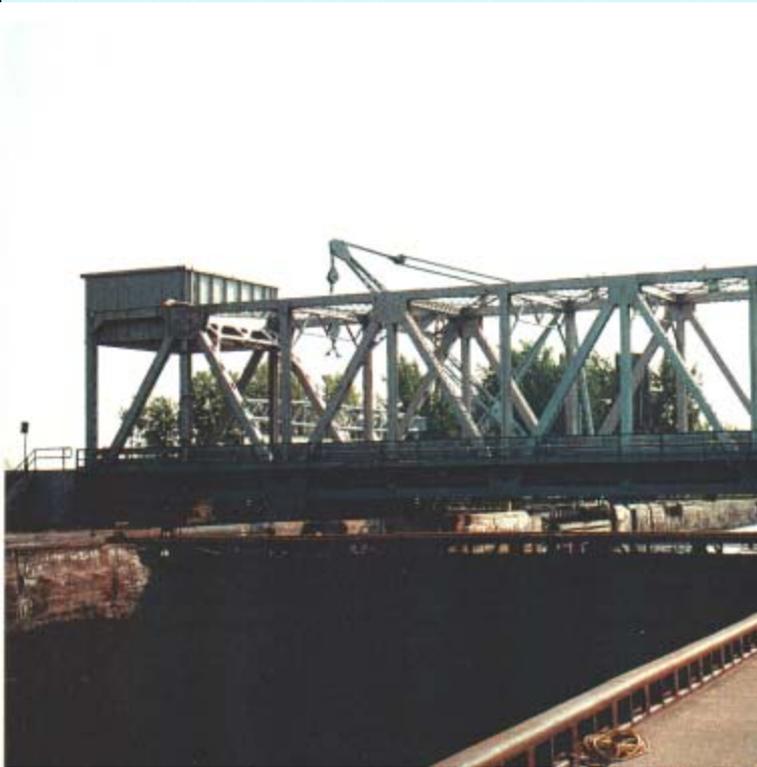
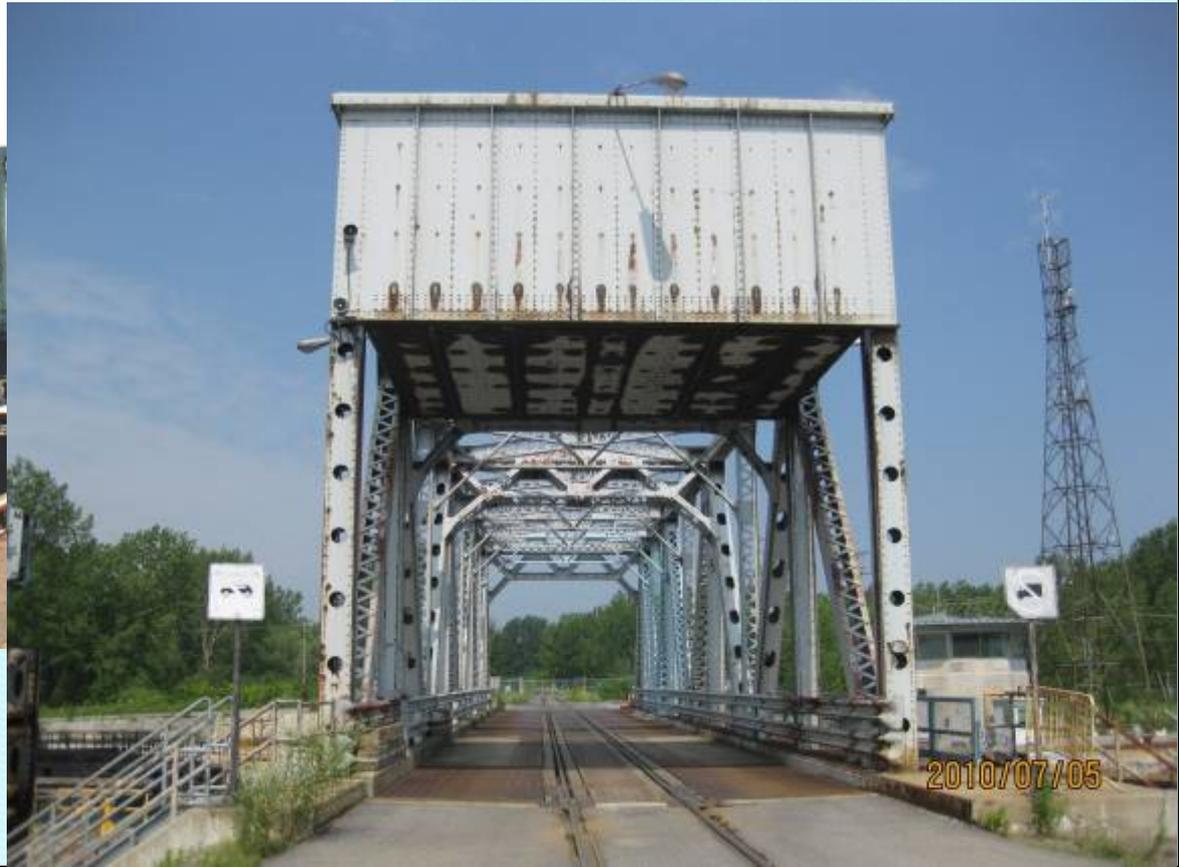
## Replace Steel Grating on Movable Bridge over lock 4
