# LD 5A Emergency Miter Gate Repair

2014 Locks Maintenance Workshop

13 Feb 2014

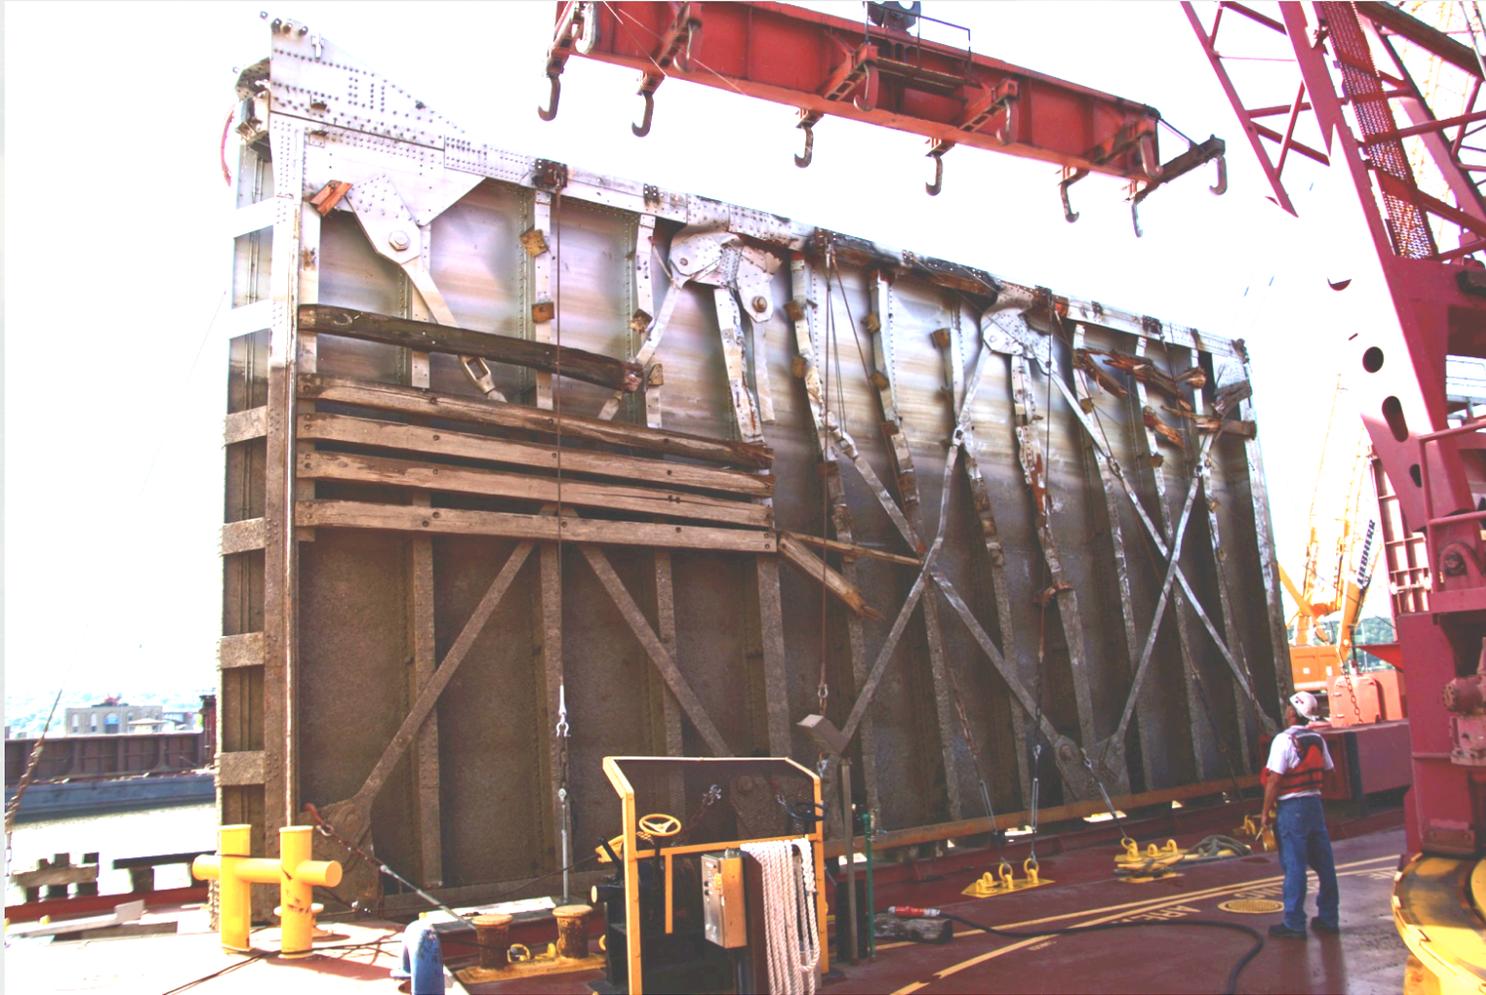
# Miter Gate Damage

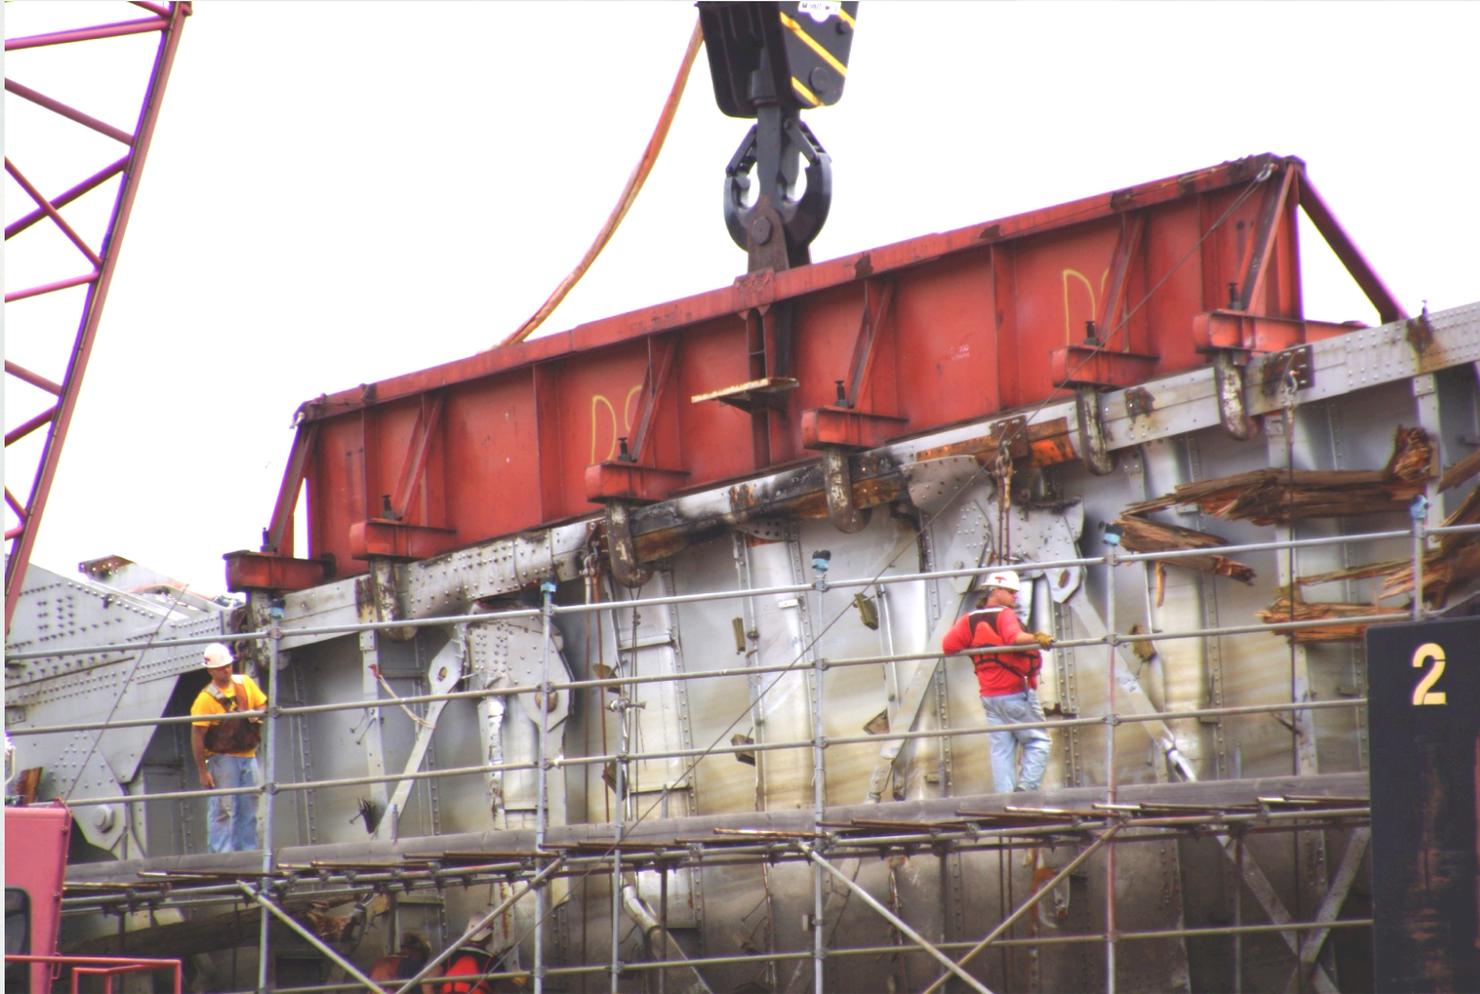
# Miter Gate Damage

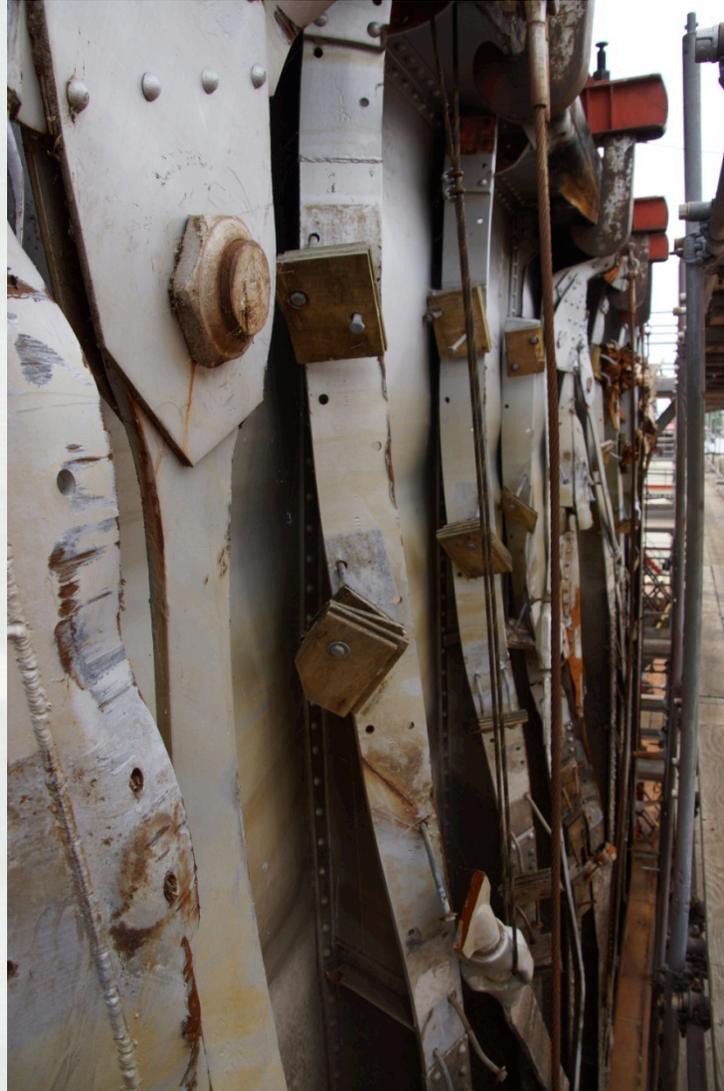
# Miter Gate Damage

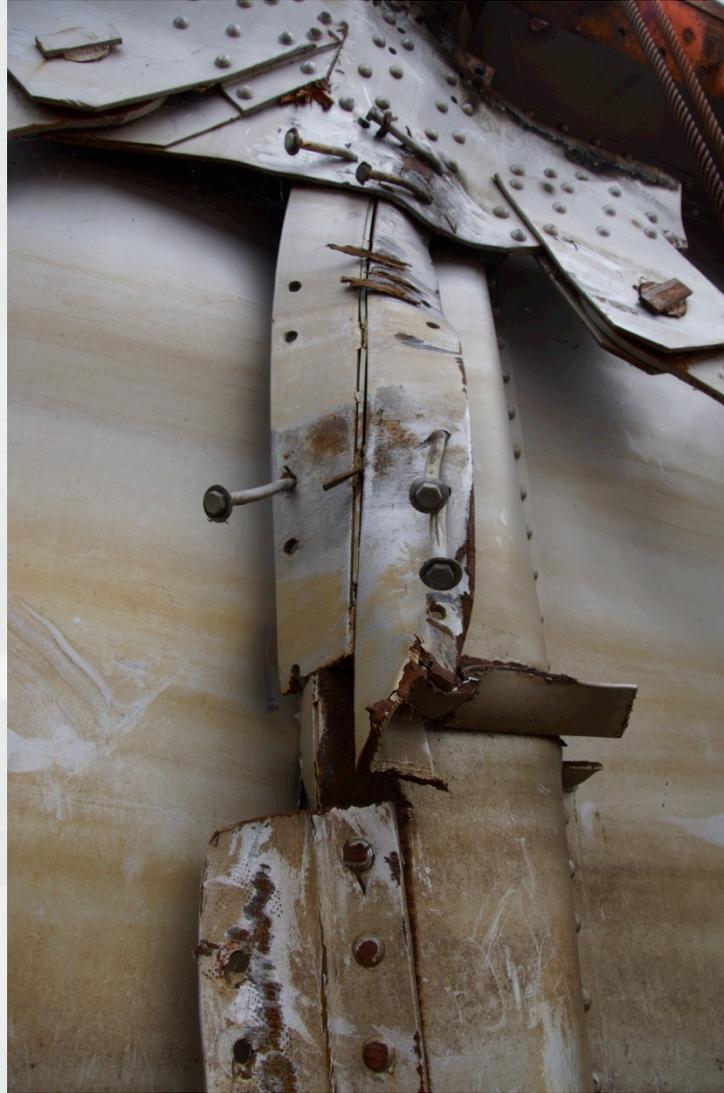
# Miter Gate Damage

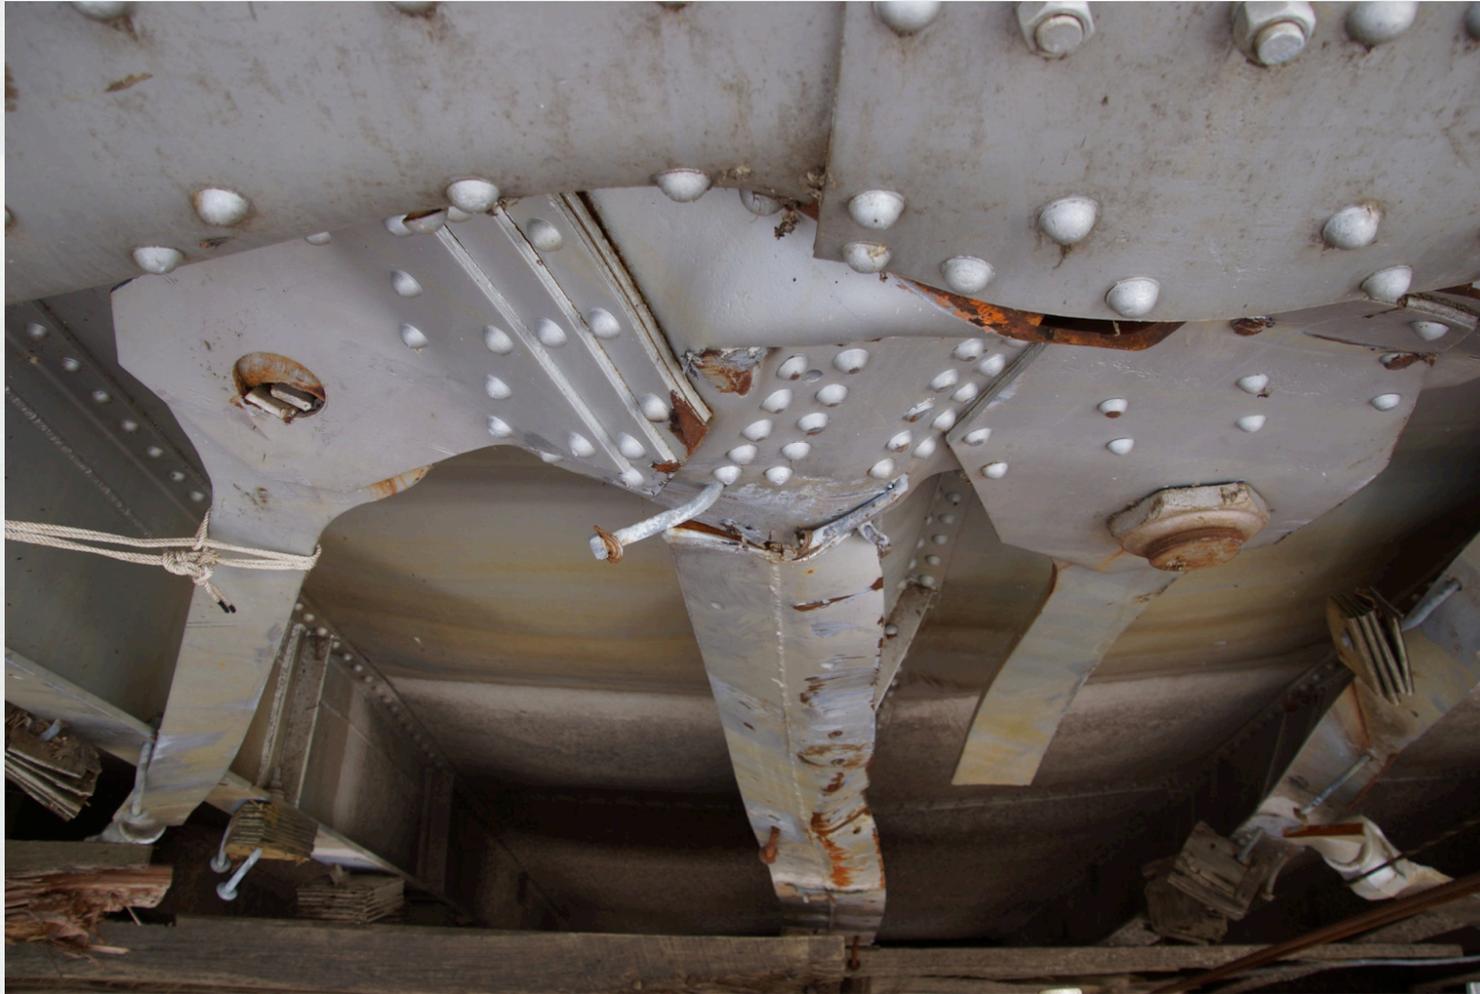
# Miter Gate Damage

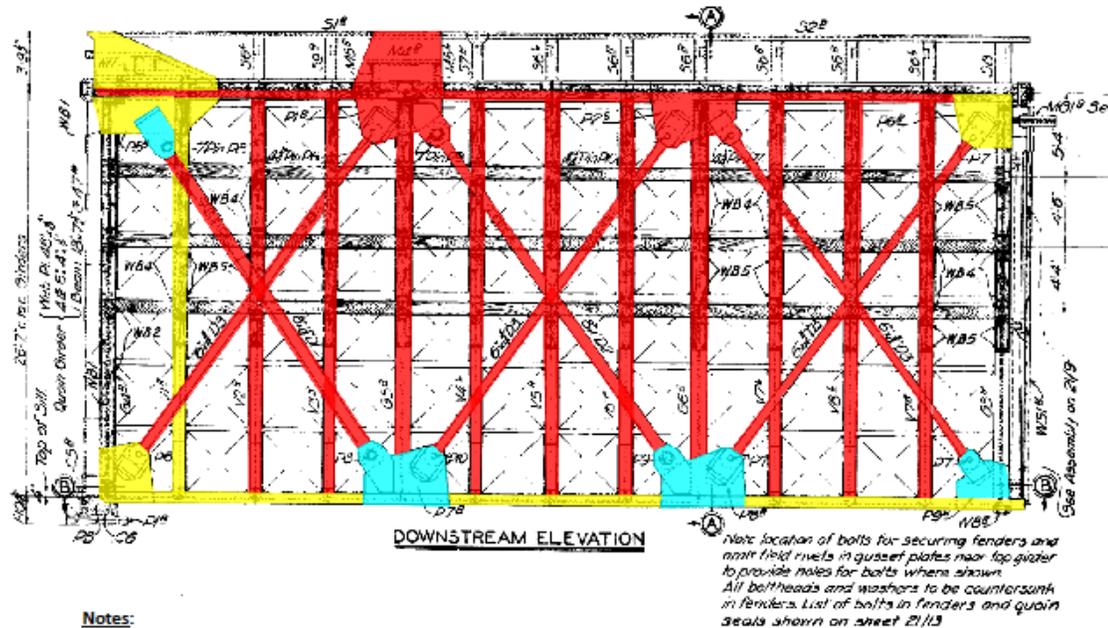
### Demolition and Removal Plan

## Lock 5A 27 Foot Miter Gate

1. Sketch is not to scale.
2. Areas highlighted in red shall be completely removed and scrapped. (Tow Company Responsibility for Materials & Labor)
3. Areas highlighted in blue shall be removed and retained for re-use. (Tow Company Responsible for Labor)
3. Areas highlighted in yellow are considered maintenance and shall be paid by the Government

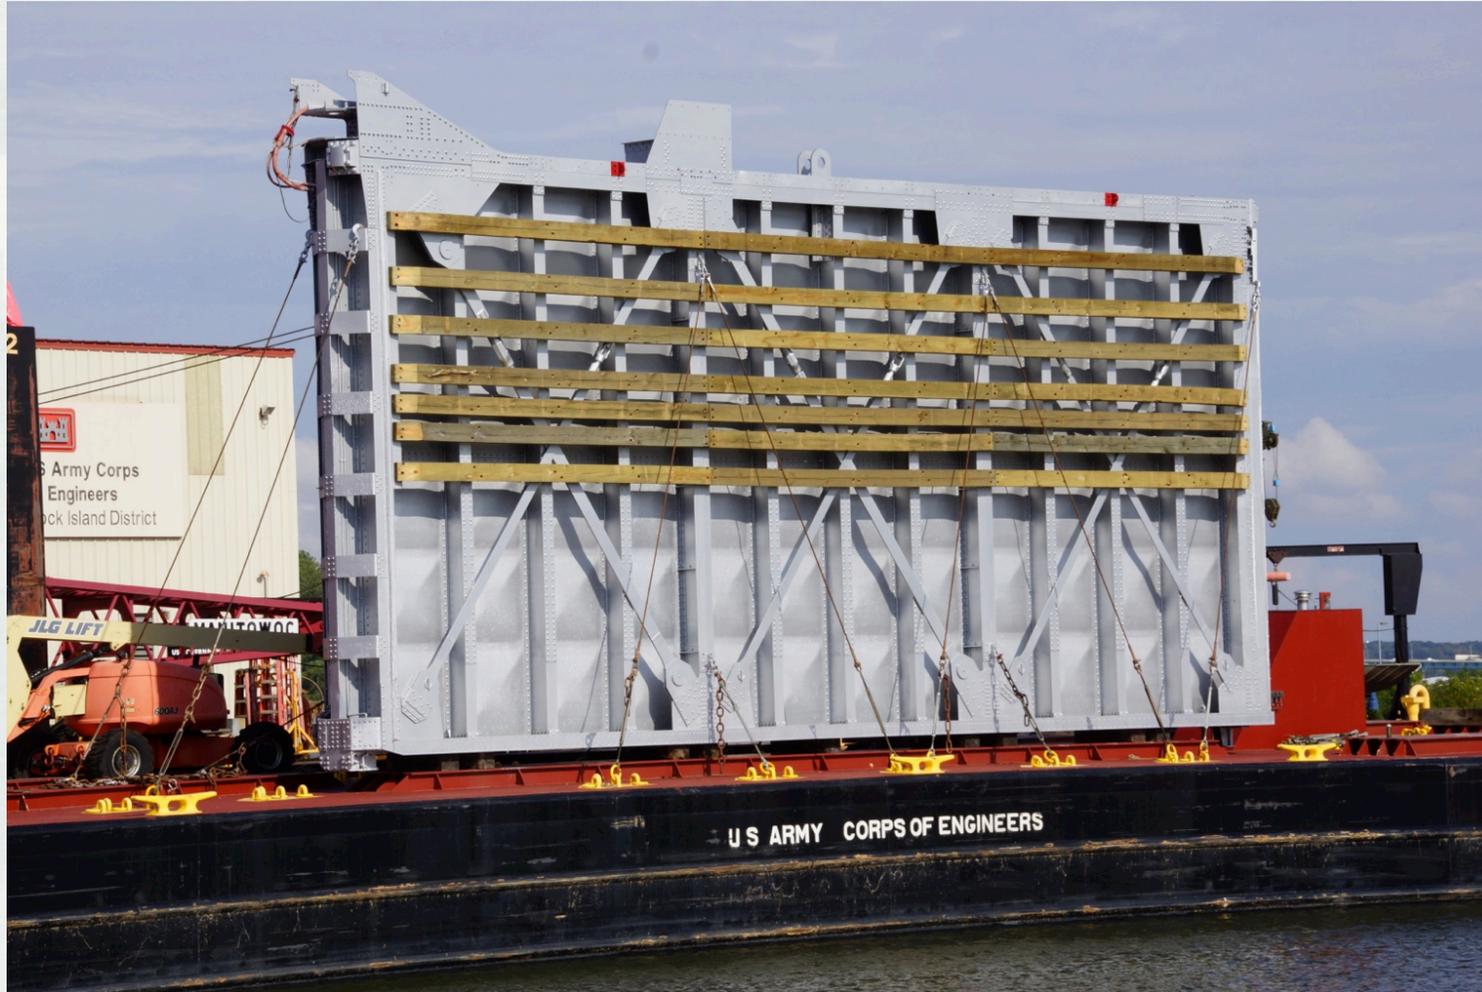
# Repaired Miter Gate

Tow Damage Gate Repair included the replacement of 9 I-Beams, 2 Complete Girder Assemblies, 6 New Diagonal Stress Bars, 5 Downstream Gussets, over 50 feet of lower Downstream Fender Angle and New Gate Timbers

Non-Tow Damage Gate repair included the repair and replacement of 3 Gussets, New Pin Plates on existing gussets, Quoin End Wrap-Around, 6 Upstream Diagonal Stress Bars, repair of the Elevation Hood, fabrication and installation of new Downstream Bearing Plate, new Quoin Omega Seal and Paint
