Innovative Materials for Repair and Retrofit of Civil Works Infrastructure

Lock Maintenance Workshop – 11 FEB 2014

Robert D. Moser, Ph.D.

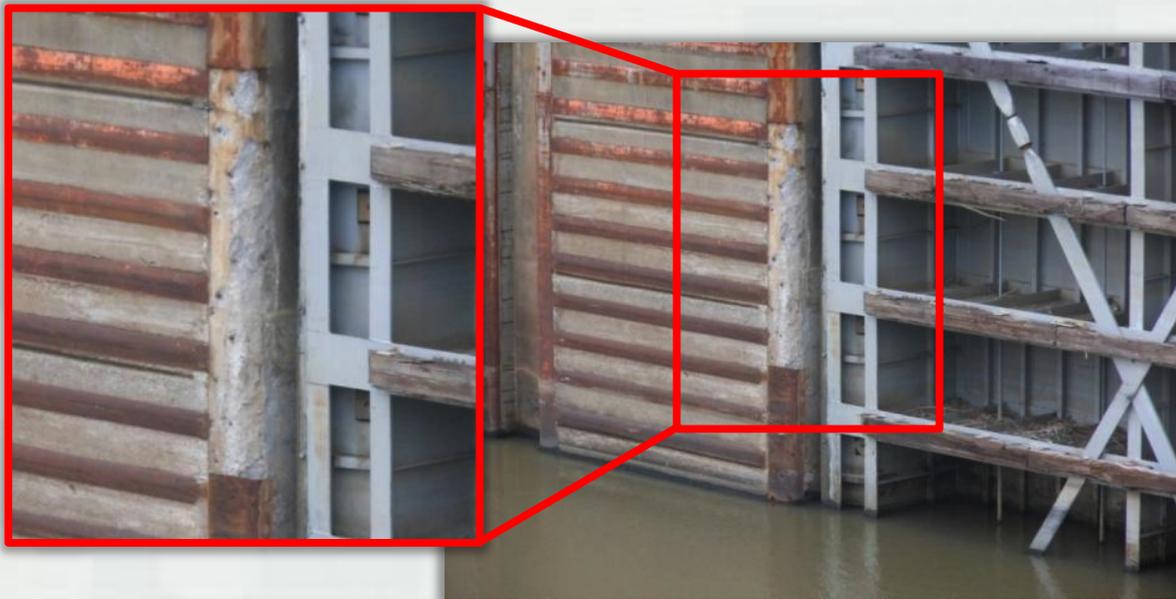
Armor plate damage at miter gate recess at Newt
Graham L&D (Tulsa District)

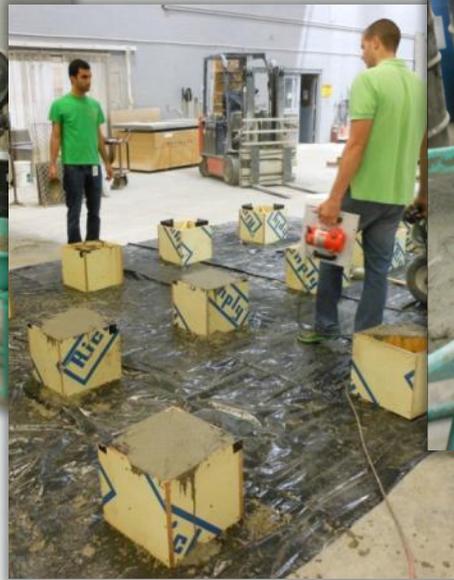
Placement of mock-ups for repair application.

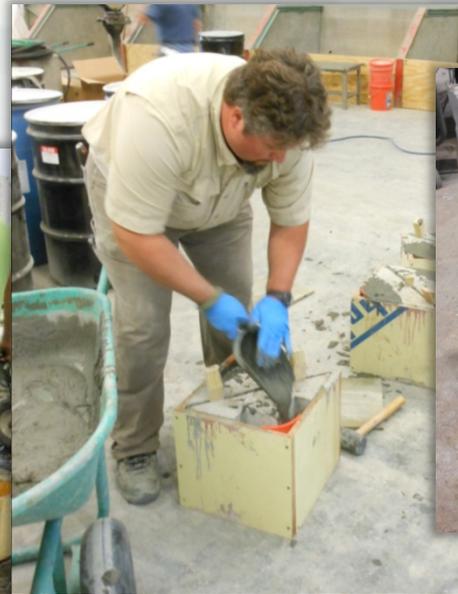
Placement of UHPC into repair cavity

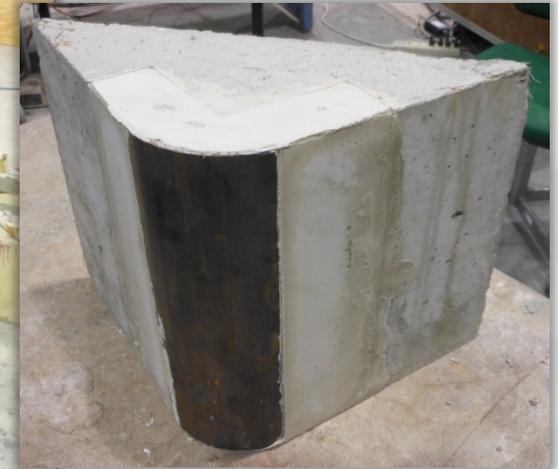
Completed test specimen

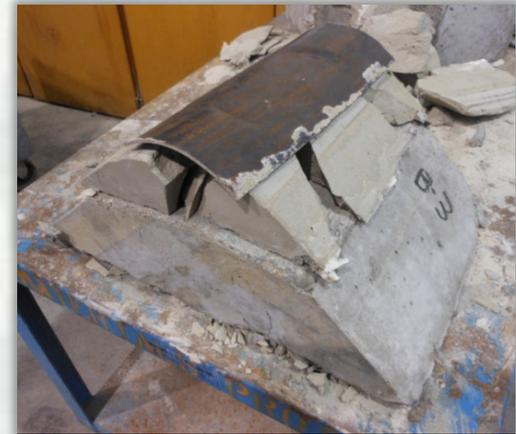
- Portland cement-based grouts:
 - Failure occurred at approximately 130 kips with extensive spalling of the repair material.
- Ultra-high performance concrete:
 - Increase in load carrying capacity to 200 kips (a 50% increase).
 - **NO** spalling or repair with presence of steel fiber reinforcement.
 - Samples without surface affixed steel armor plate exhibited similar load carrying capacities.
- Rapid repair materials:
 - Strengths similar to portland cement-based grout.
 - Removes logistic constraints for repair!

Without steel fiber reinforcement.

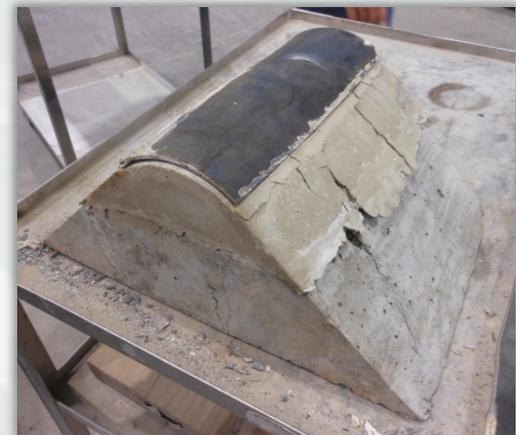
With steel fiber reinforcement.

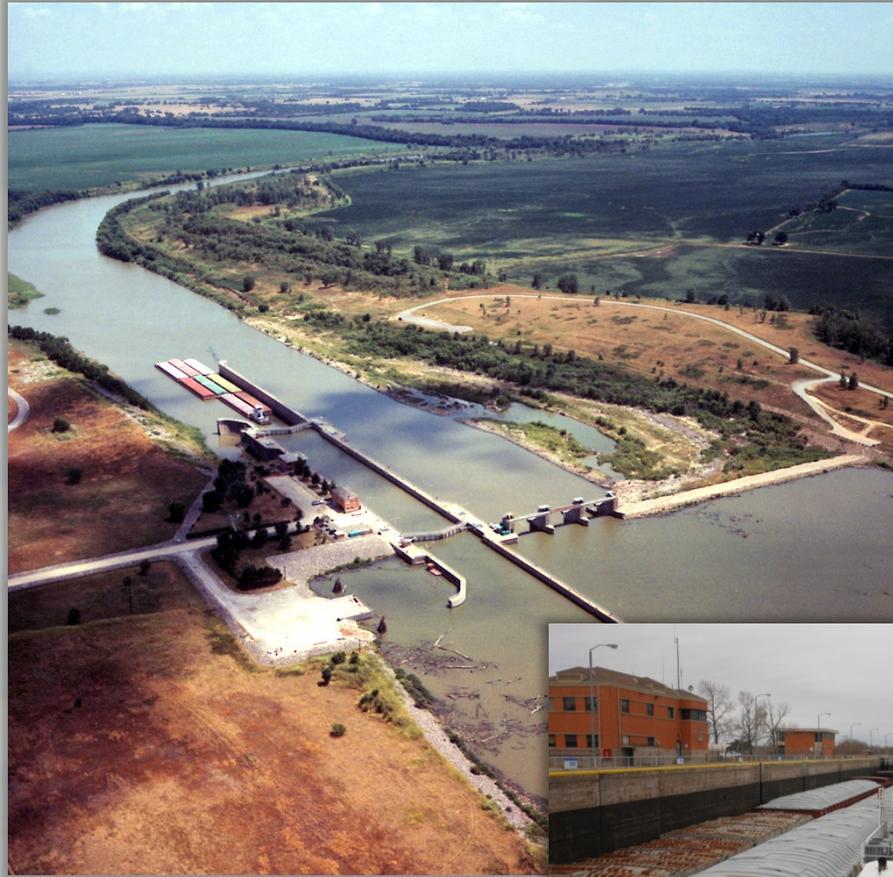
- ▶ Located on Verdigris River
- ▶ East of Tulsa, OK
- ▶ 1,630 ft. long
- ▶ Combined earthfill and concrete gravity dam
- ▶ Single-lift lock chamber
 - 110-ft by 600-ft long
 - 21-foot lift

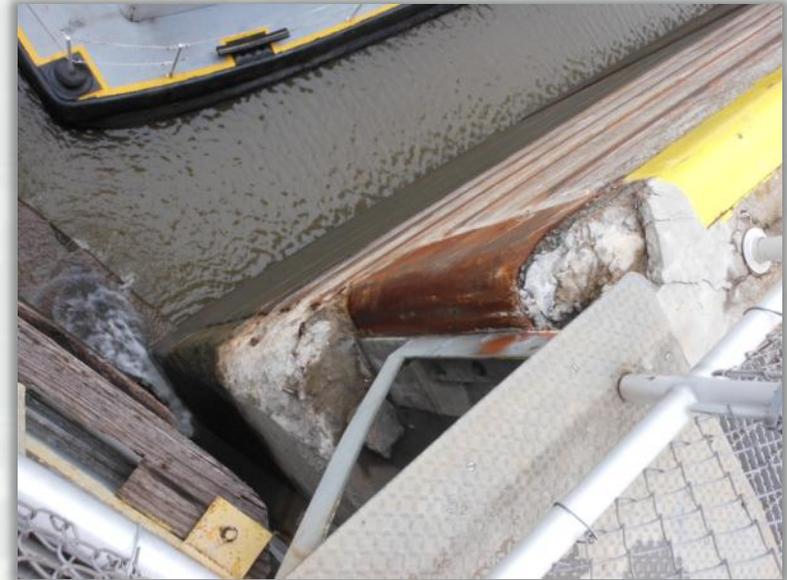
Armor plate damage at Newt Graham
Lock and Dam

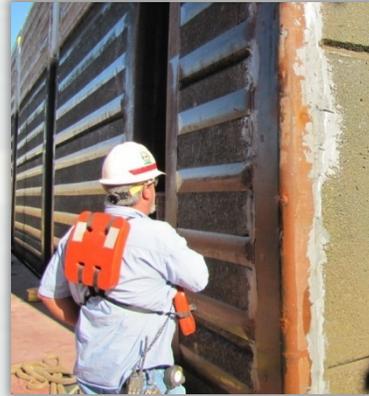
Repair cavity prior to placement

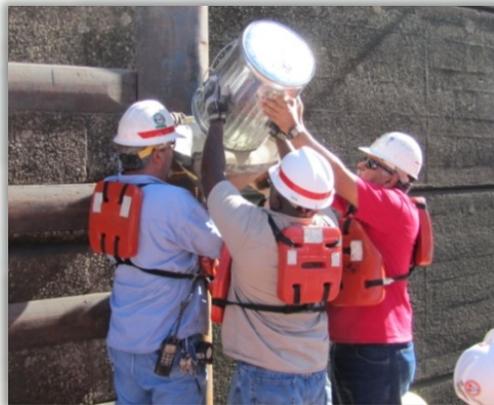
Consolidation via external vibration

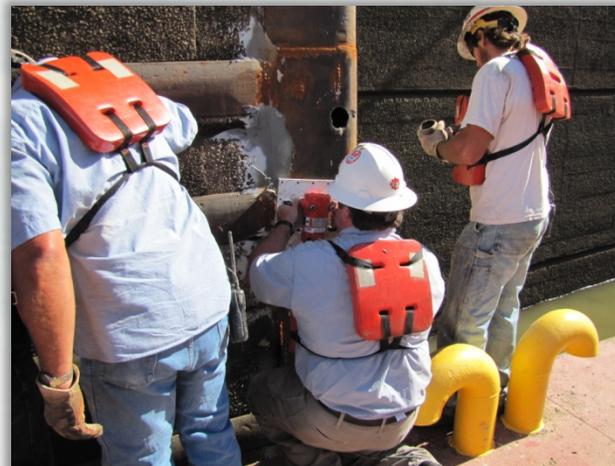
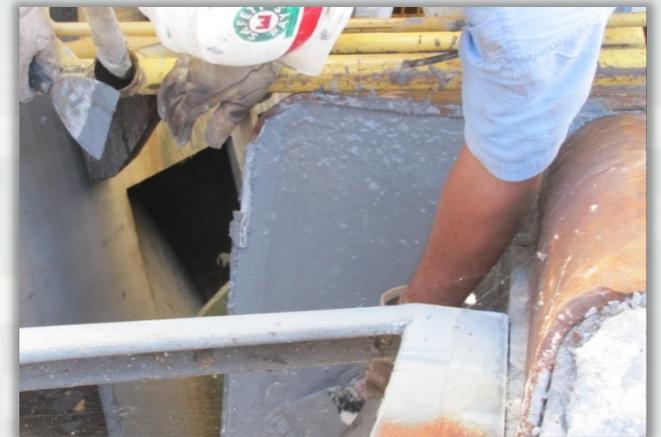
Completed UHPC repair

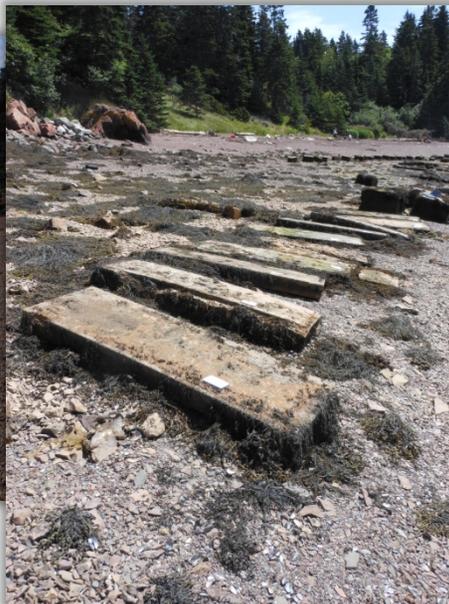
- Site visit to Treat Island Natural Weathering Station to assess condition of repair slabs placed in 1995.
- Eleven slabs fabricated with different repair materials: polymer modified, shrinkage reducing admixtures, rapid repair materials, alternative cements, etc...
- Not studied since completion of REMR.

REMR Thin Repair Slabs
