Lock 52 Upper Guide Wall Resurfacing

Lakes and River Division

Louisville District

February 2015

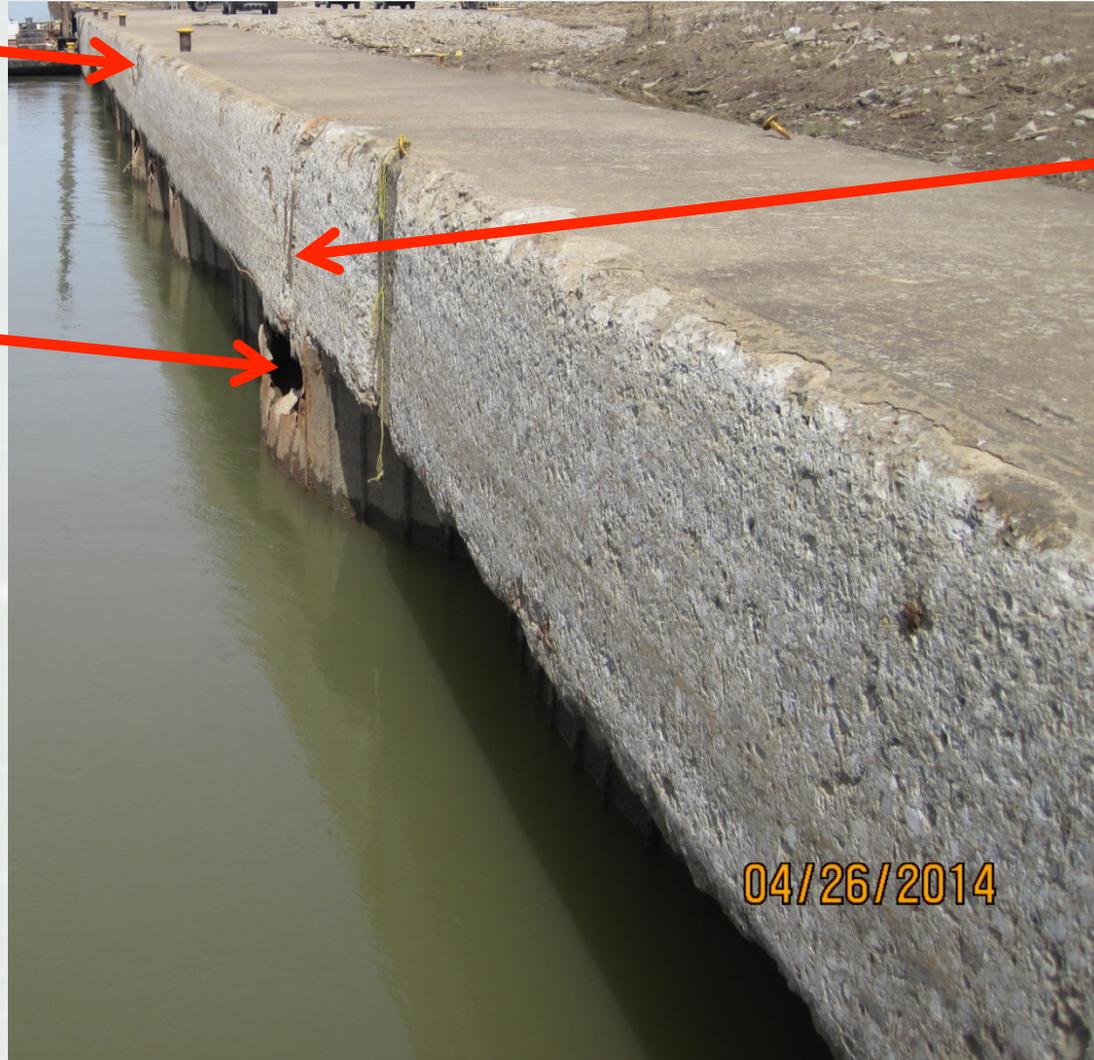
Pre work - Condition

Shaved off
ladder recess

Worn sheet pile
Cell and loss of
Fill material

Exposed rebar
Indicating 4-6"
material loss

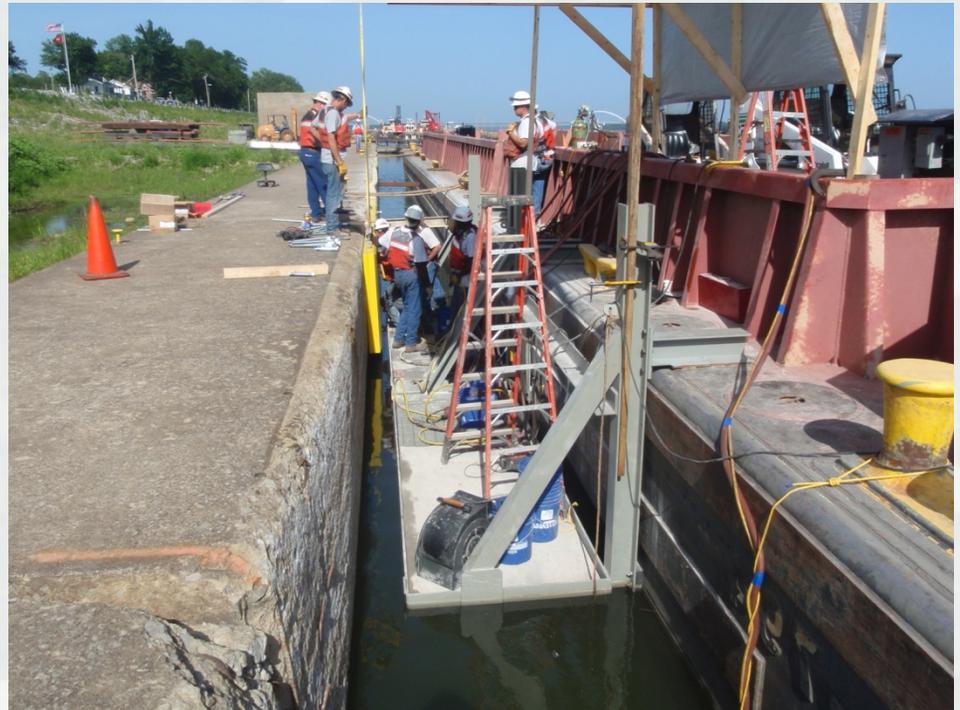
- Work access was an important consideration. Custom platforms were constructed and mounted to our barges.
