Lock 53 Wicket Lifter Winch Failure

Brian L. Holcomb, P.E.

Louisville District

February 2015

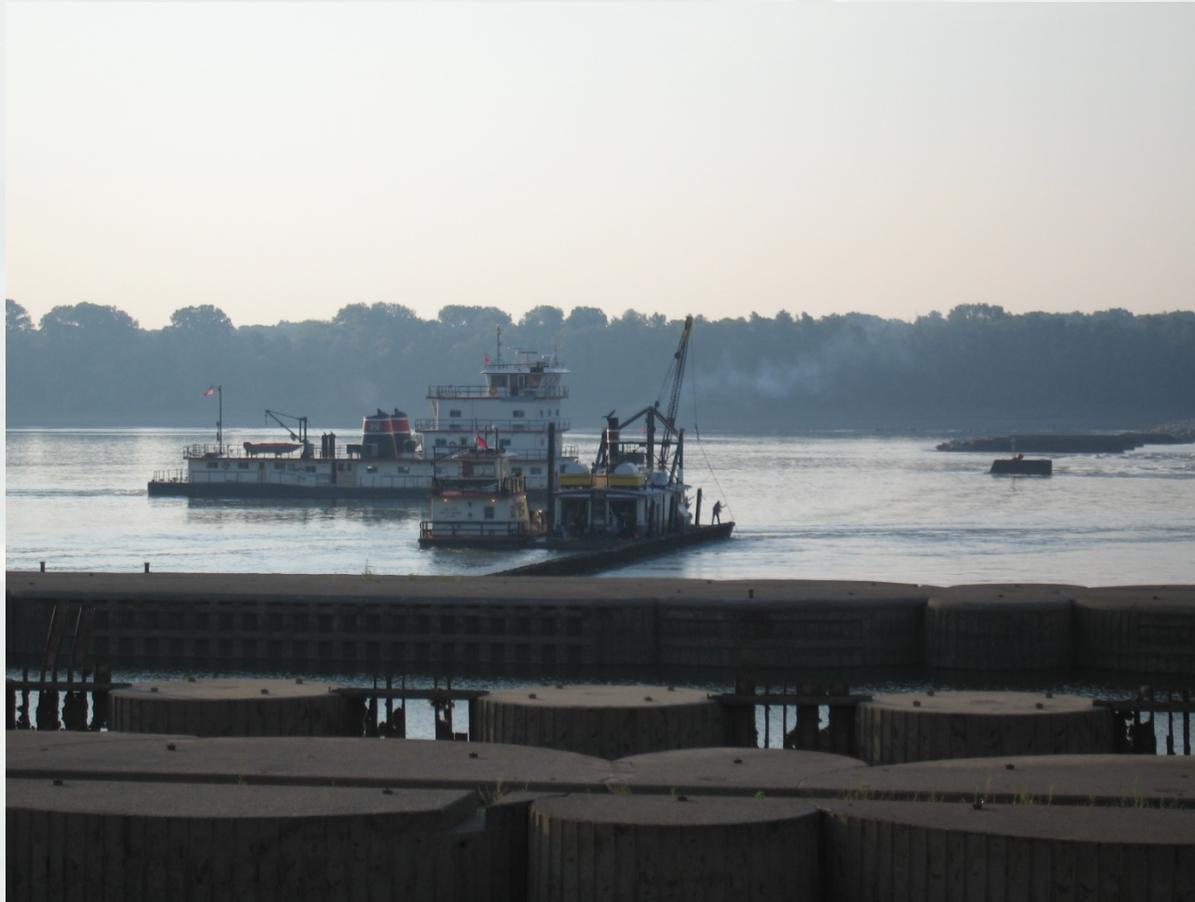
Maneuver Boat in Action

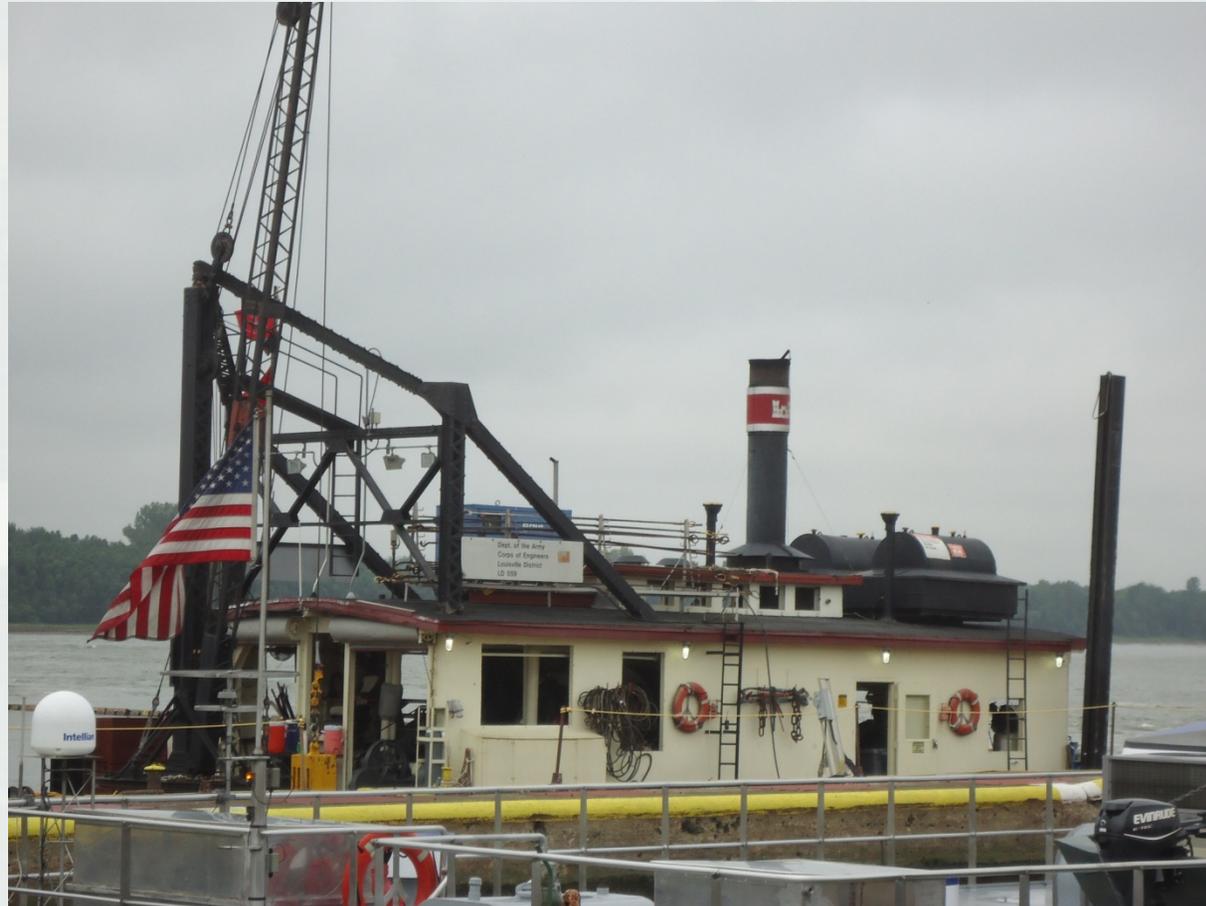
Existing Steam Maneuver Boat

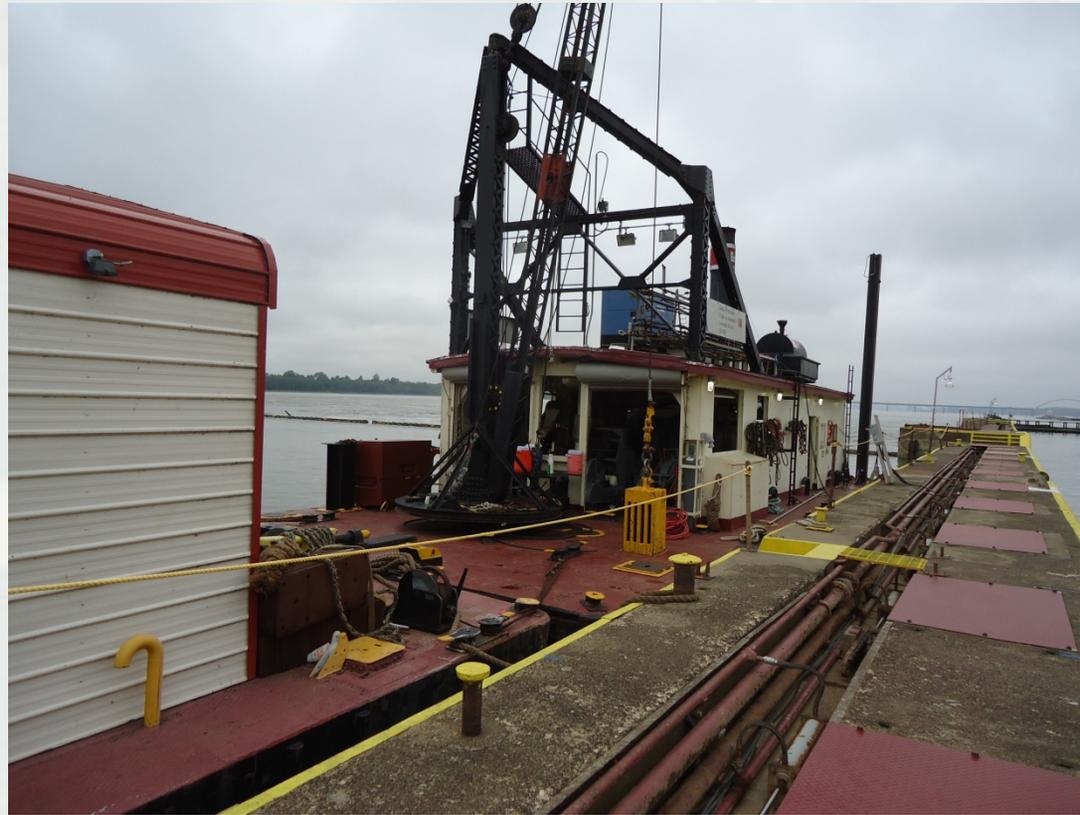
Existing Steam Maneuver Boat

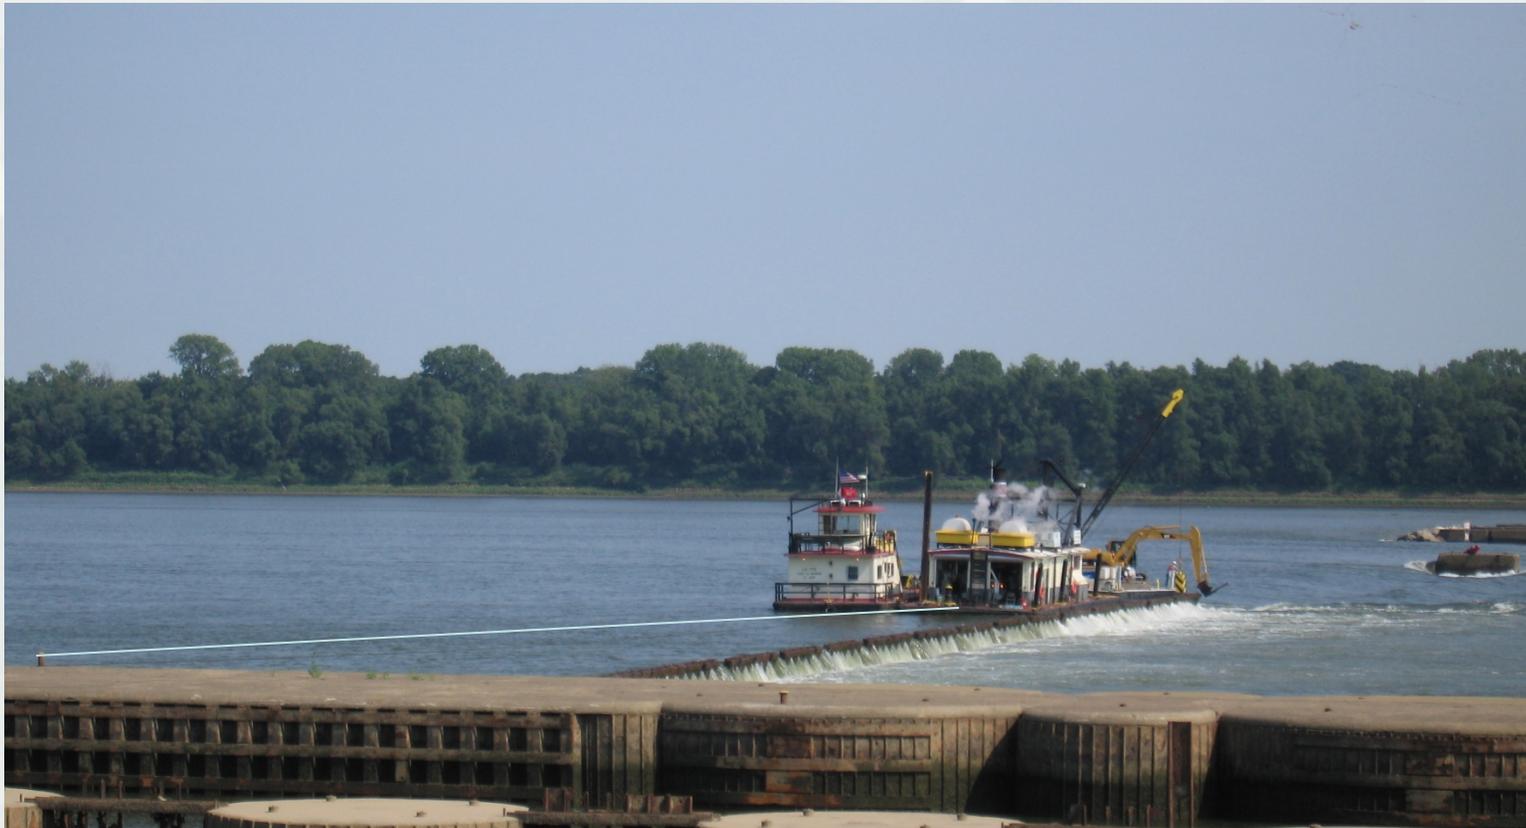
- Wicket Lifter was developed as a replacement to the original steam powered maneuver boat to raise and lower the dam
- Both have refitted or modified hulls with an excavator to raise and lower wickets.

Wicket Lifter in Action

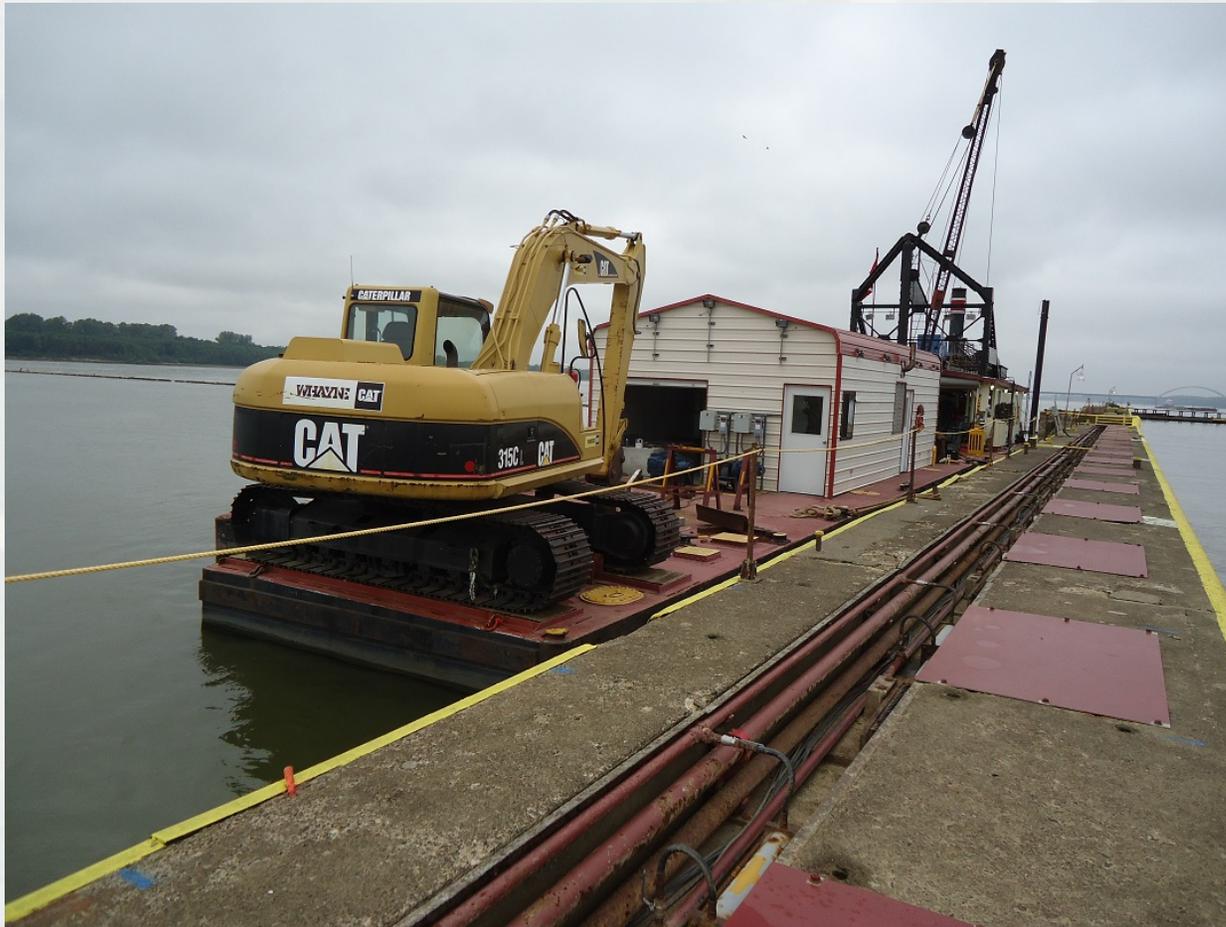
53 Wicket Lifter

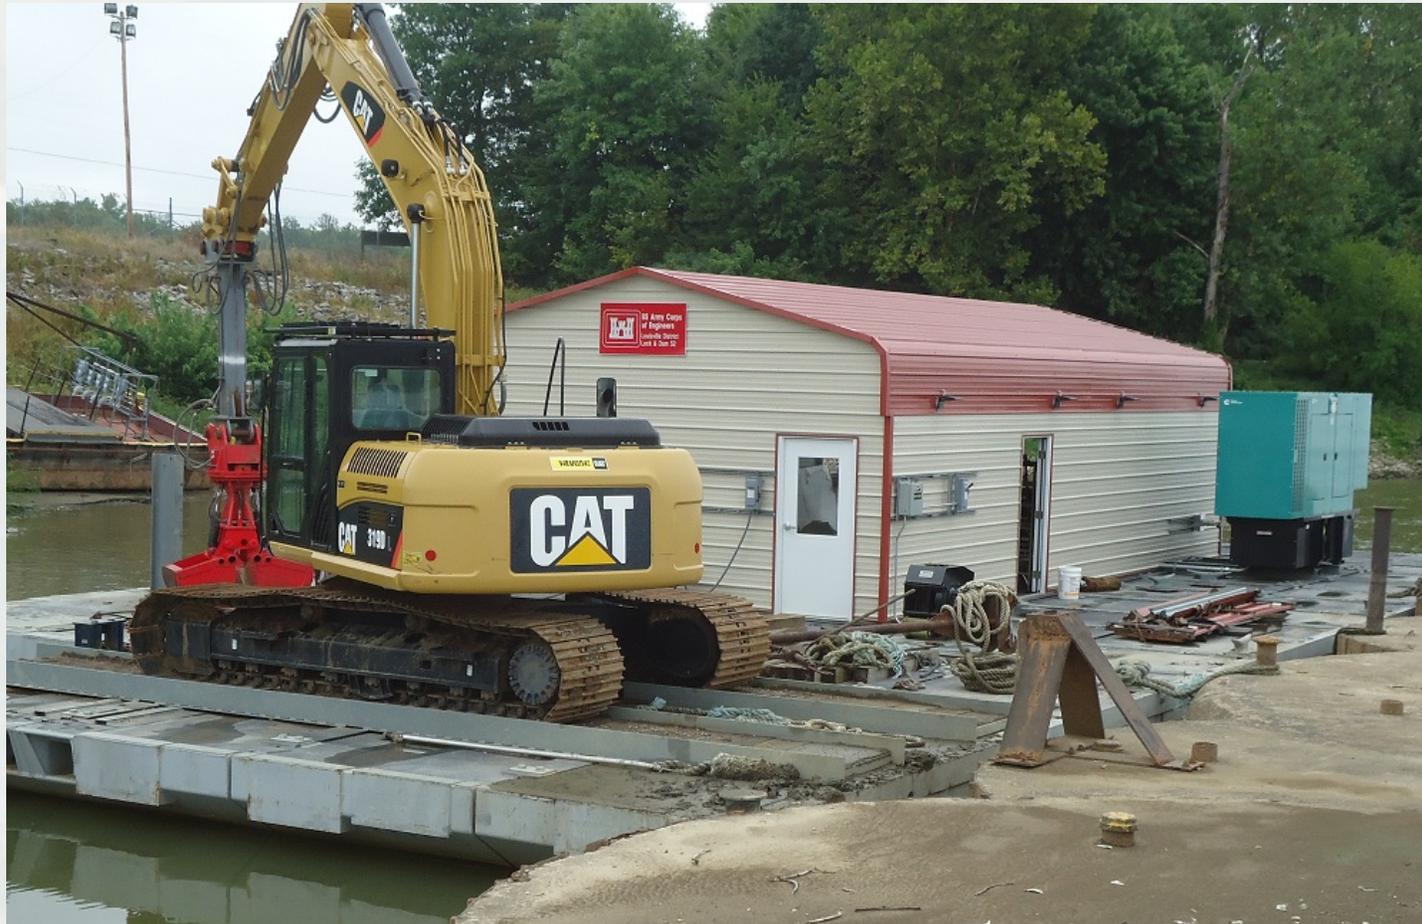
52 Wicket Lifter

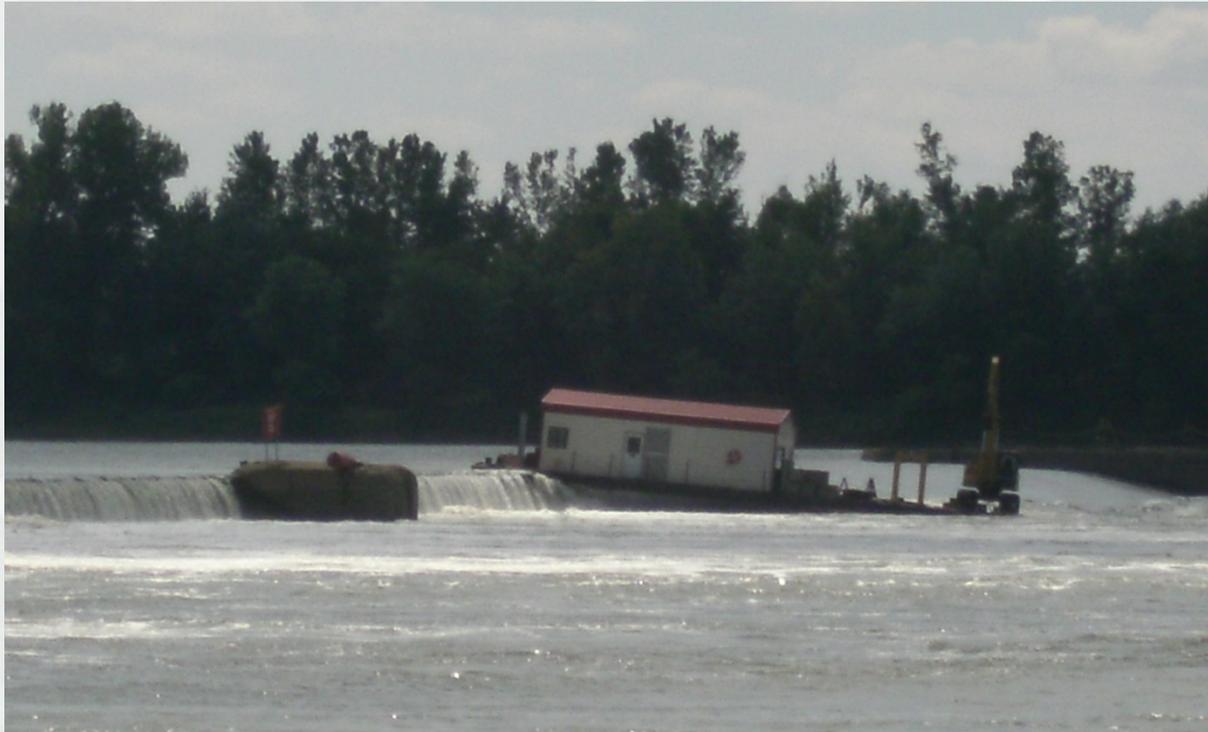
53 Wicket Lifter stuck on dam

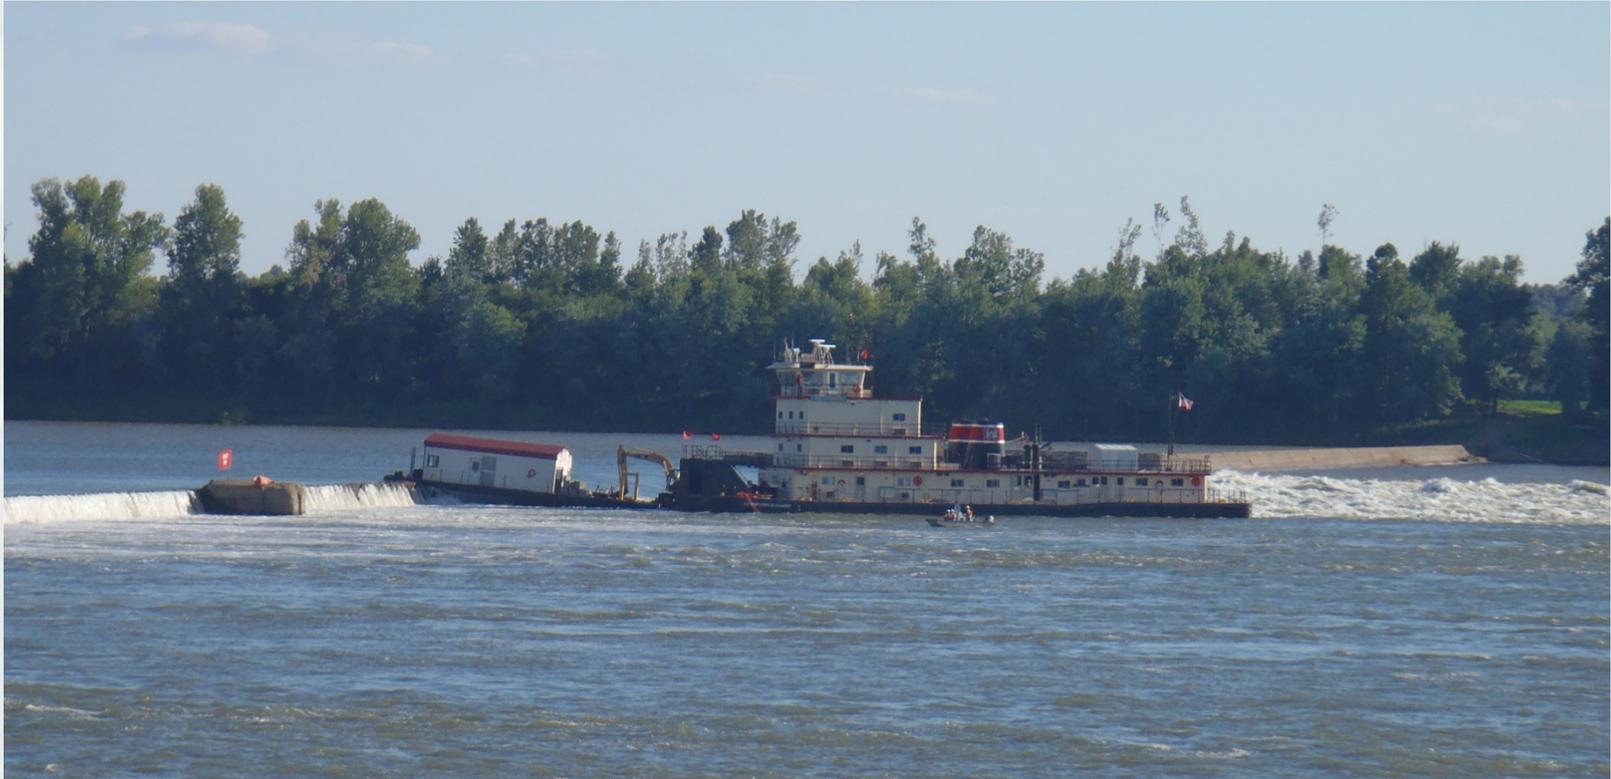
Recovery
