# R. S. Kerr Lock 15

## Cormorant Roosting – A Solution

**Lock Maintenance Workshop**  
Vicksburg, MS  
9-11 February 2016

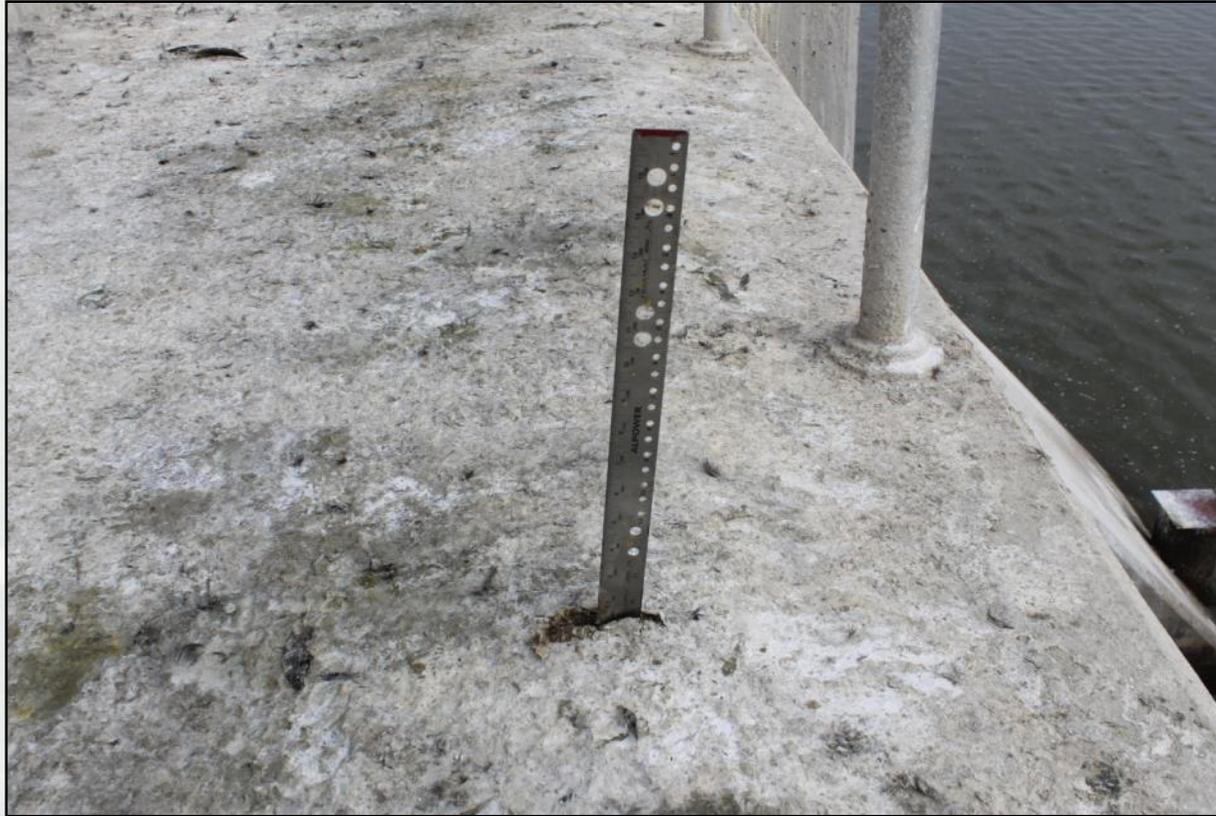
**= 5 to 10 tons of bird droppings on structure**

# Over 2 inches cover the facility!

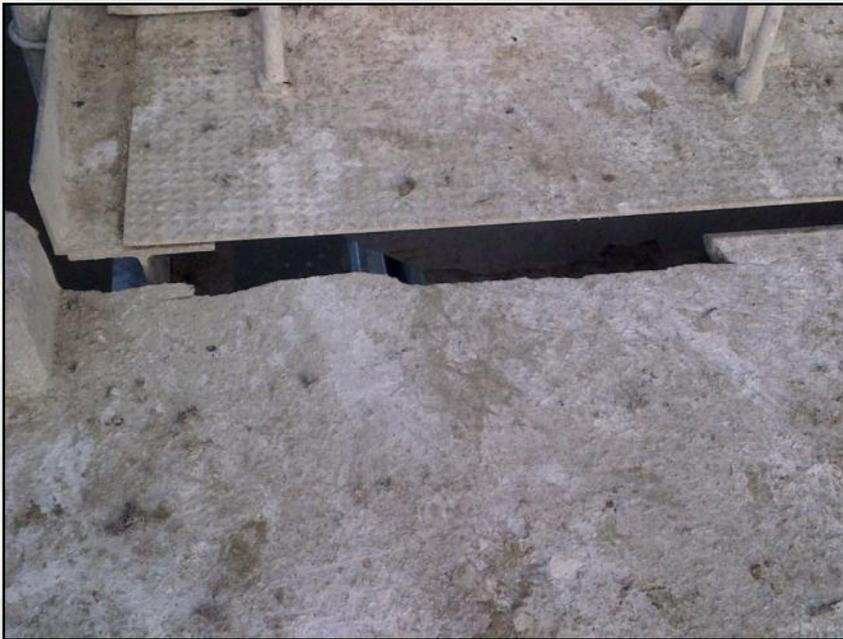
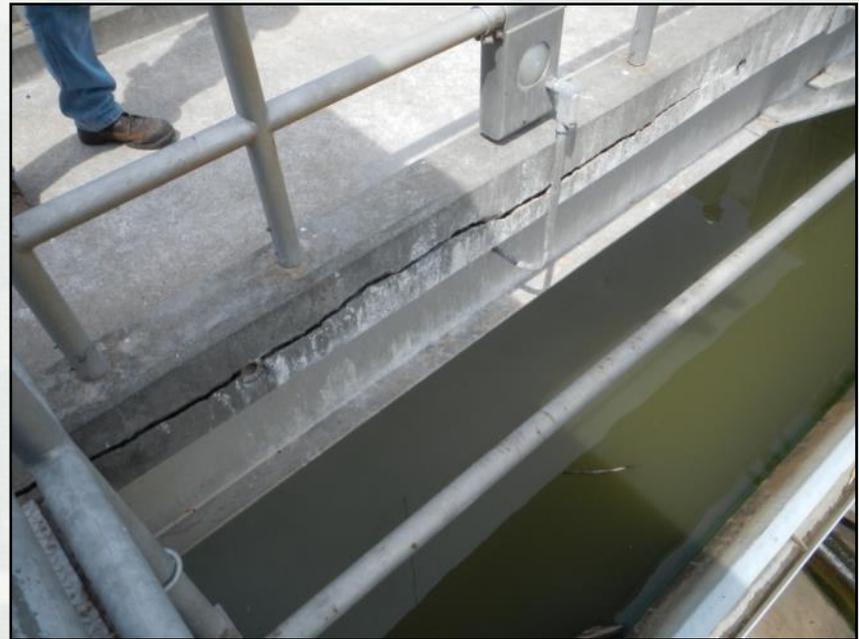
# Structural damages

- **Health hazards to operators and maintenance personnel**
- **Corrosion from acids**
  - ▶ **Structural damage**
  - ▶ **Equipment damage**
- **Annual costs \$\$\$\$**
  - ▶ **Clean up**
  - ▶ **Damage repairs**

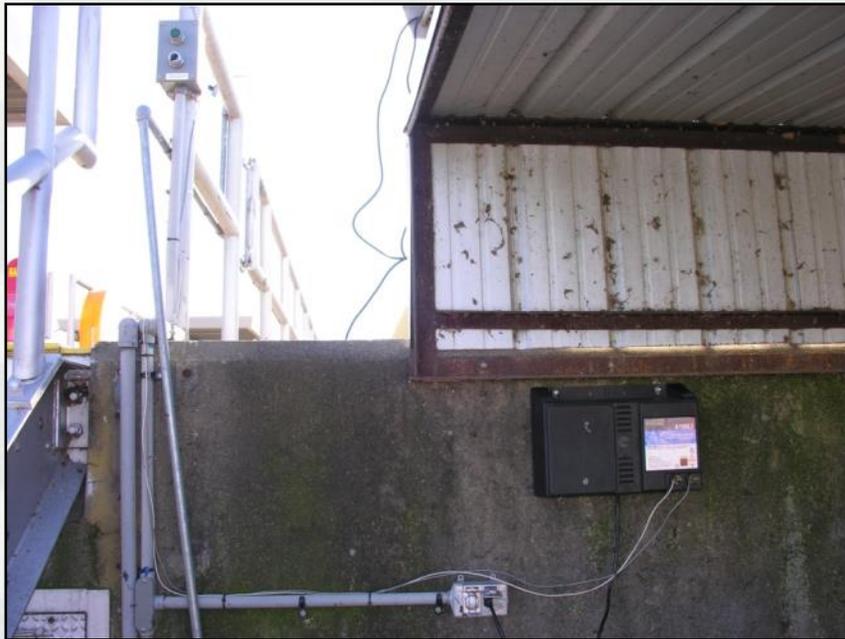
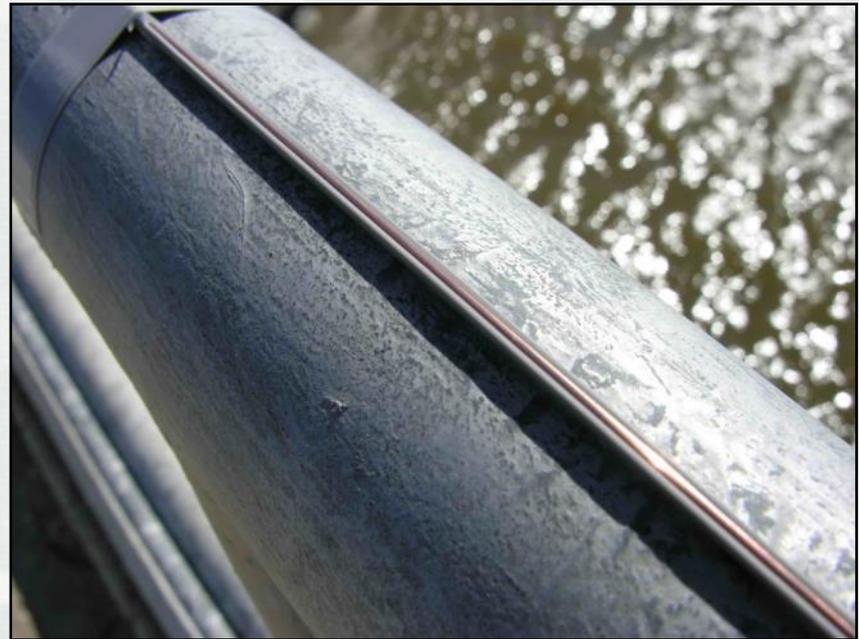
# Hot wired rails

**NOT EFFECTIVE & COST PROHIBITIVE**

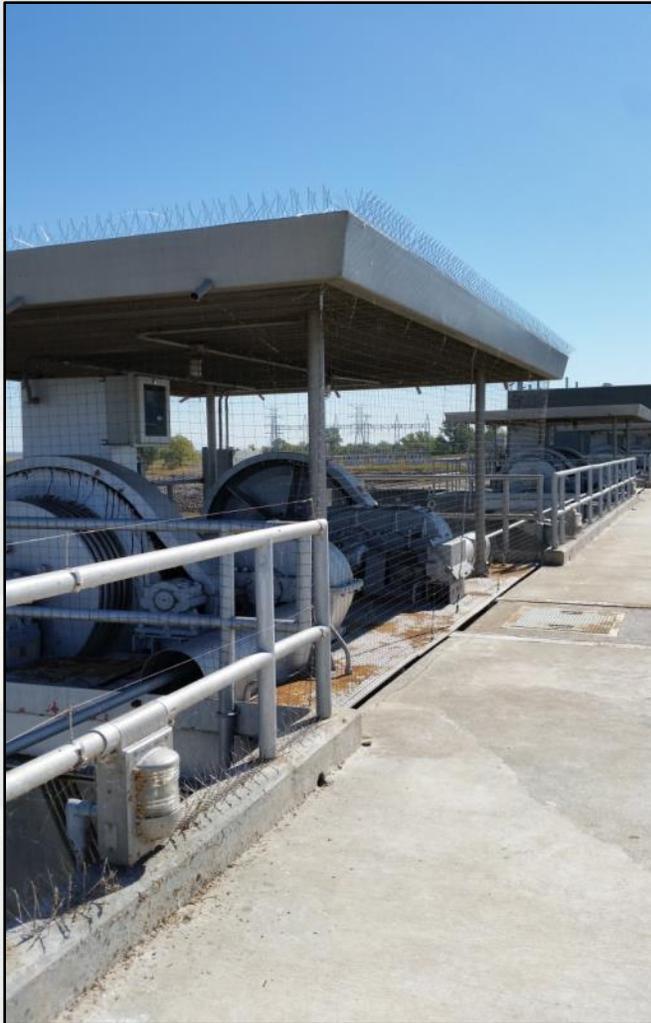
# Bird Deterrent Costs

- **\$6,000 - 1 spillway gate (done)**
  - ▶ **\$2,500 materials**
  - ▶ **\$3,500 labor 5 people**

- **\$108,000 - 18 spillway gates**
  - ▶ **Cost prohibitive**

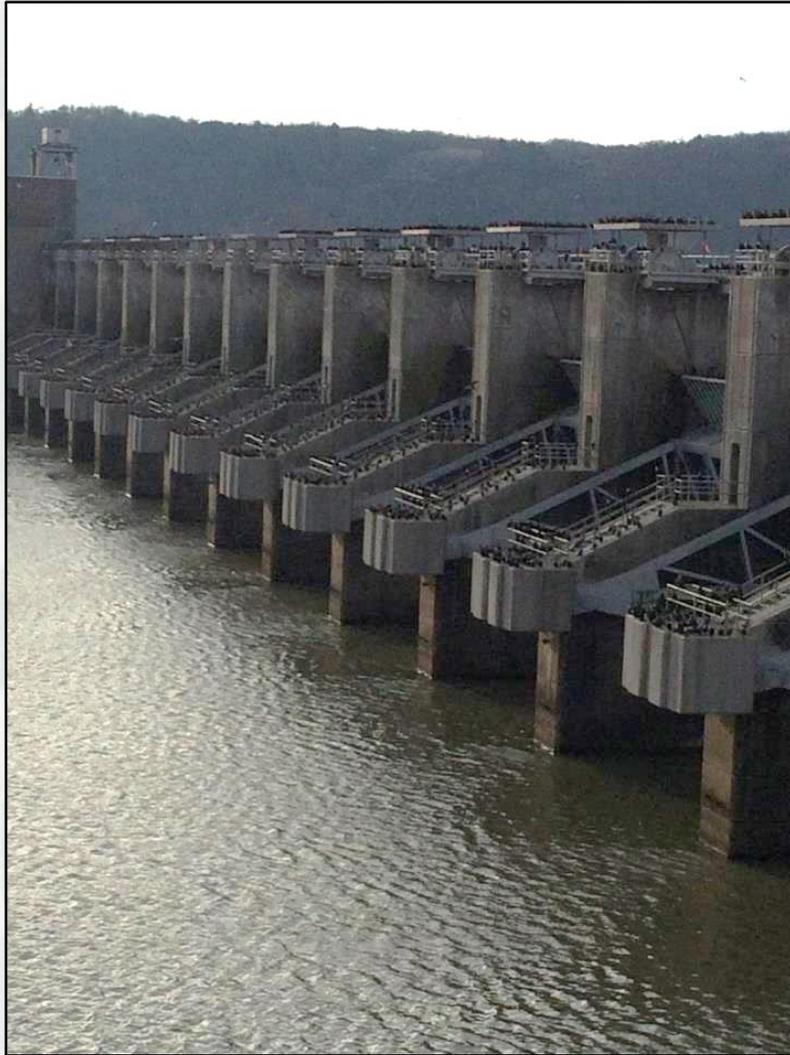
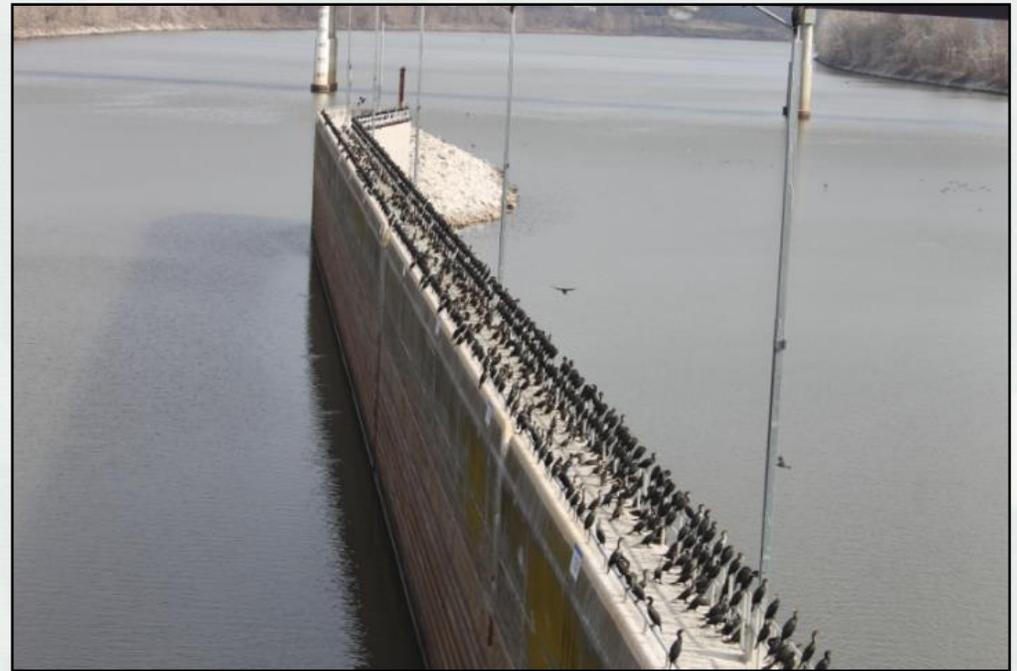
- **Partially effective for equipment**
- **Ineffective for walkway**

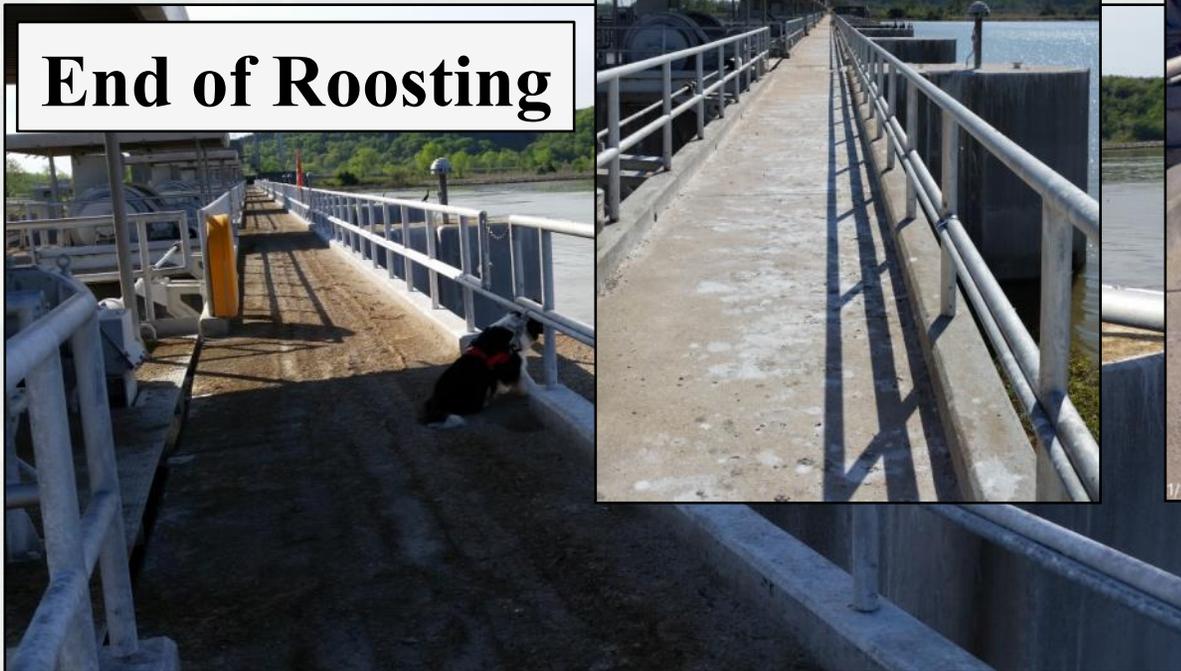
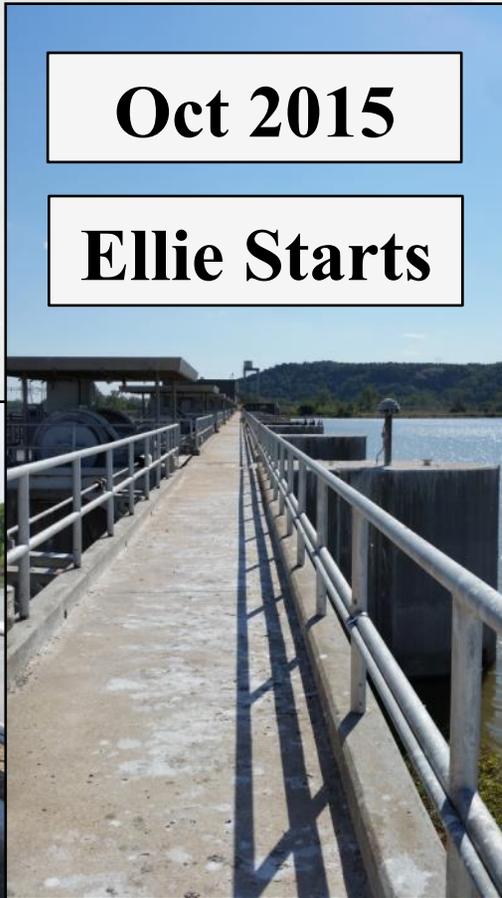
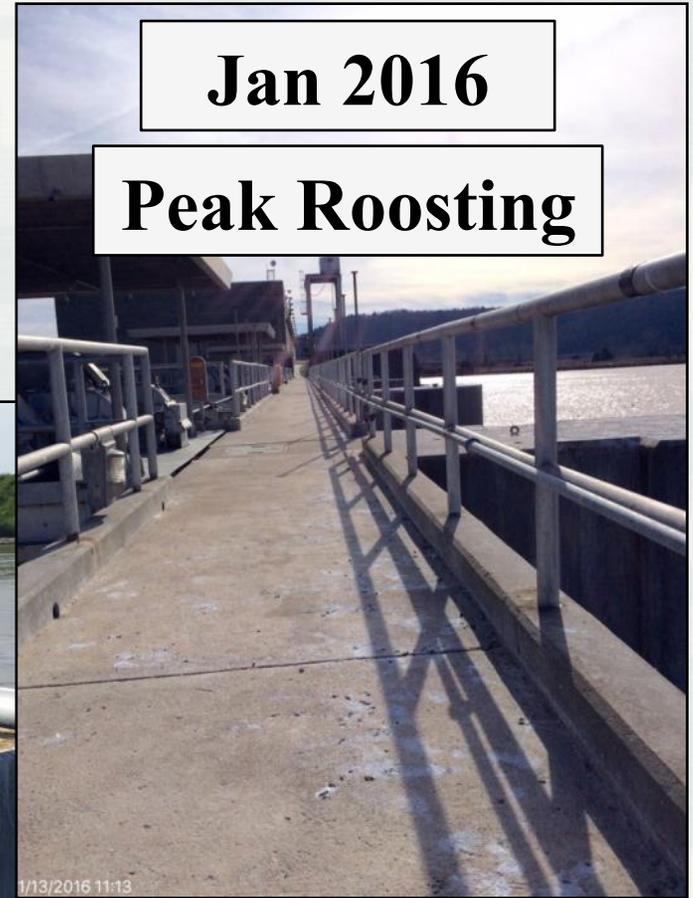
# Spillway Results

**Apr 2015**

**End of Roosting**

**Oct 2015**

**Ellie Starts**

**Jan 2016**

**Peak Roosting**

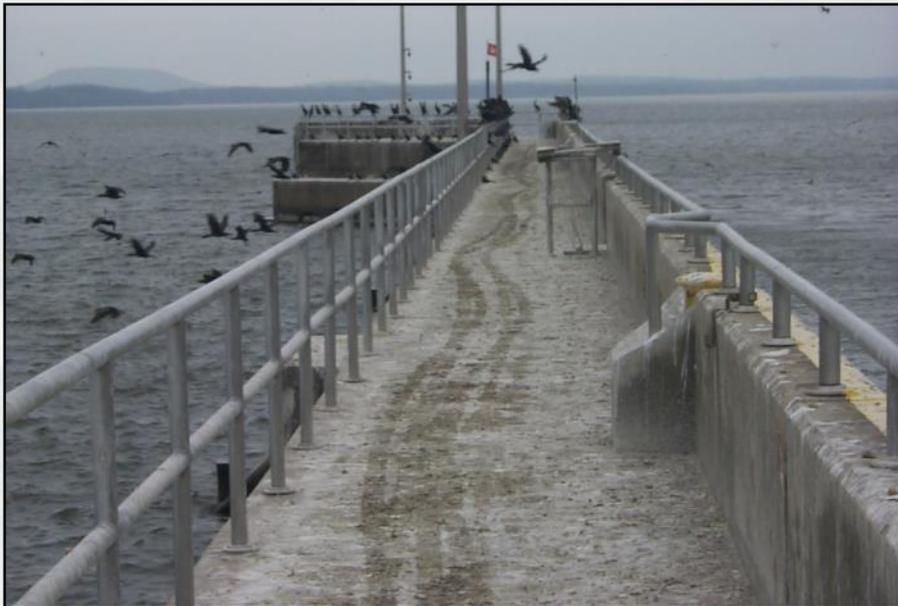
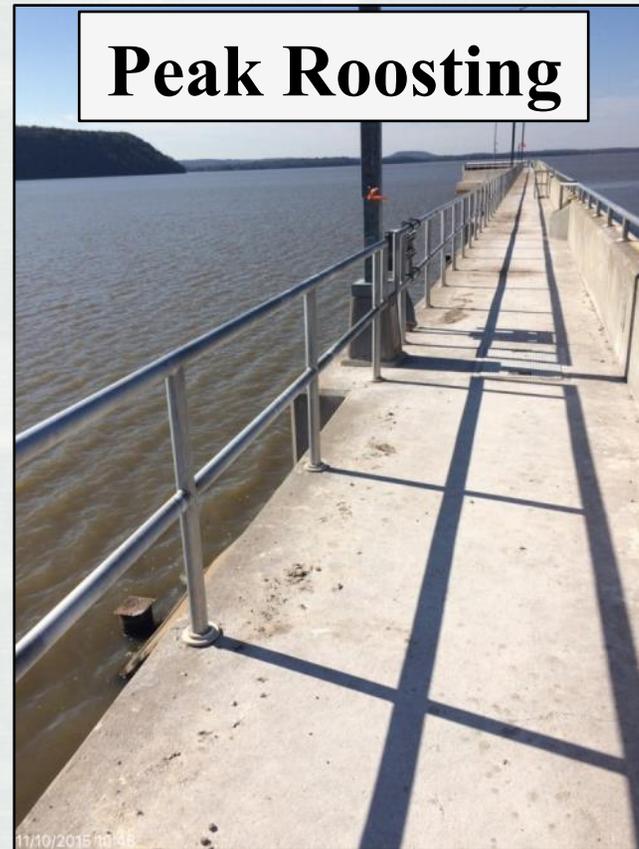
# Upper Guide Wall Results

Apr 2015

End of Roosting

Jan 2016

Peak Roosting

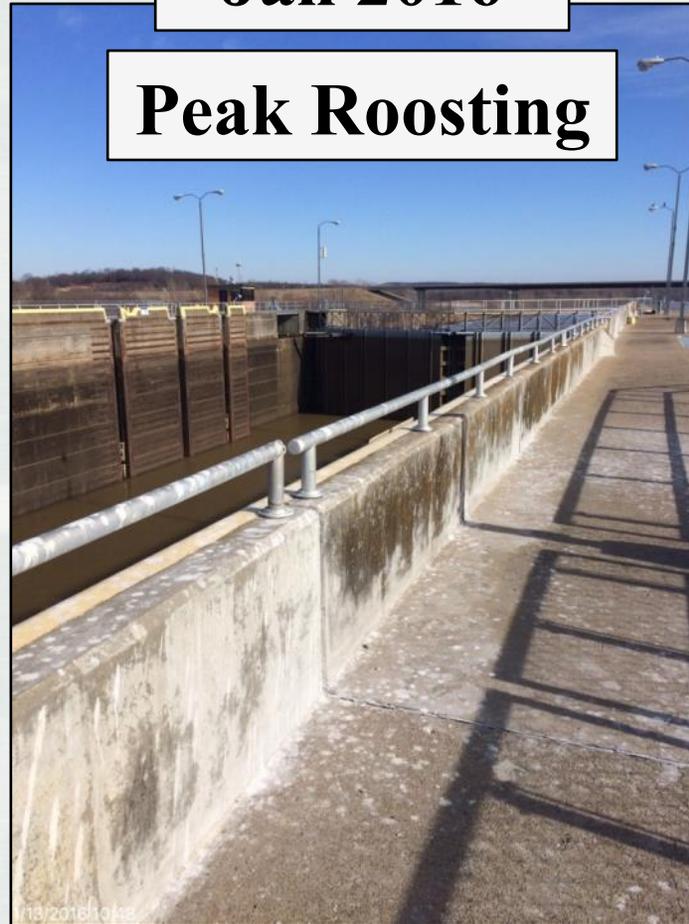
# Lock Wall Results

Jan 2016

Peak Roosting

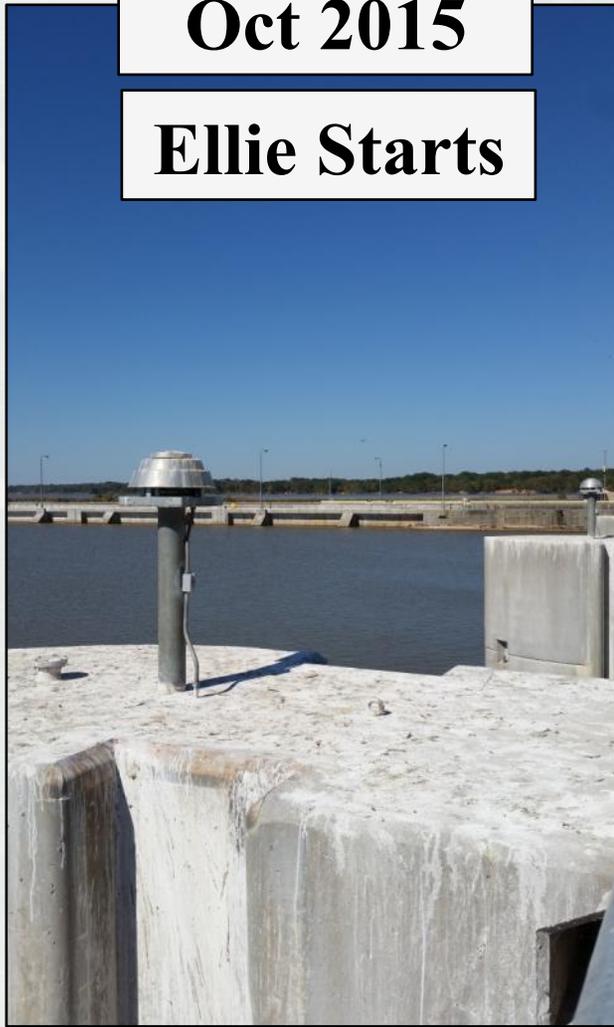
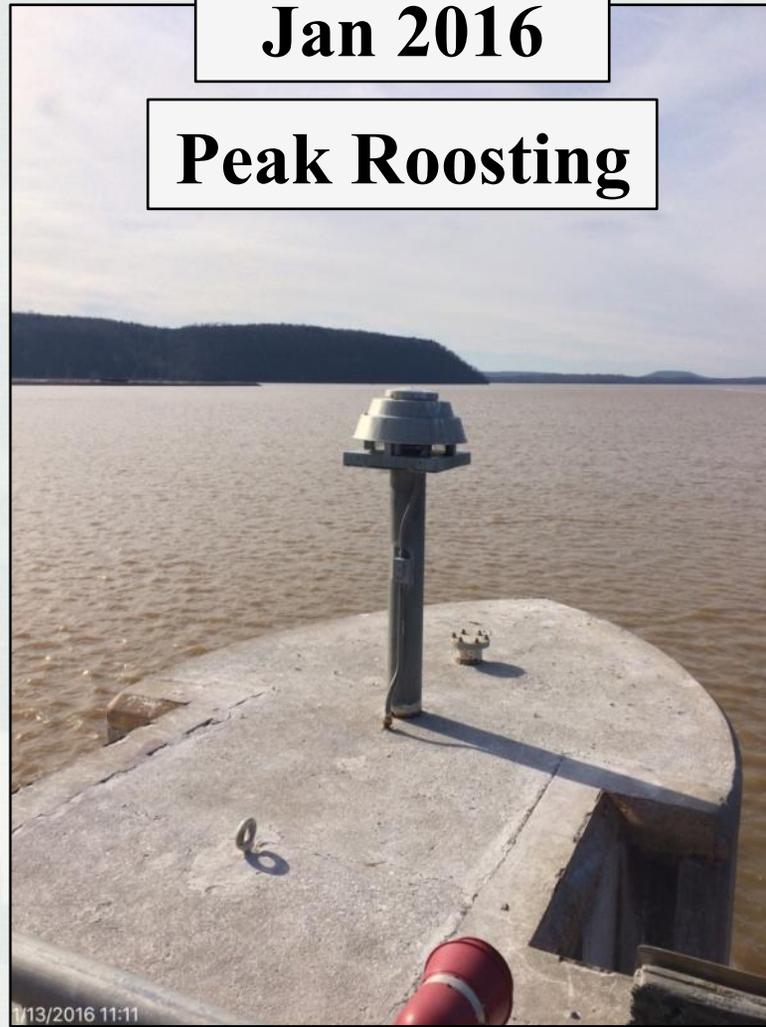
# Pillar Results

**Oct 2015**

**Ellie Starts**

**Jan 2016**

**Peak Roosting**

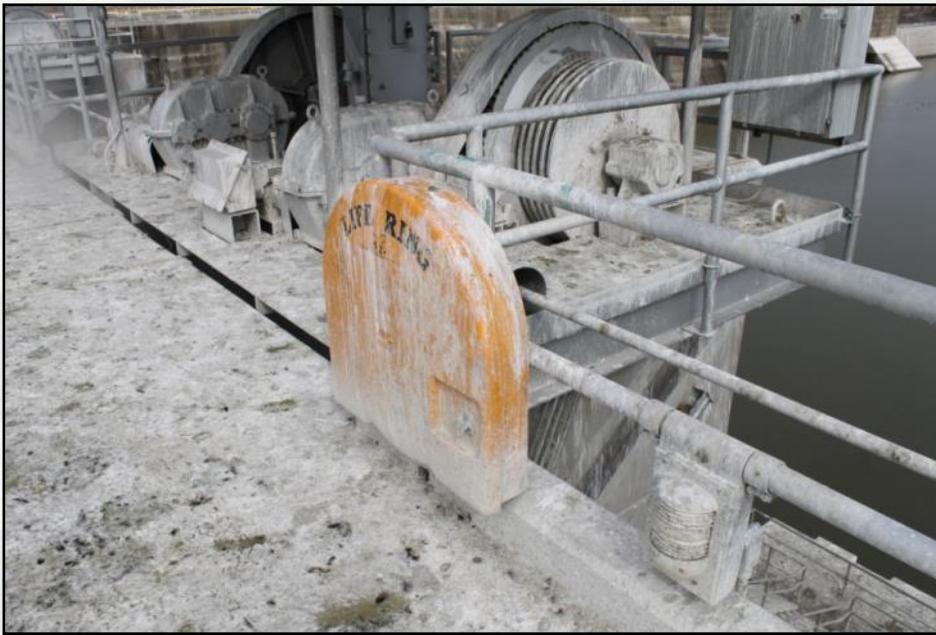
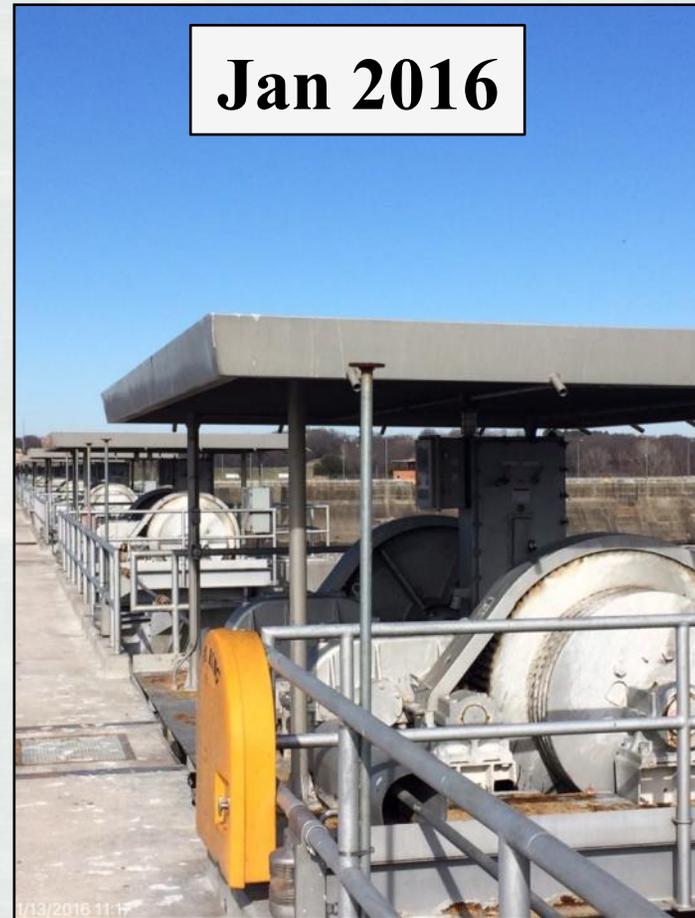
# Equipment Damage Results

Apr 2015

Jan 2016

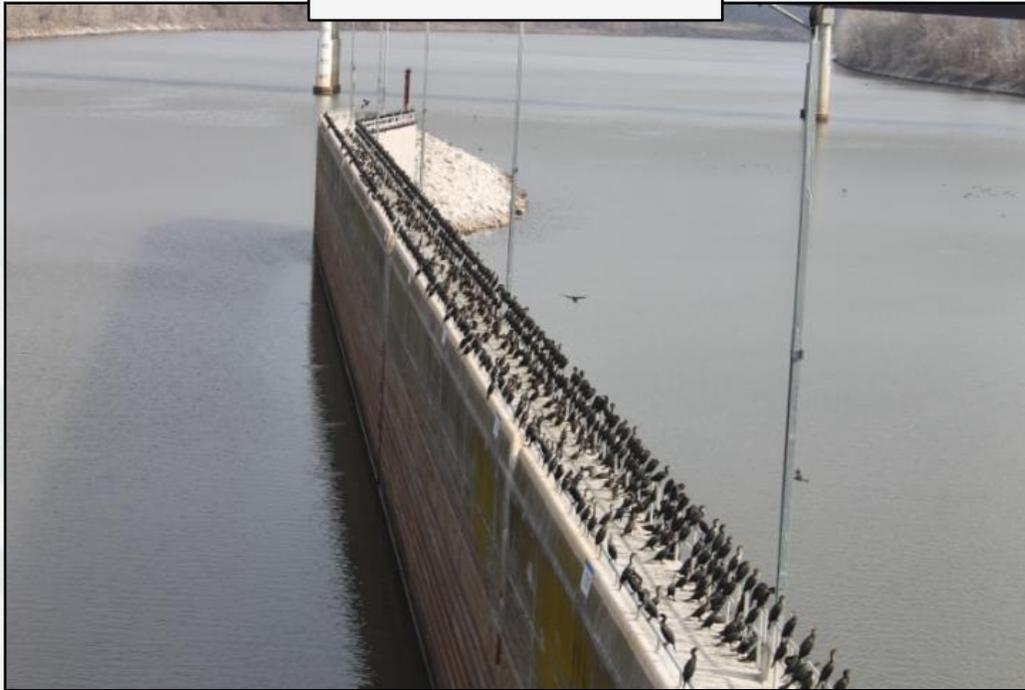
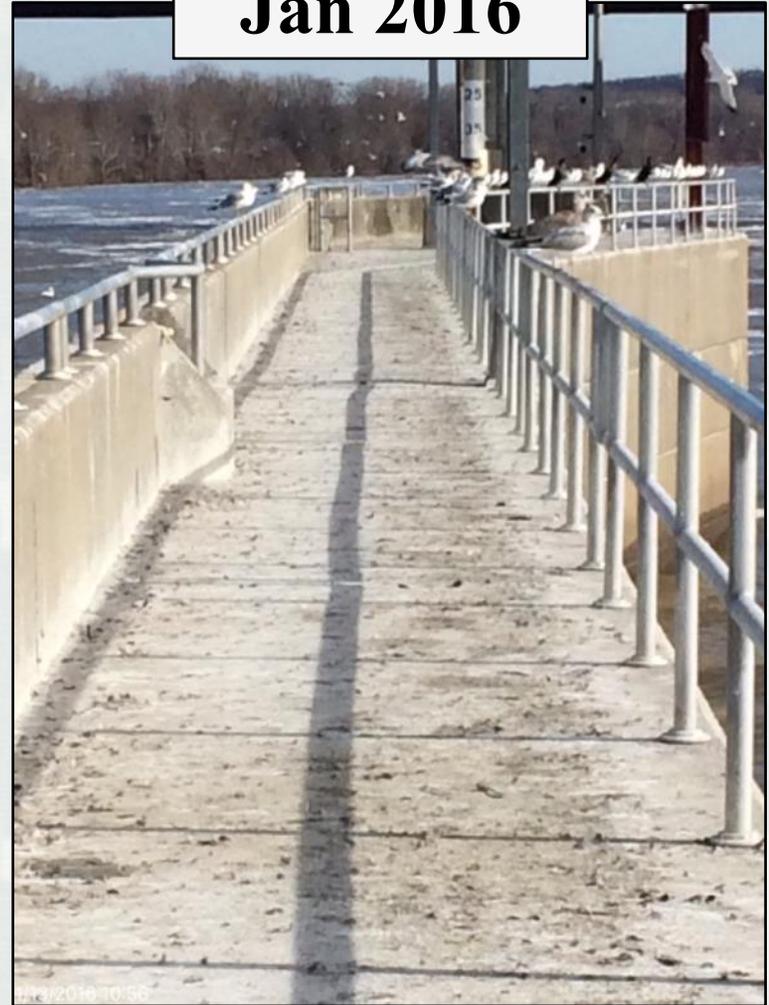
# Lower Guide Wall Results

Jan 2015

Jan 2016
