NEW CUMBERLAND L/D OHIO RIVER

Dam Gate #10

-Line Shaft Replacement

-Quick-Disconnect Couplers

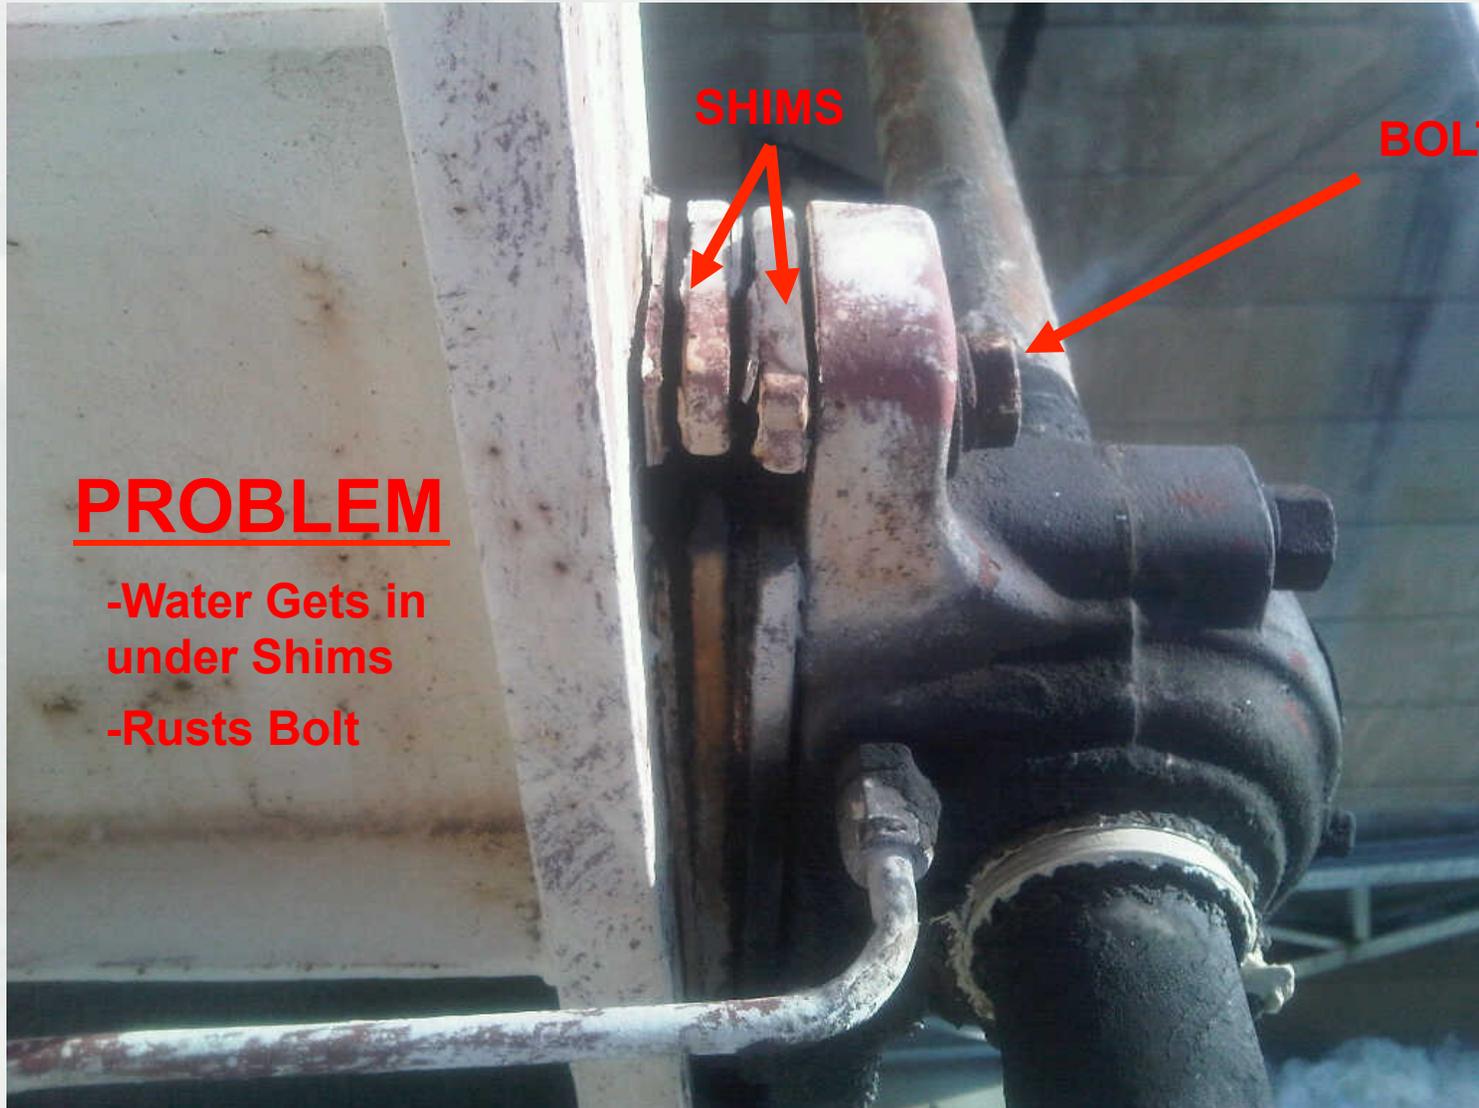
GATE FALLS – Reason??

PROBLEM

- Water Gets in under Shims
- Rusts Bolt

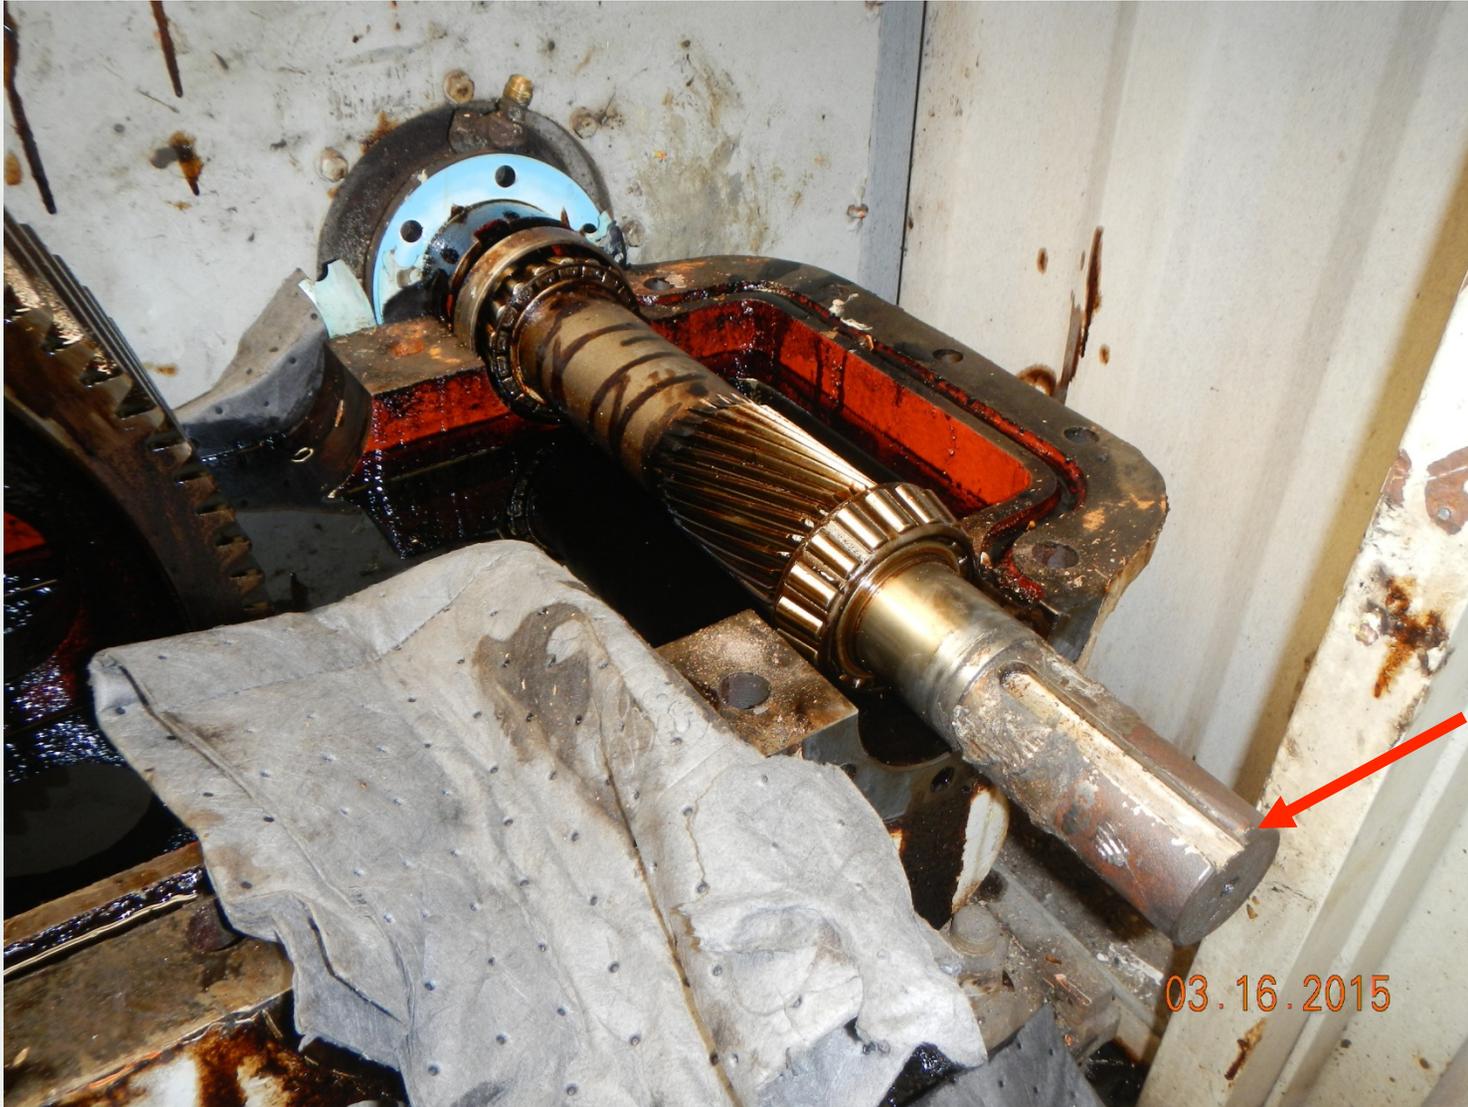
REBUILD – Gear Boxes

**Damaged
Shaft**

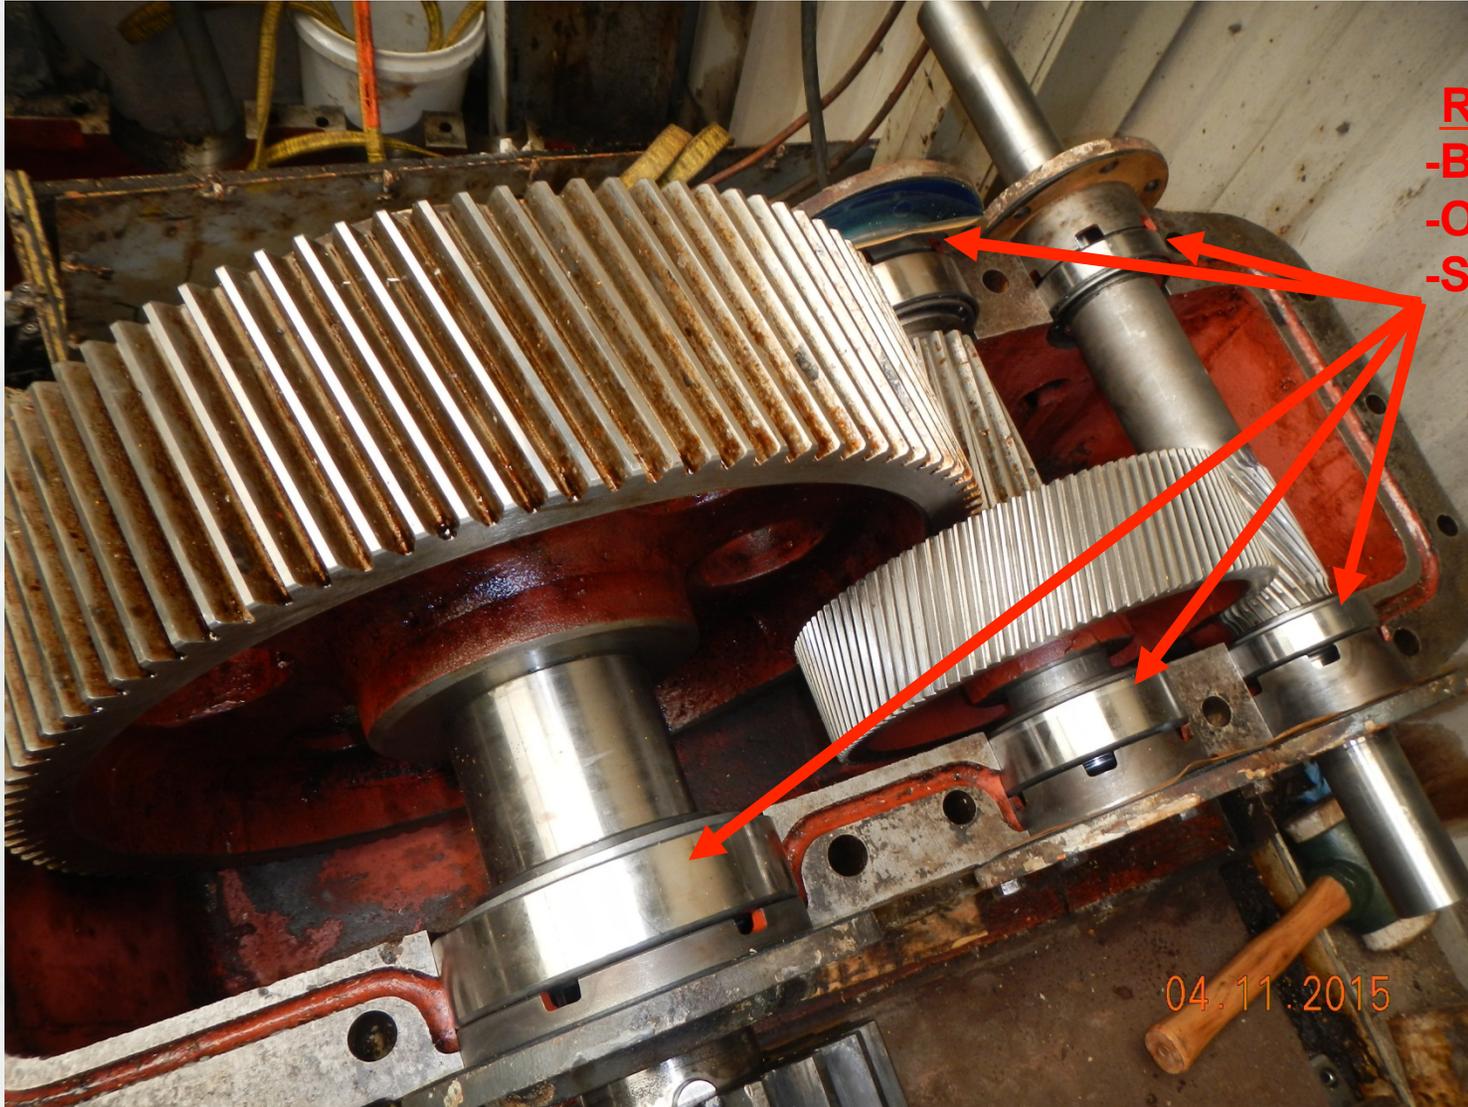
REBUILD – Gear/Brake Drum

REPLACED

- Bearings
- Oil Seals
- Shims

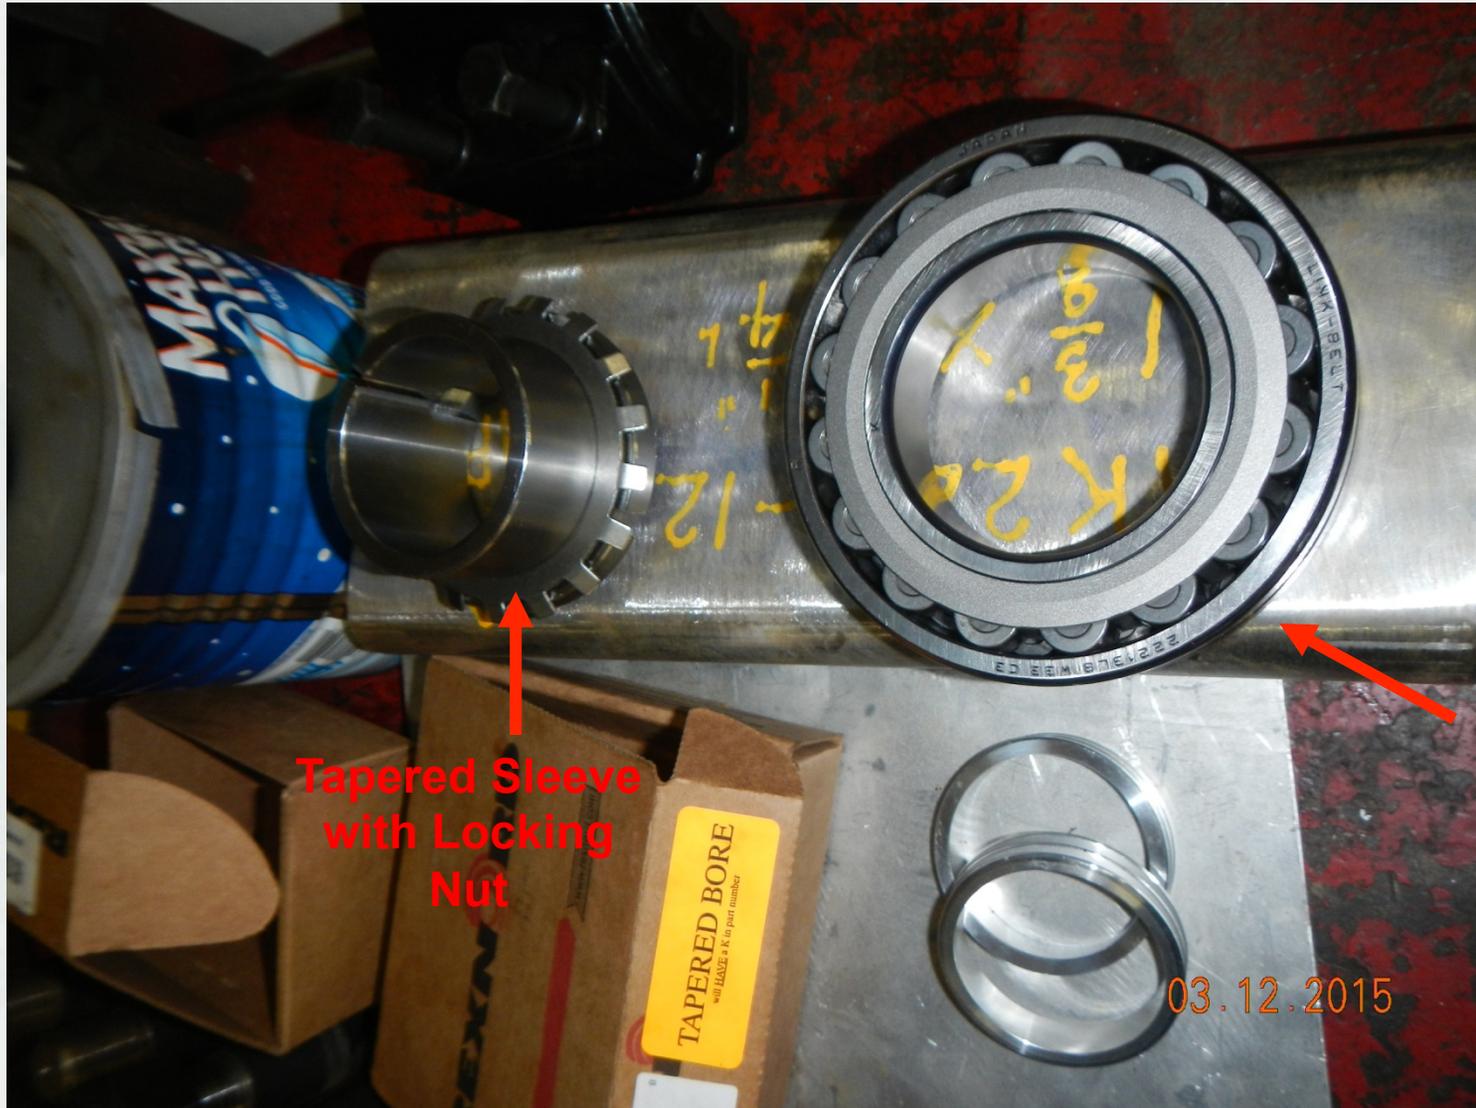
How-To: PILLOW BLOCKS

Tapered Sleeve
with Locking
Nut

Bearing

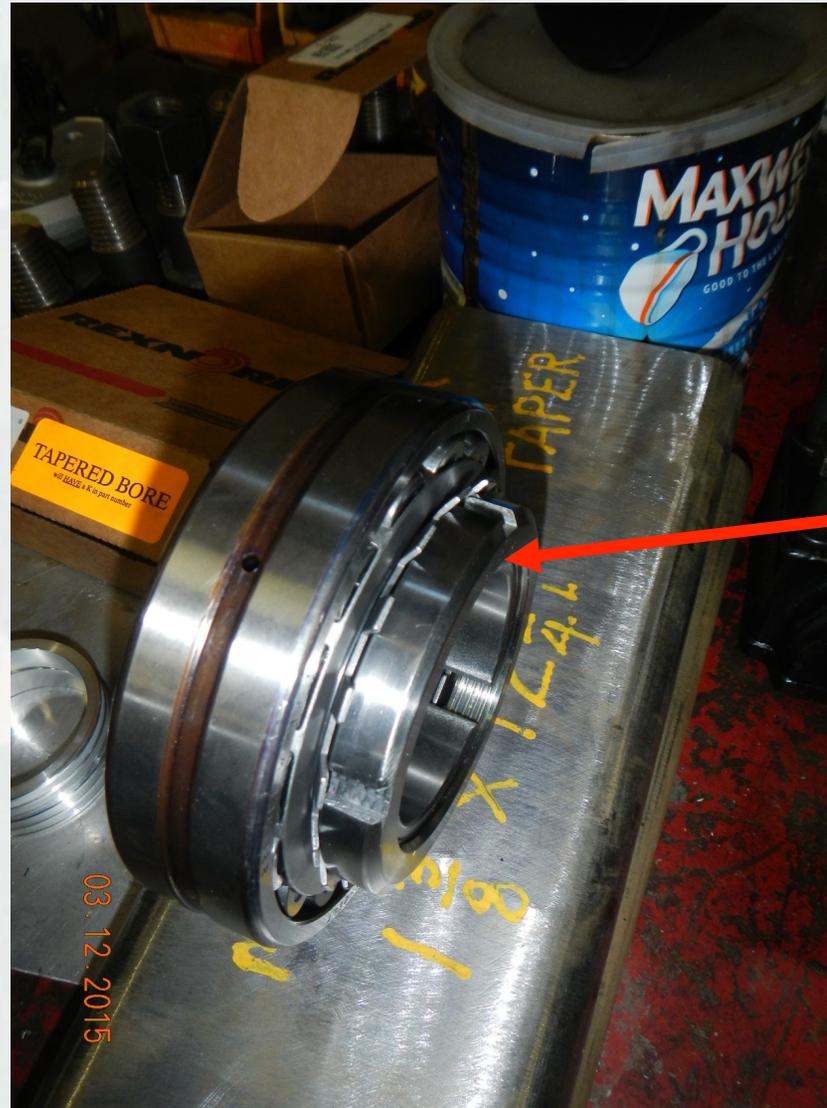
How-To: PILLOW BLOCKS

As the Nut Tightens, It moves the Bearing up the taper of the sleeve

This tightens the whole assembly onto the line shaft and locks it into place

Locking Nut

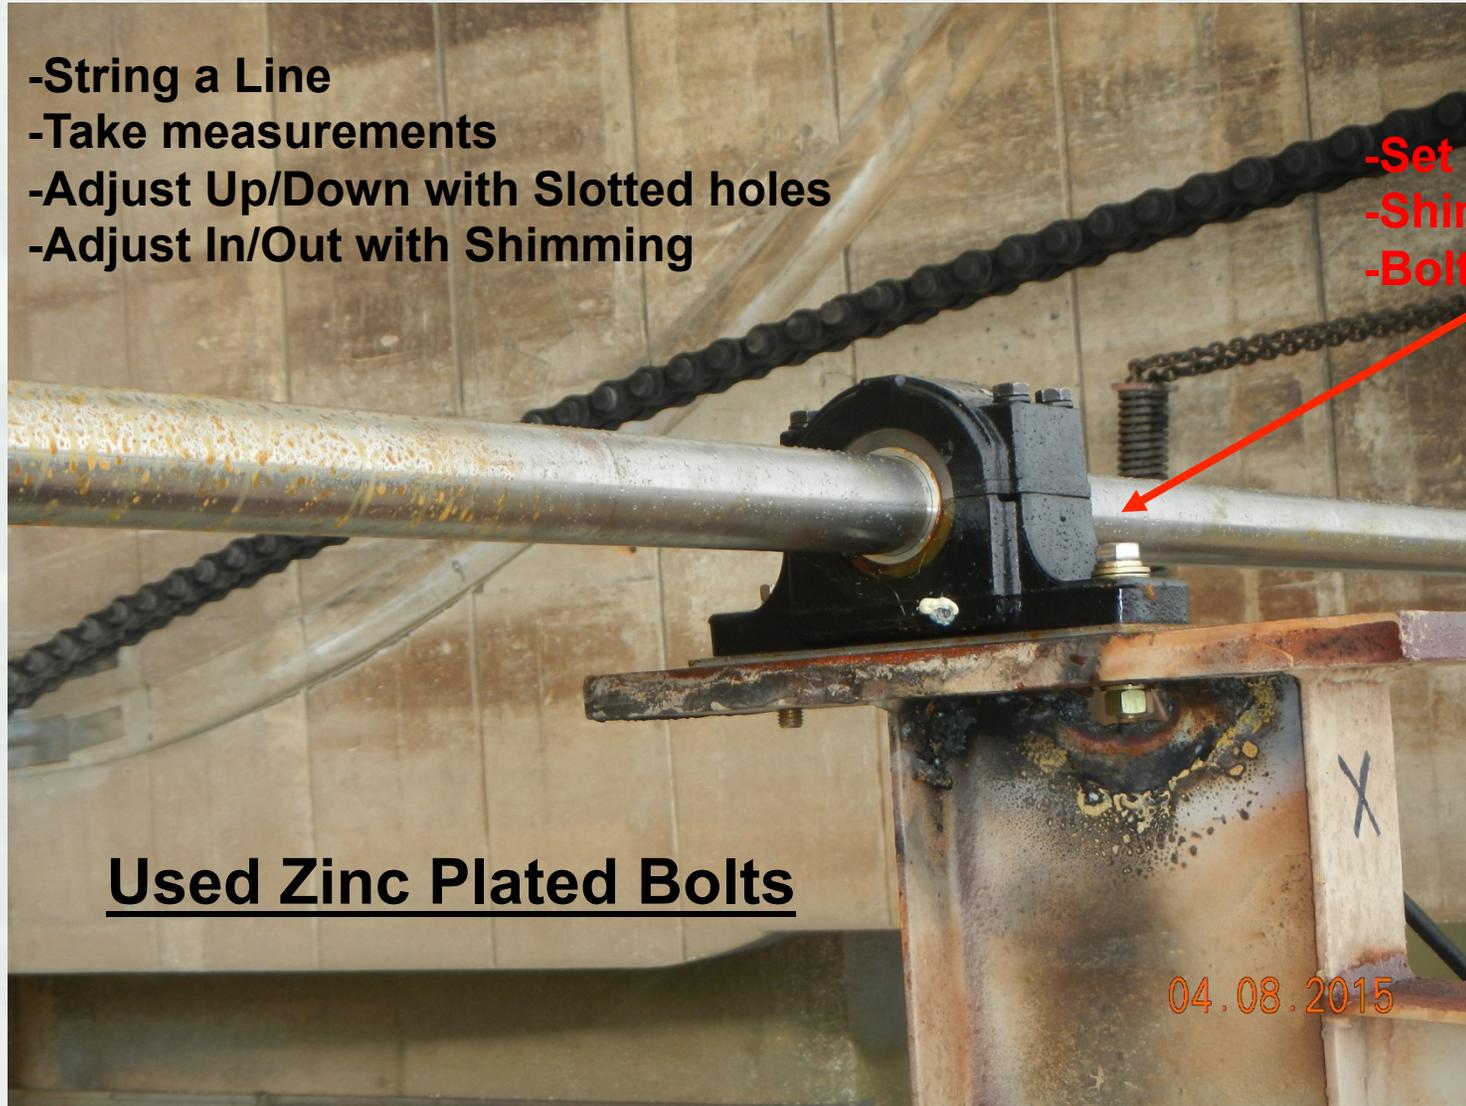
ALIGN NEW PILLOW BLOCKS

- String a Line
- Take measurements
- Adjust Up/Down with Slotted holes
- Adjust In/Out with Shimming

- Set the base
- Shim as needed
- Bolt it in place

Used Zinc Plated Bolts

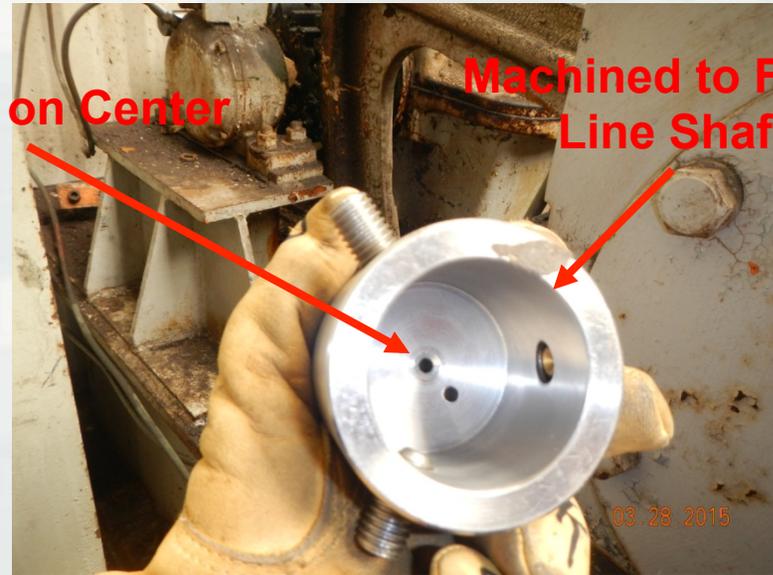
Drilled Hole on Center

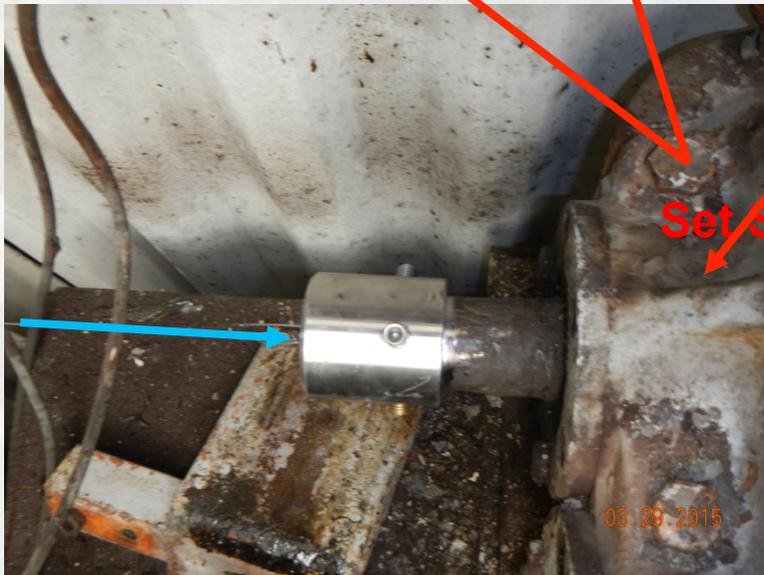
Machined to Fit on Line Shaft

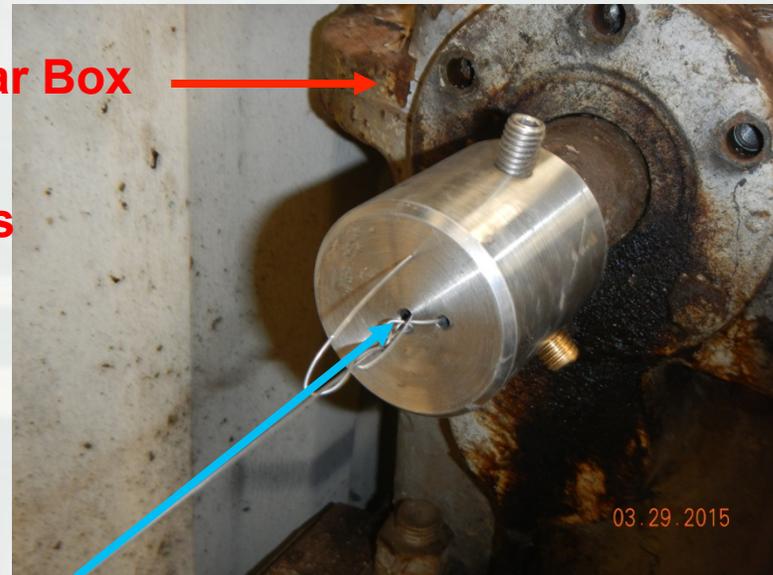
Gear Box

Set Screws

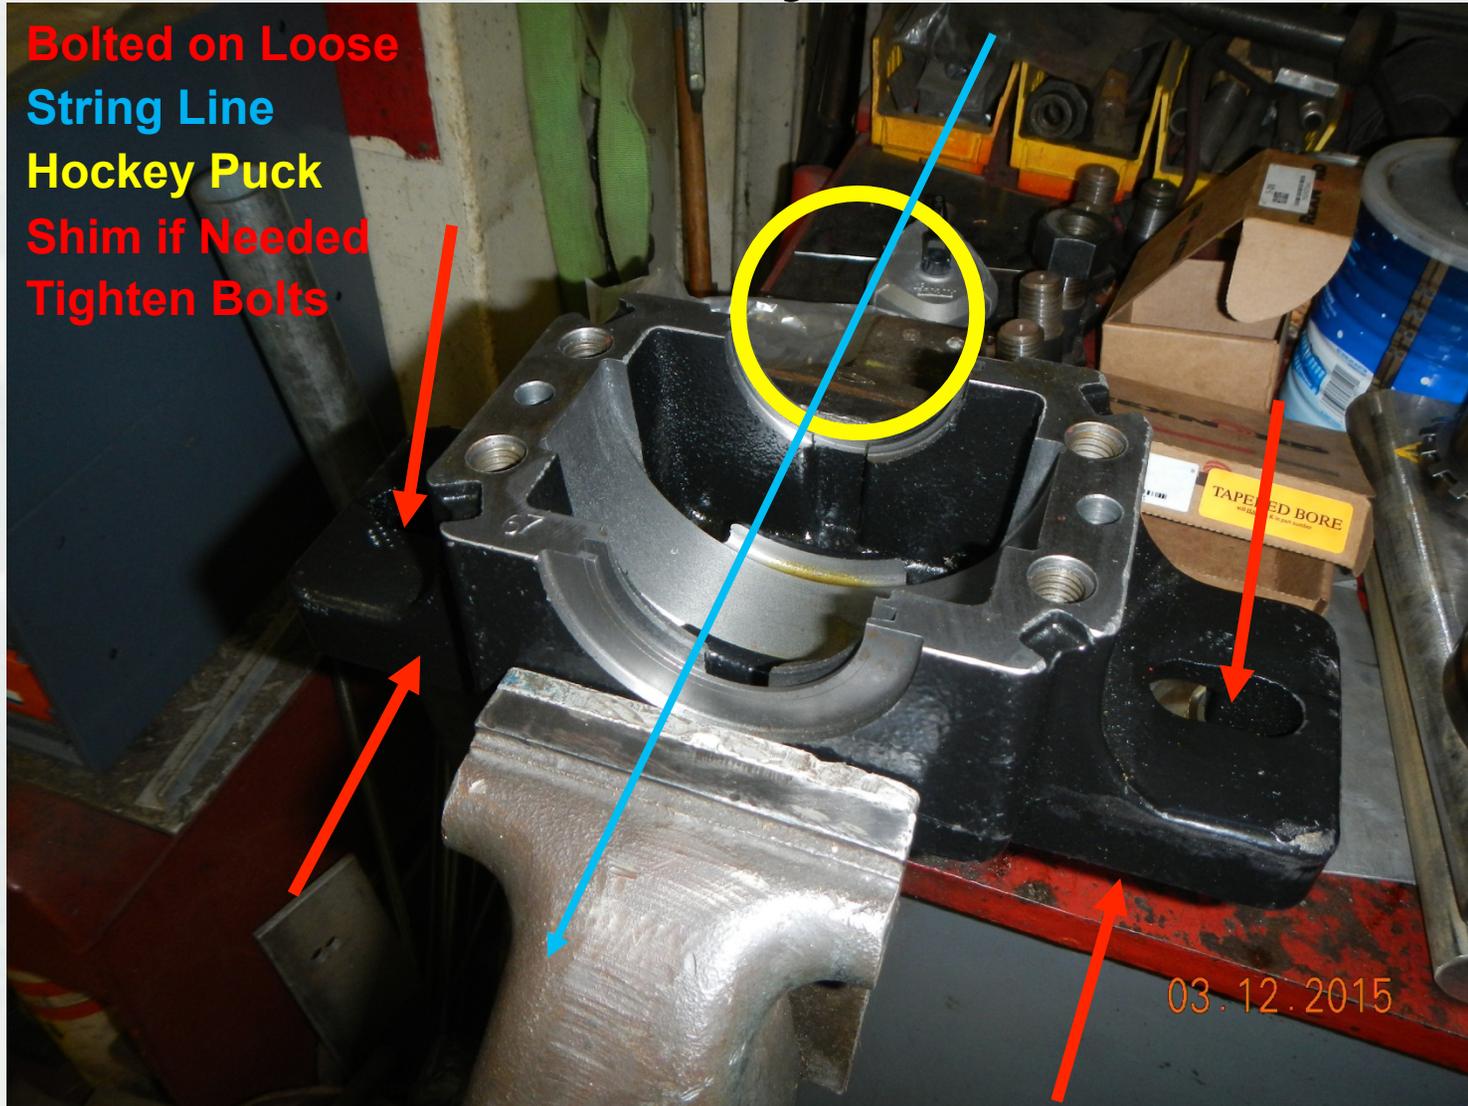
“Hockey Puck”

Bolted on Loose
String Line
Hockey Puck
Shim if Needed
Tighten Bolts

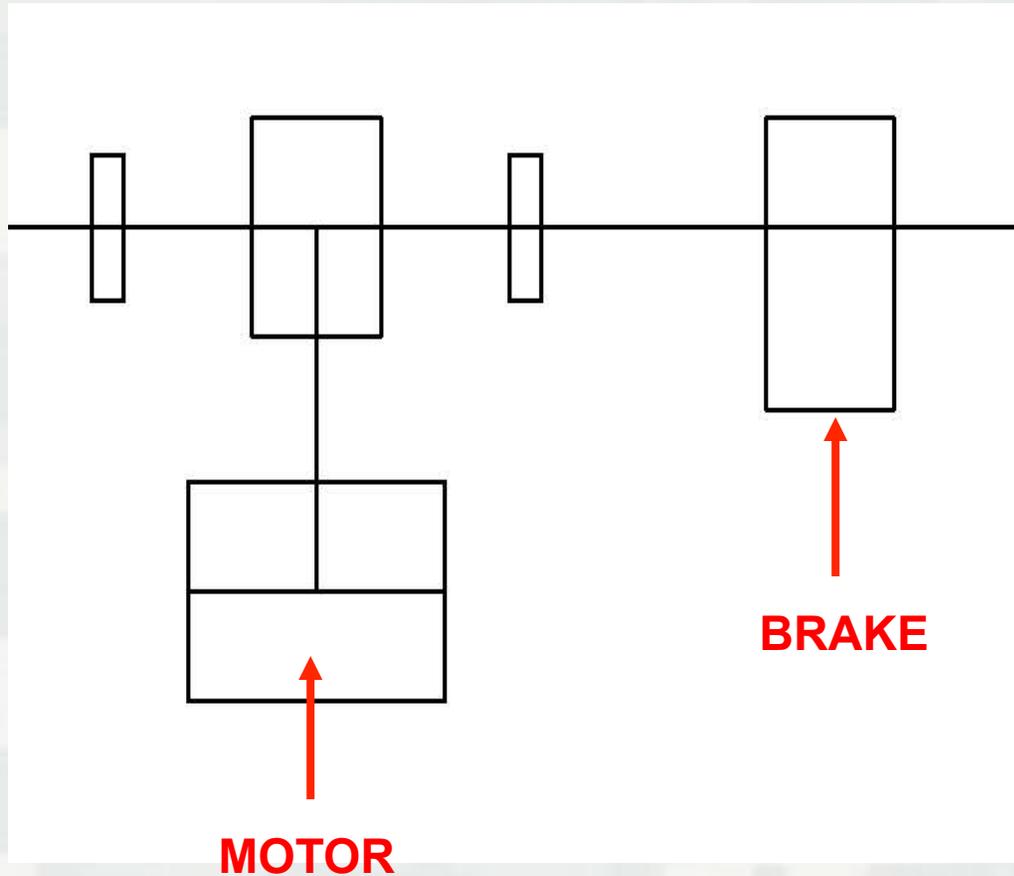
How the Brakes Work

1. Turn the motor on
2. Electric Signal sent to coil in the Brake to overcome the Spring Strength
3. The Brake disengages
4. Line Shaft is allowed to spin
5. If for any reason power is lost, the coil in the brake relaxes and the Spring clamps the brake shoes back onto the brake drum

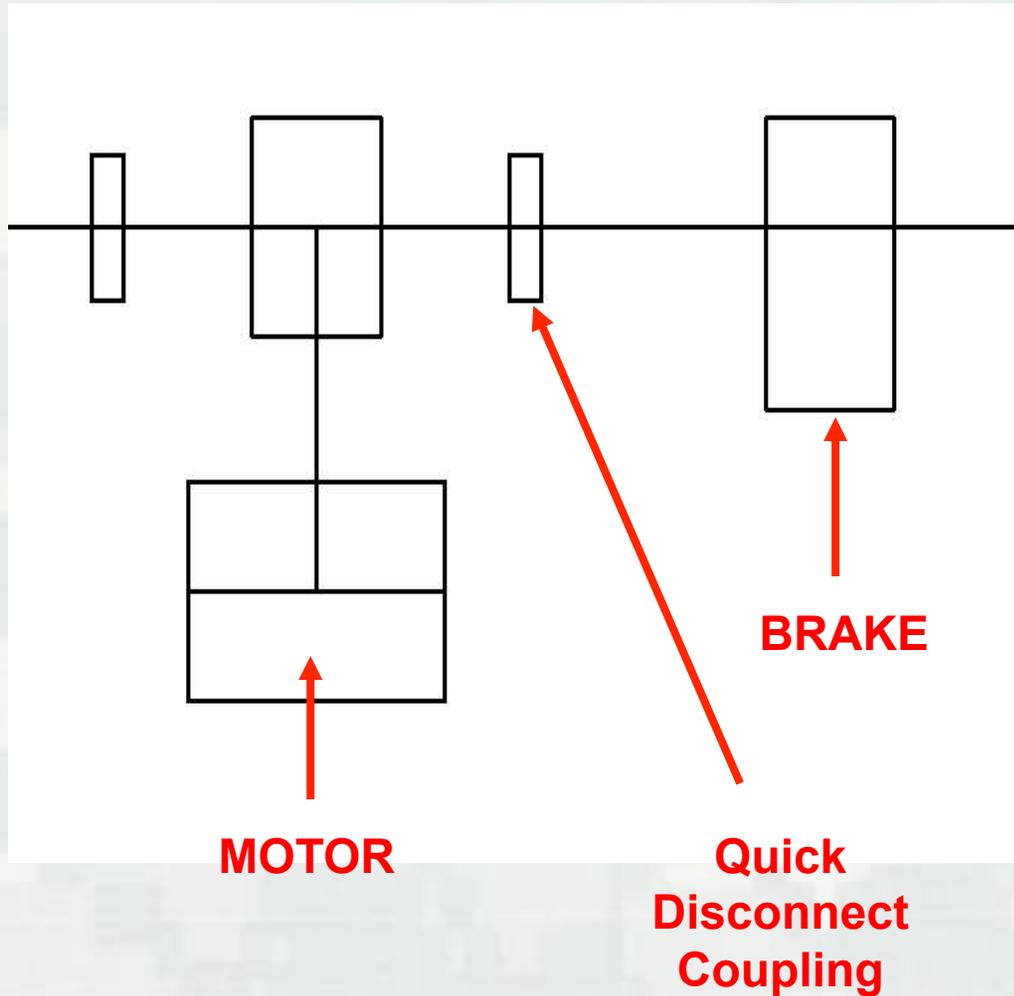
What Happened??

1. The brake did not engage
2. The motor kept running
3. Power was not lost in system
4. Both sides of gate fell uniformly

The Quick Disconnect Coupling was disengaged

- First and Foremost, ensure that all Lock Personnel know the proper installation of these couplings
 - ▶ Difficult to tell if it is fully engaged
 - ▶ There is grease, oil, dirt preventing them from being fully engaged
- Second, Come up with a fail safe to ensure that these couplings will not back off even if the set screws fail
- Ideas
 - ▶ Go/No-Go Gage
 - ▶ Install a clamp next to the flange once engaged
 - ▶ Have a district-wide “expert” that will be there for every installation

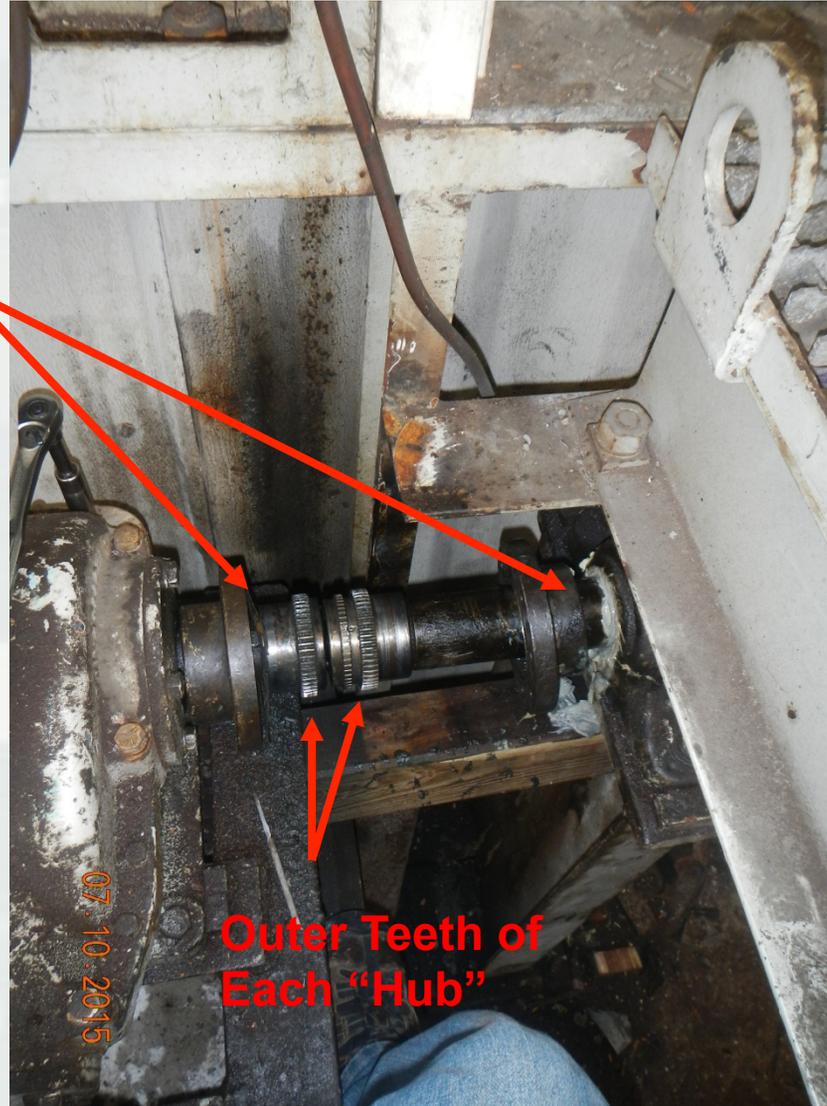
Quick Disconnect Coupling

Flanges with
Inner Teeth

Outer Teeth of
Each "Hub"

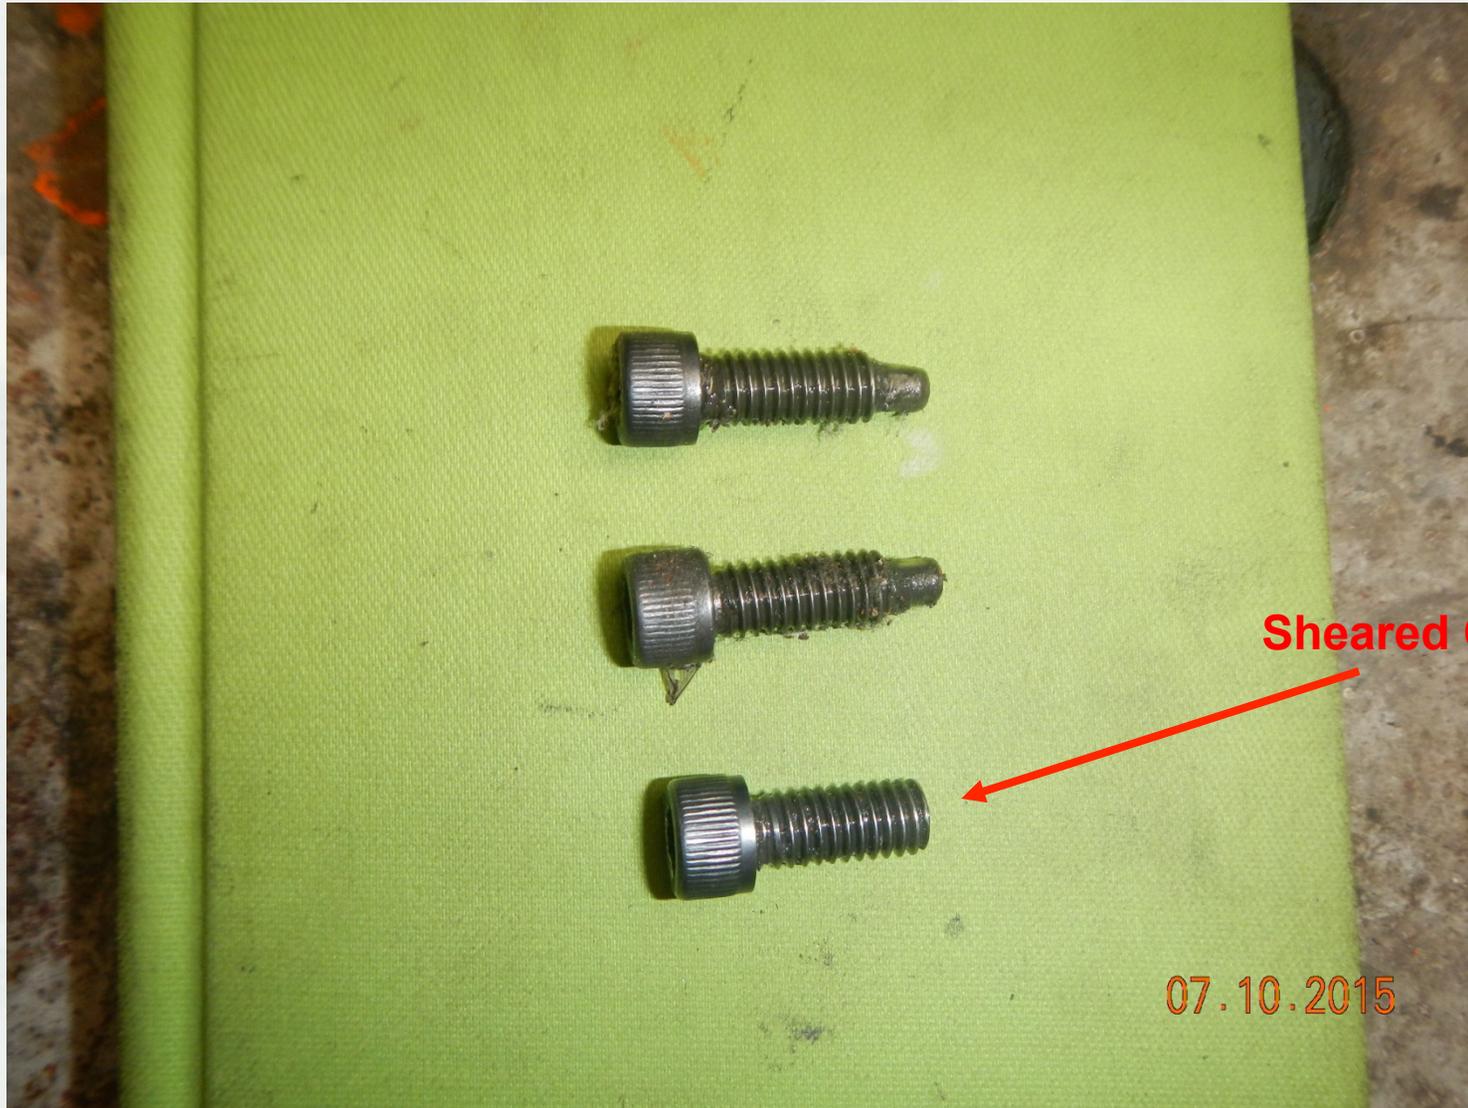
- Flanges would walk off of the hubs as the line shaft rotated
- The set screws are supposed to stop this
- Why didn't it work?
 - 1 Set Screw was sheared
 - 2 Set Screws were backed out

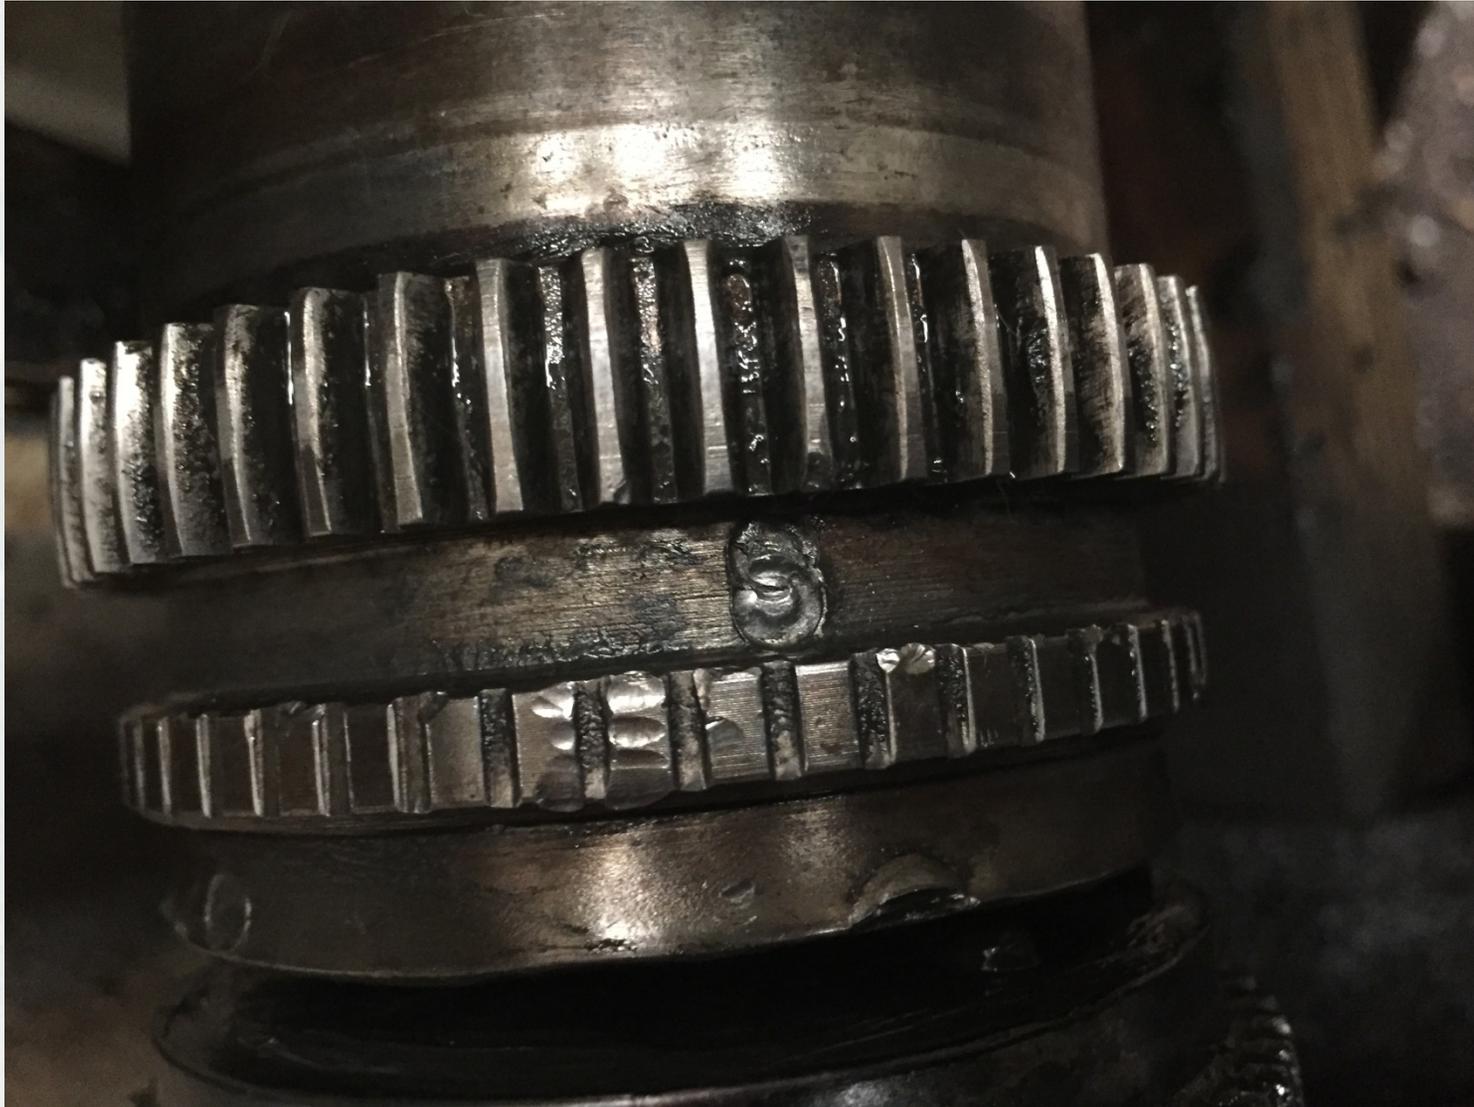
Set Screw Slot 1

- 1st Set Screw was most likely tightened into the “Wall” that divides the slots
- 2nd and 3rd Set Screws bottomed out on top of the “Wall” and were considered engaged
- The coupling could not be moved by hand because of the 1st set screw
- The 1st Set Screw sheared off from the spinning of the Line Shaft
