Markland L/D Ohio River Louisville District

Board of Investigation Briefing, Downstream Miter Gate Failure

USACE Brief - 7 December

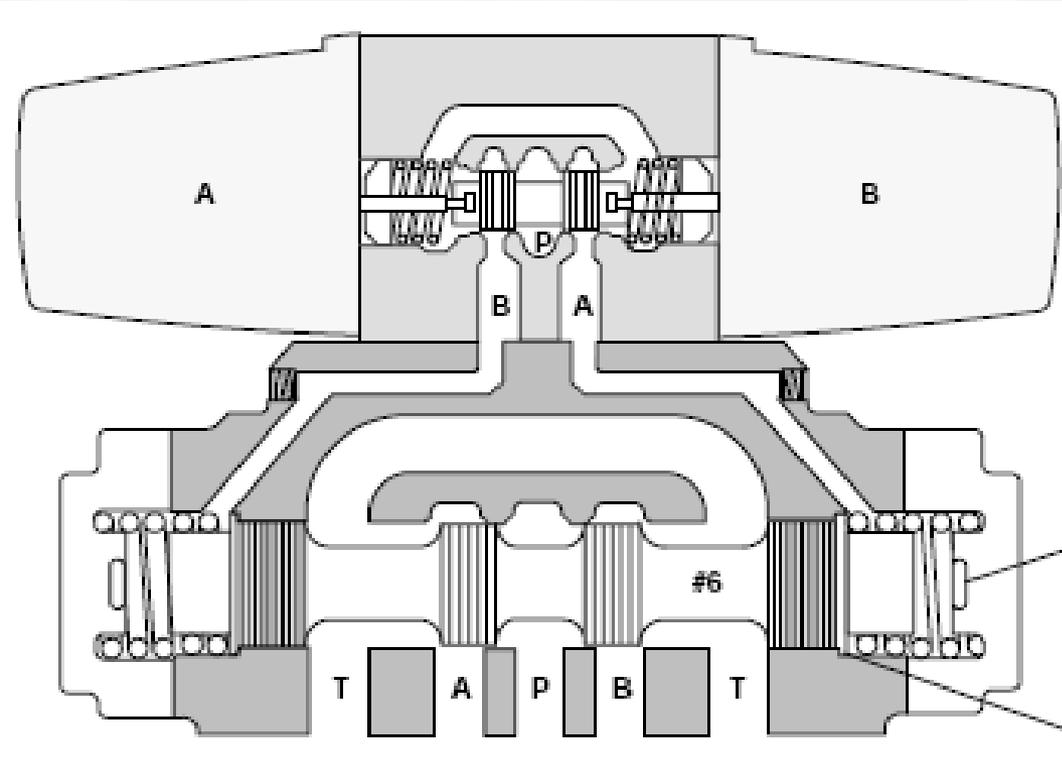
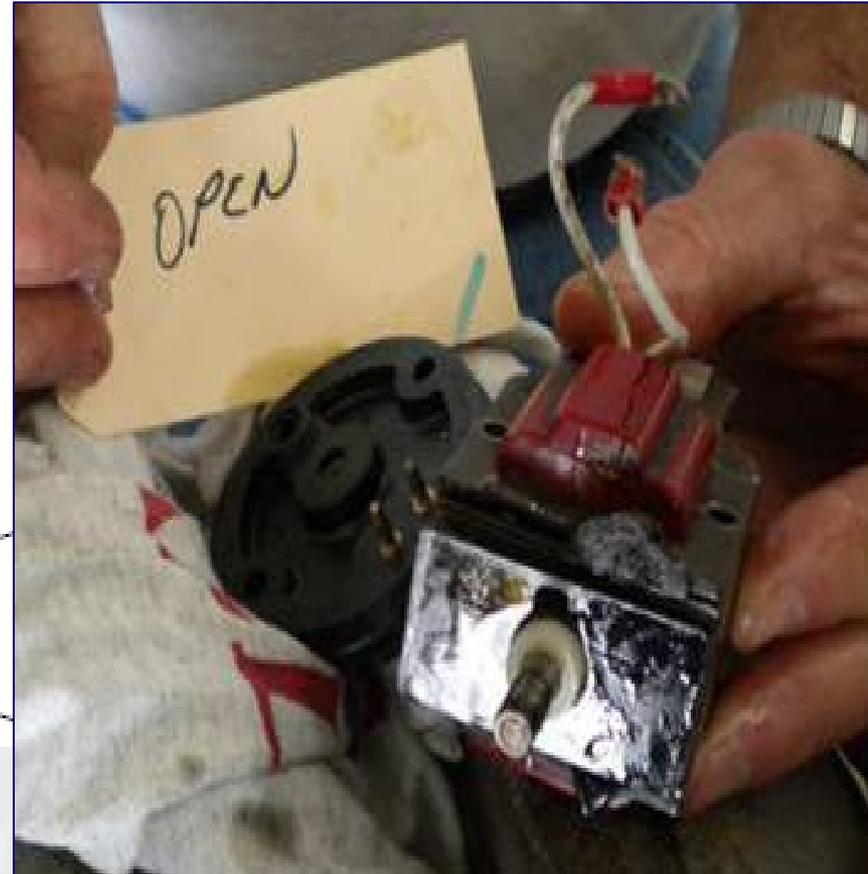
Causation Theory

- 0544 M/V Colby calls for lockage. **The filling valves solenoid overheats.**

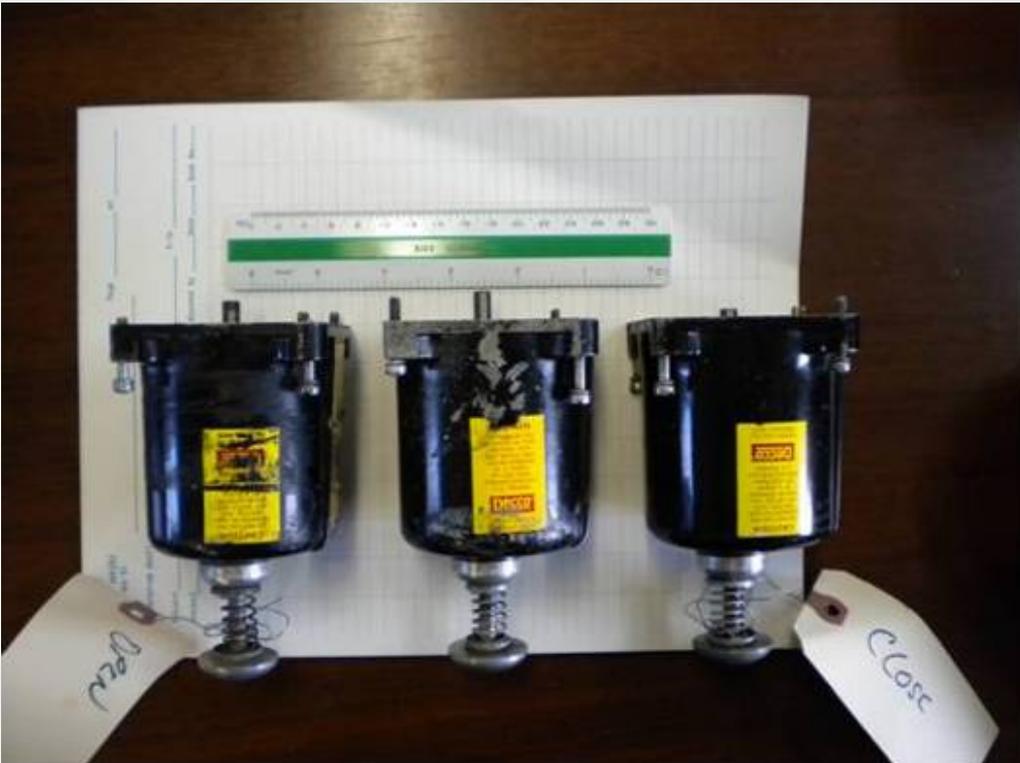
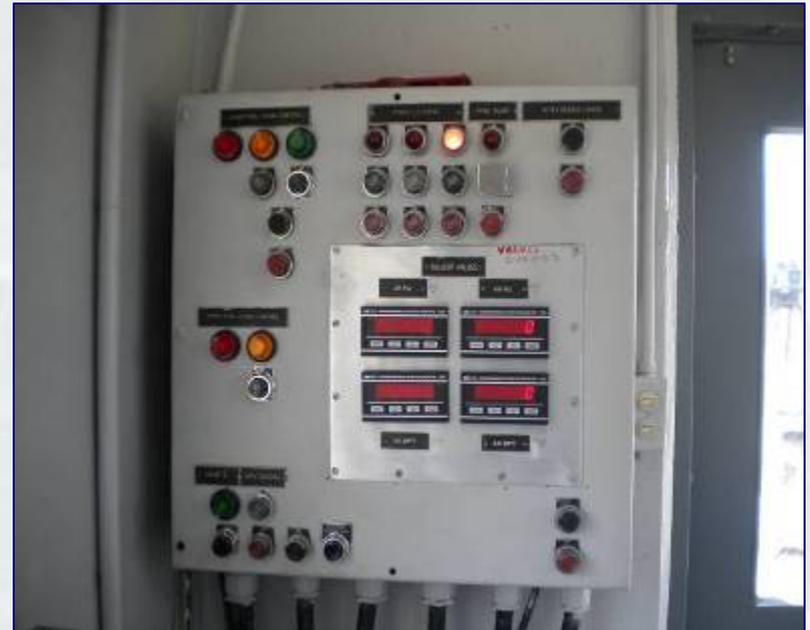
- Unintentional opening of the river wall filling valve due to an ATYPICAL equipment failure.
- The Lock Operator did not observe the valve position display just prior to initiating the downstream gate closure.
