# Ruptured Pipe and Fish Tails!

Lake Washington Dewatering Pump Plant is almost 100 years old and still pumping, but for how long?

# LWSC Dewatering Pump Plant

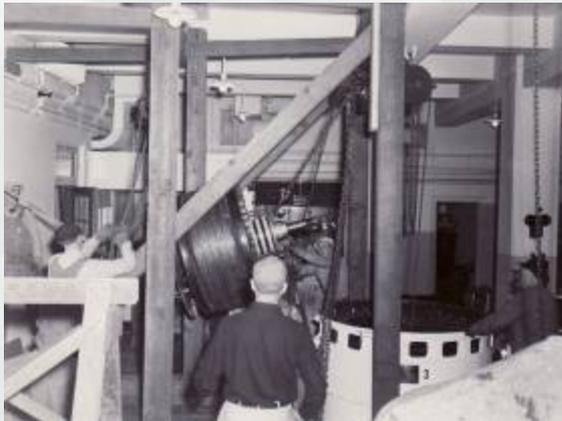
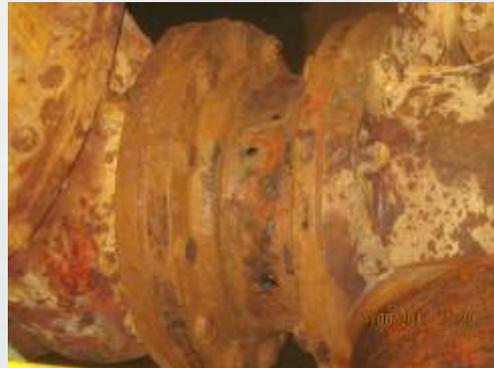
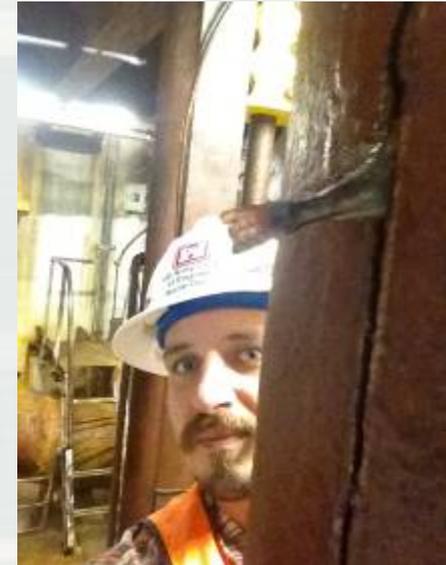
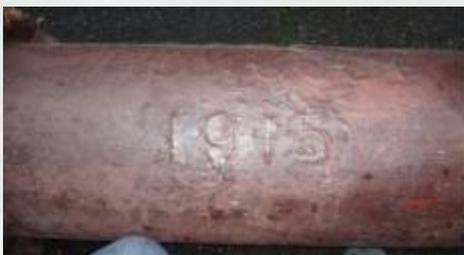
- Most Components have been in place since 1915 and operated annually

- Components that have failed have been replaced
- Most components severely corroded and worn

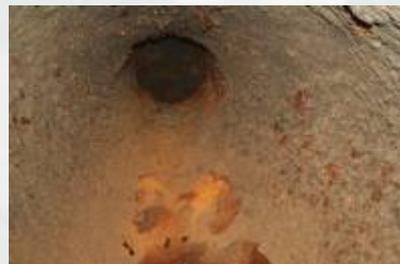
- Condition of most of the 60" and 30" pipe is unknown

- Unsuccessful NDT testing
- Destructive Testing on 60" Discharge last year

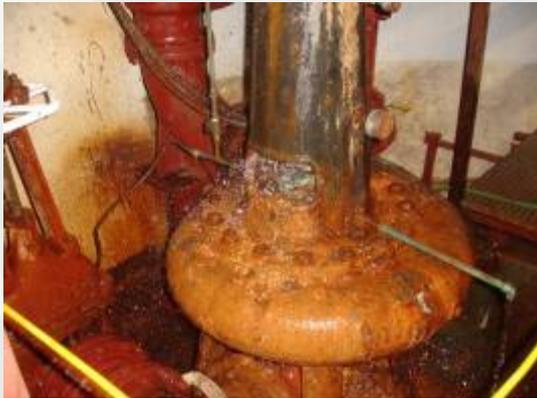
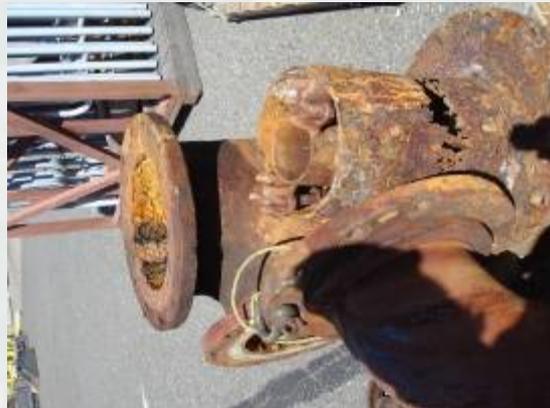
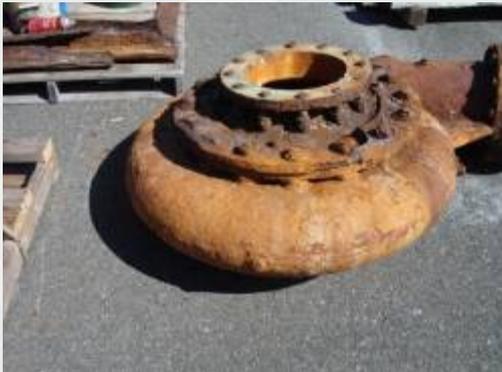
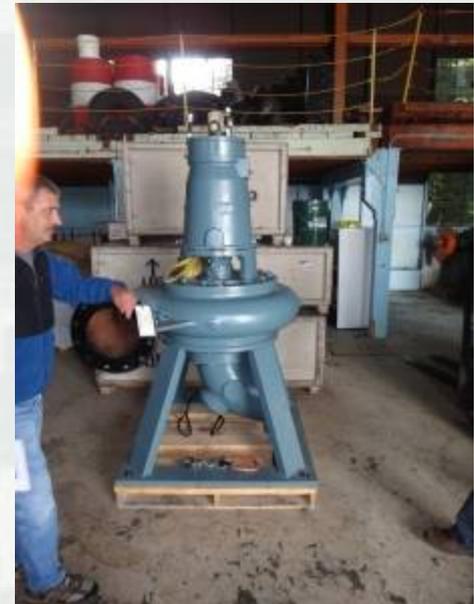
- New 10" Pump as of March 2012

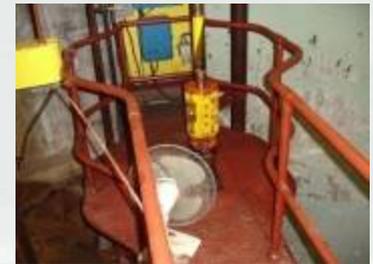
- Grease cups need to be manually turned for babbit bearings on shafts
- Life risk if major failure during operation

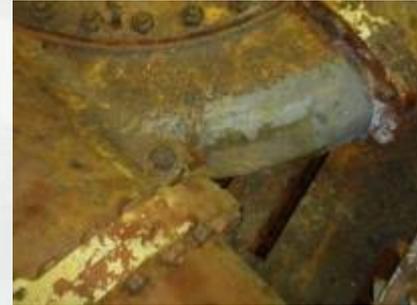
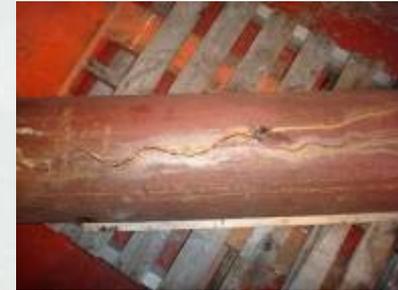
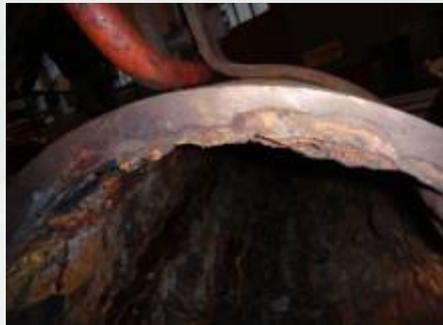
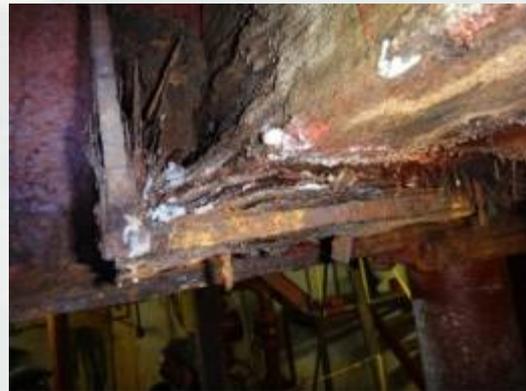
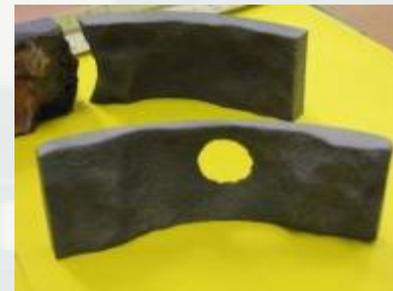
- Recent burst.....
- Past failures.....
- Patches .....
- Missing Check valves .....
- Severe Corrosion.....

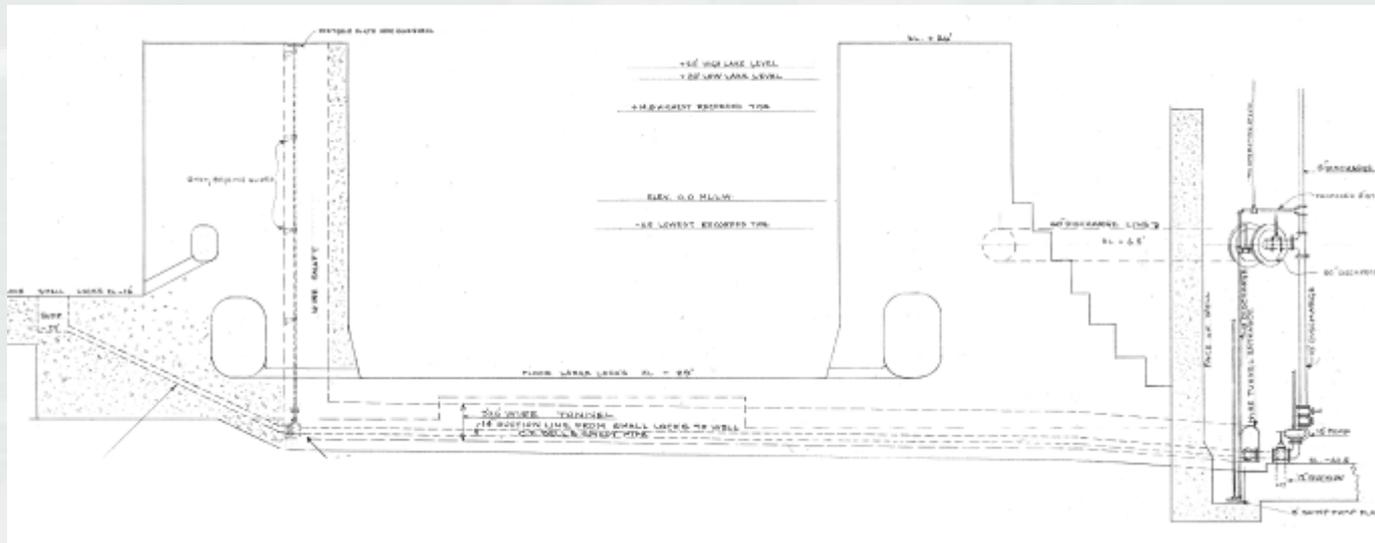
- Tide Level flooding would shut LWSC down for 1-2+ months because of the 2400V electrical feeder that runs under the lock chamber. Electrical equipment and wiring would likely need to be replaced.
- Spillway would be operated manually or by generators

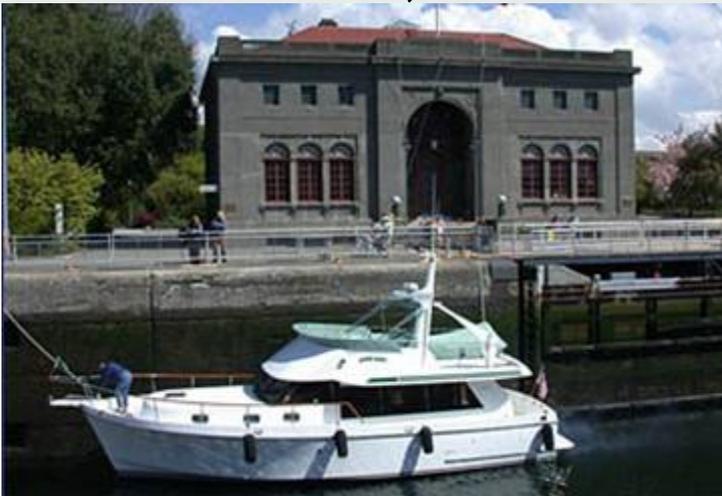
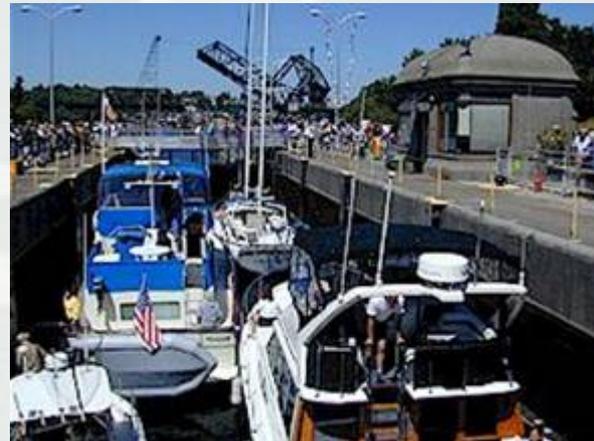
Lake Level flooding would shut LWSC down for 6 months to 1 year or more

- Complete flooding of the pump well, including the pump motors, the electrical substation in the basement of the Admin Building, electrical rooms below the 4 control houses, Stoney gate valve motors, hydraulic pump motors for miter gates, driver cards, transformers, feeders etc.
