# Meldahl & Greenup Miter Gate and Top anchorage replacement

# Meldahl Miter Gate Replacement

# Greenup Miter Gate Replacement

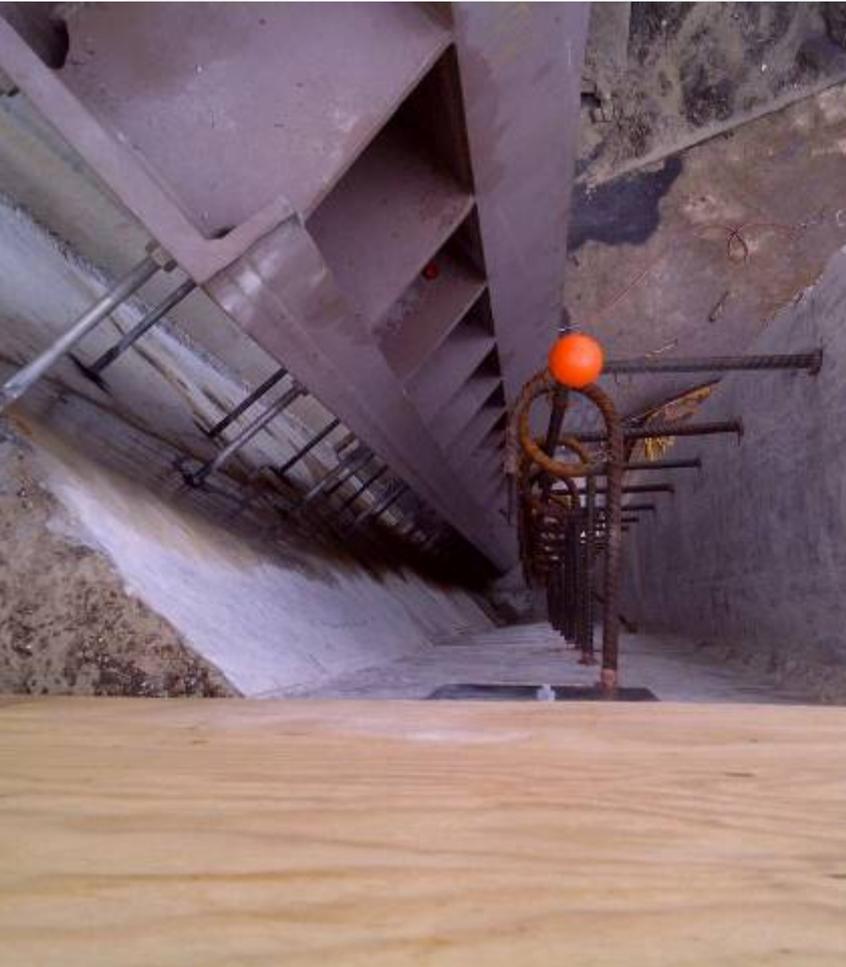
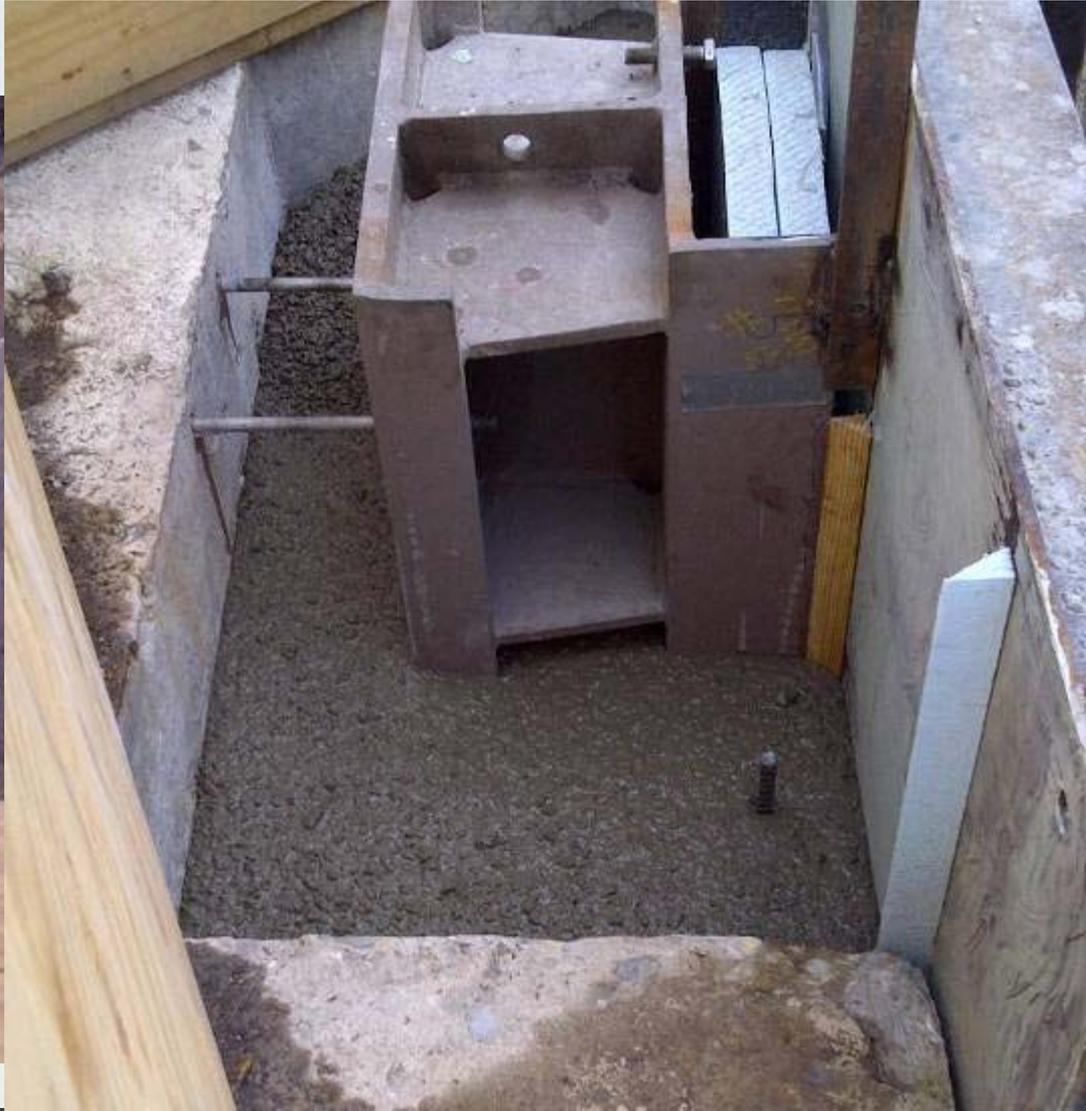
# Greenup Miter Gate Embedded Wall Quoin

- Corps personnel installed new embedded wall quoin structure
- Installed formwork
- Placed SCC concrete
  - ▶ Completed in 3.5 weeks (time savings of 3 weeks after incorporating lessons learned)

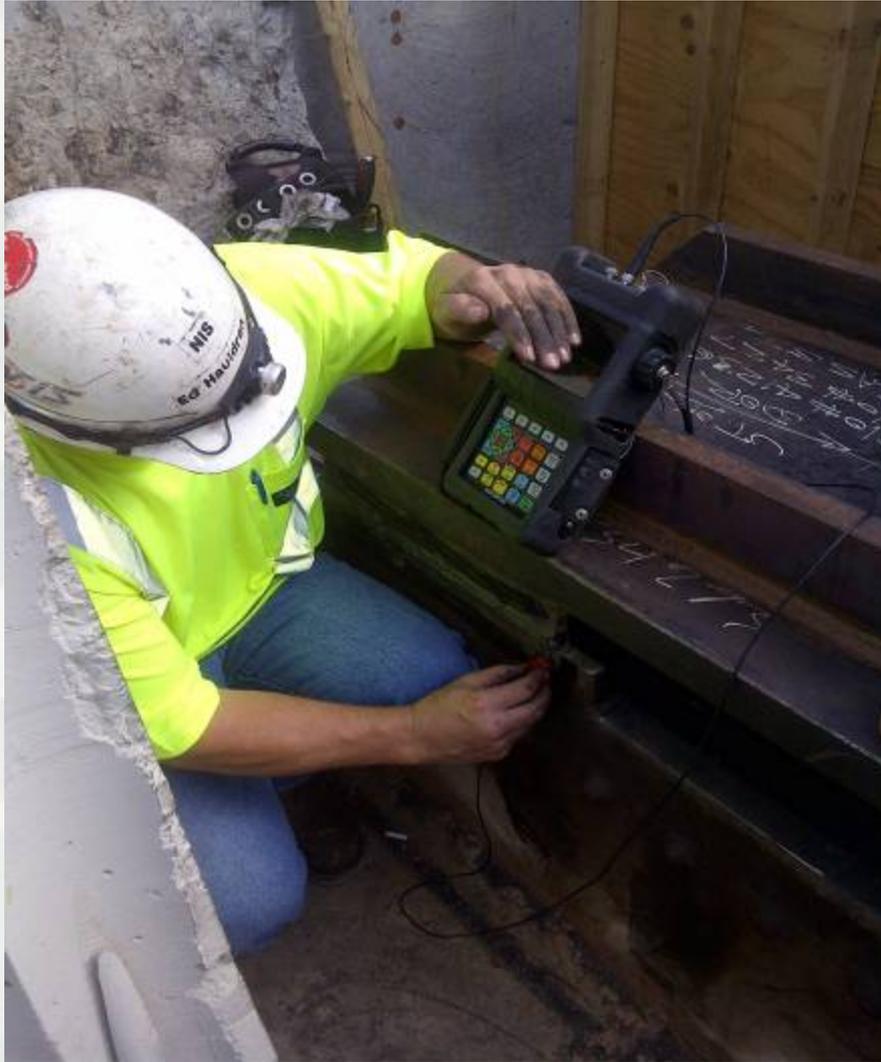
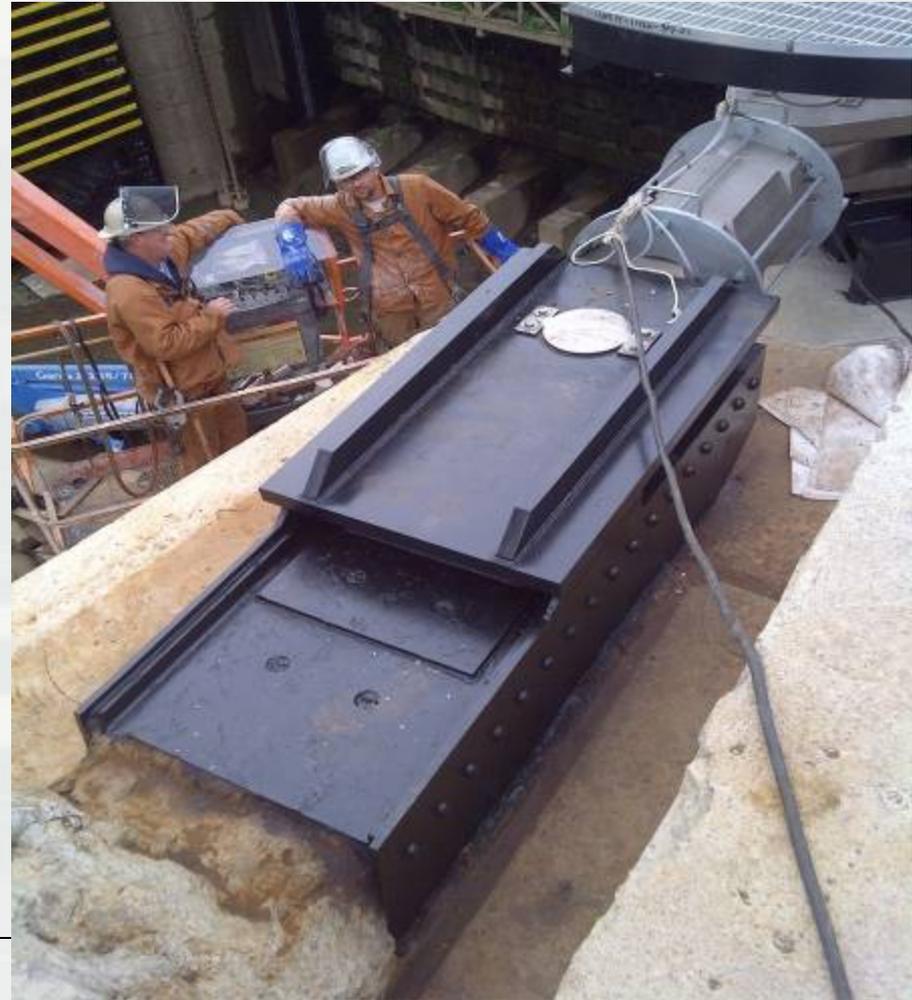
- Small crew sent to CAM to pick-up miter gates
  - ▶ Gates were delivered horizontally
    - Crew set-up cribbing to allow rotation of gates to vertical position

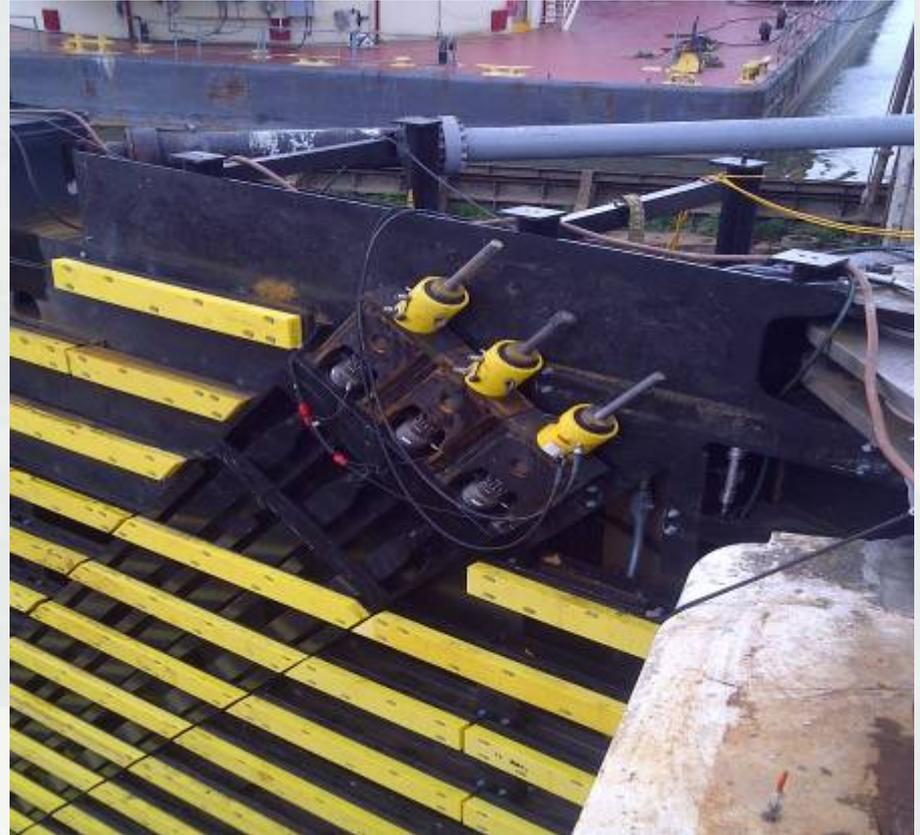
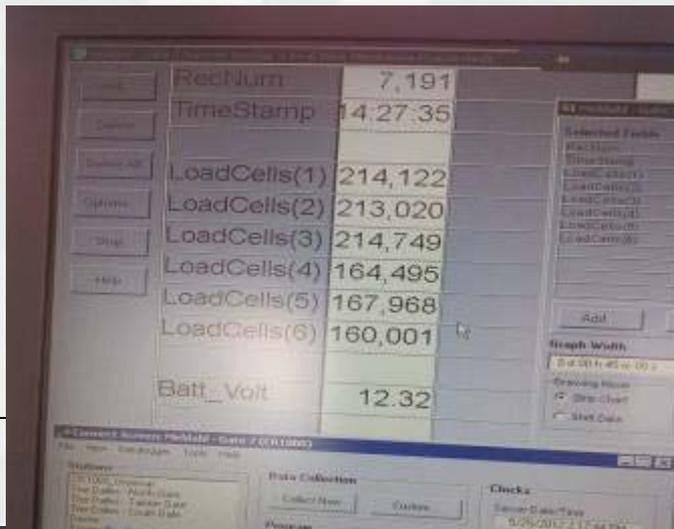
- New Miter gates installed 5 Sept
- Diagonal stressing completed in 5 days (1.5 week time savings)

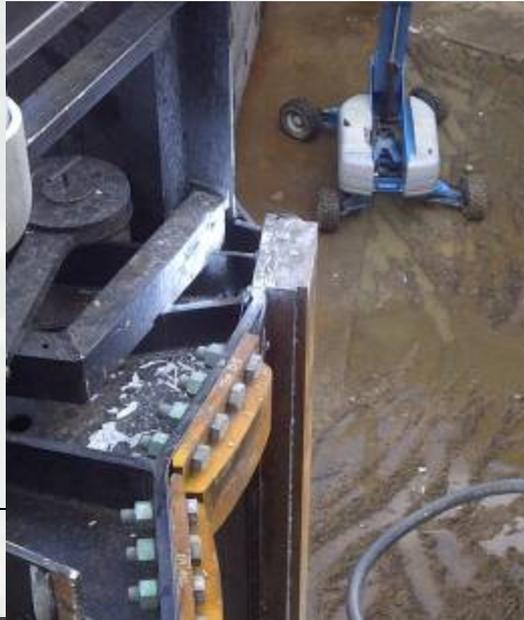
- Installed new miter and quoin blocks
- Repaired air lines
- Chamber open to traffic 5 Oct 2012
- Total timeframe: 17 Weeks-1 week over schedule
