# L&D 52 Wicket Sill Dewatering Box & Wicket Sill Replacement

**Keith Fleck**

Louisville District

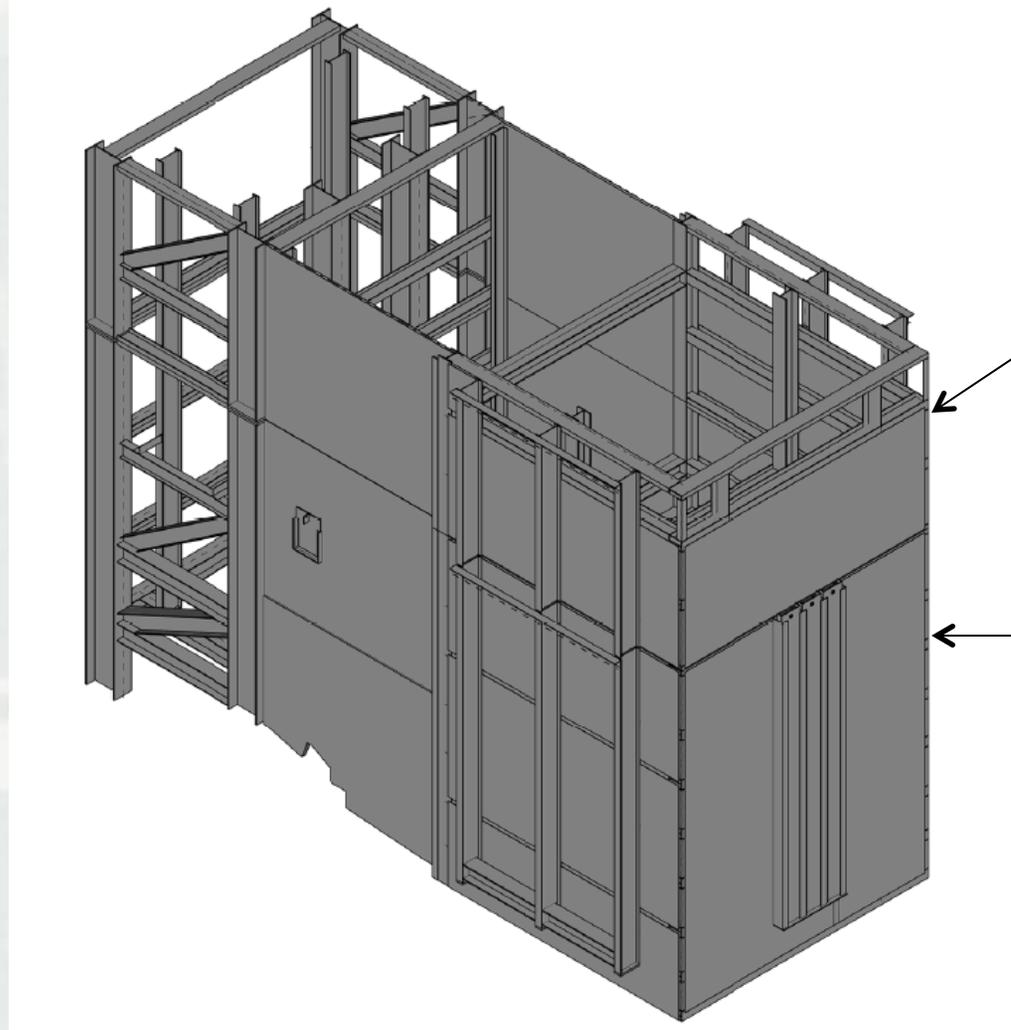
Top section is added for the navigable pass wickets

Bottom section is used for the chanoine weir wickets. Only the bottom section was fabricated in 2013.

ED based the wicket dewater box design from Rock Island's wicket dewatering box, but modified it to fit L&D 52 and 53's sill profile.

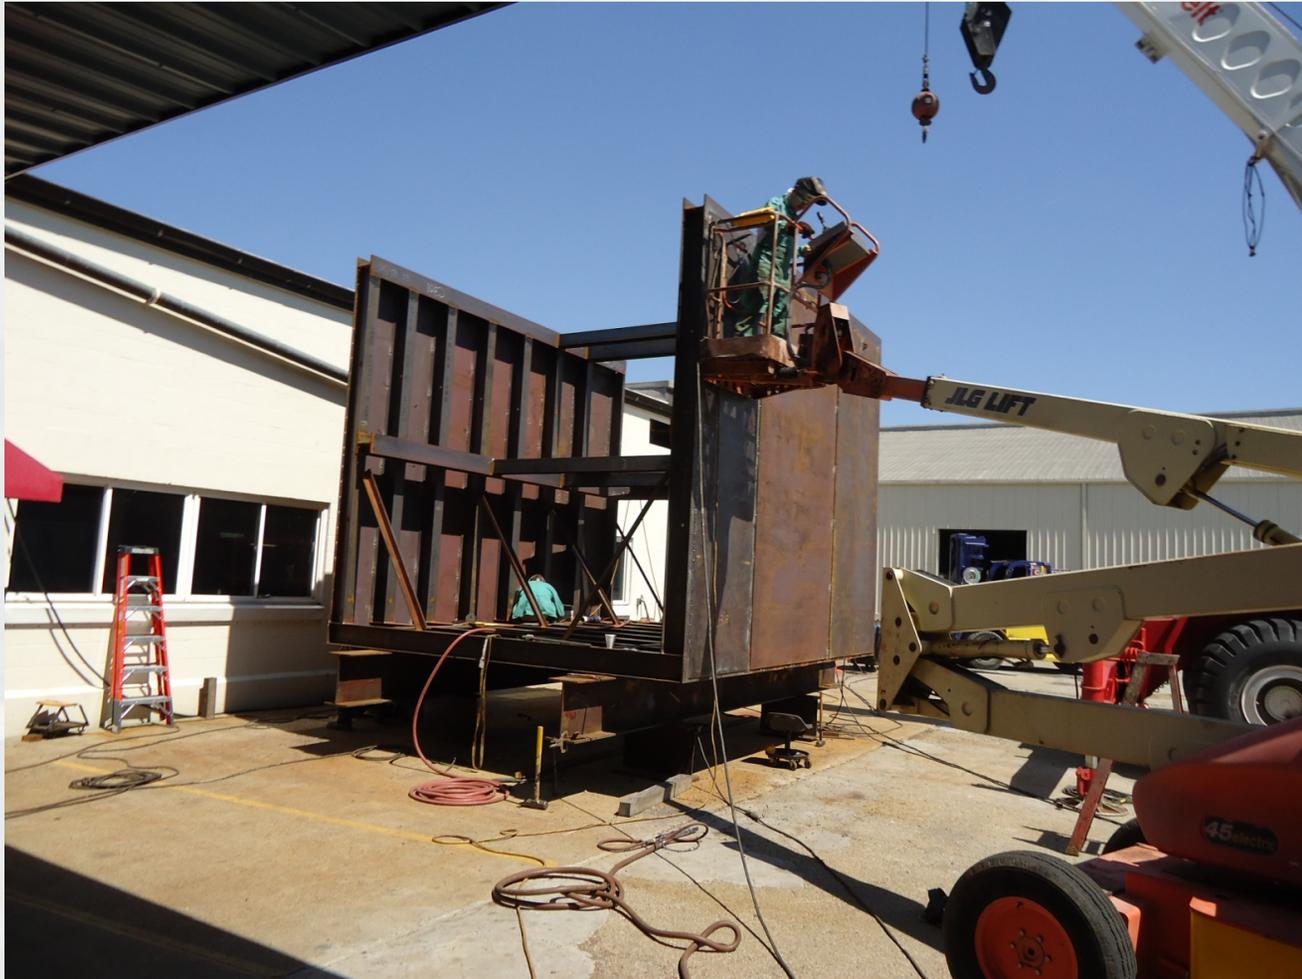
The skin sheets were seal welded inside and out, which cause heat shrinkage issues and warping on the W-beams. The beams had to be heated and cooled to get them plumb.
