# Winfield Hydraulic Cylinder Replacement

Waylon Humphrey, PE

LRL-Maintenance Section

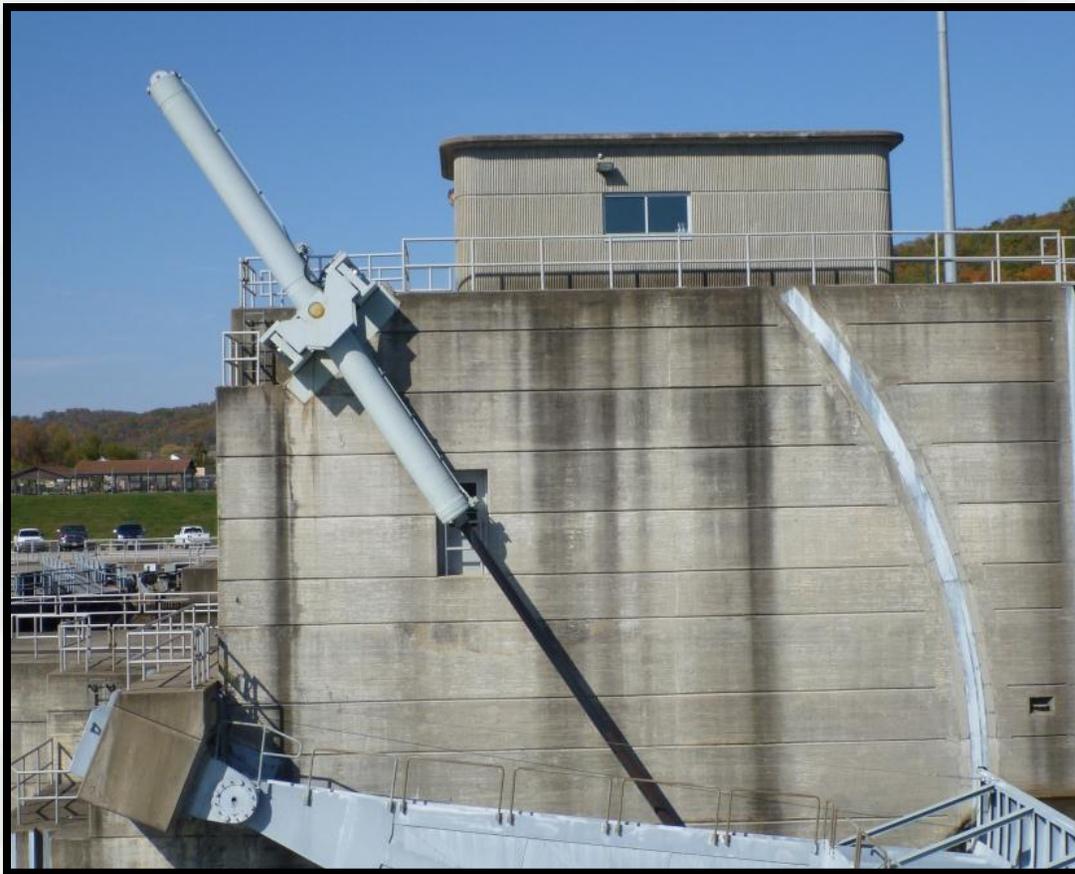
- Cylinders remain extended the majority of the year.
- Cylinders were installed with ceramic coated rods

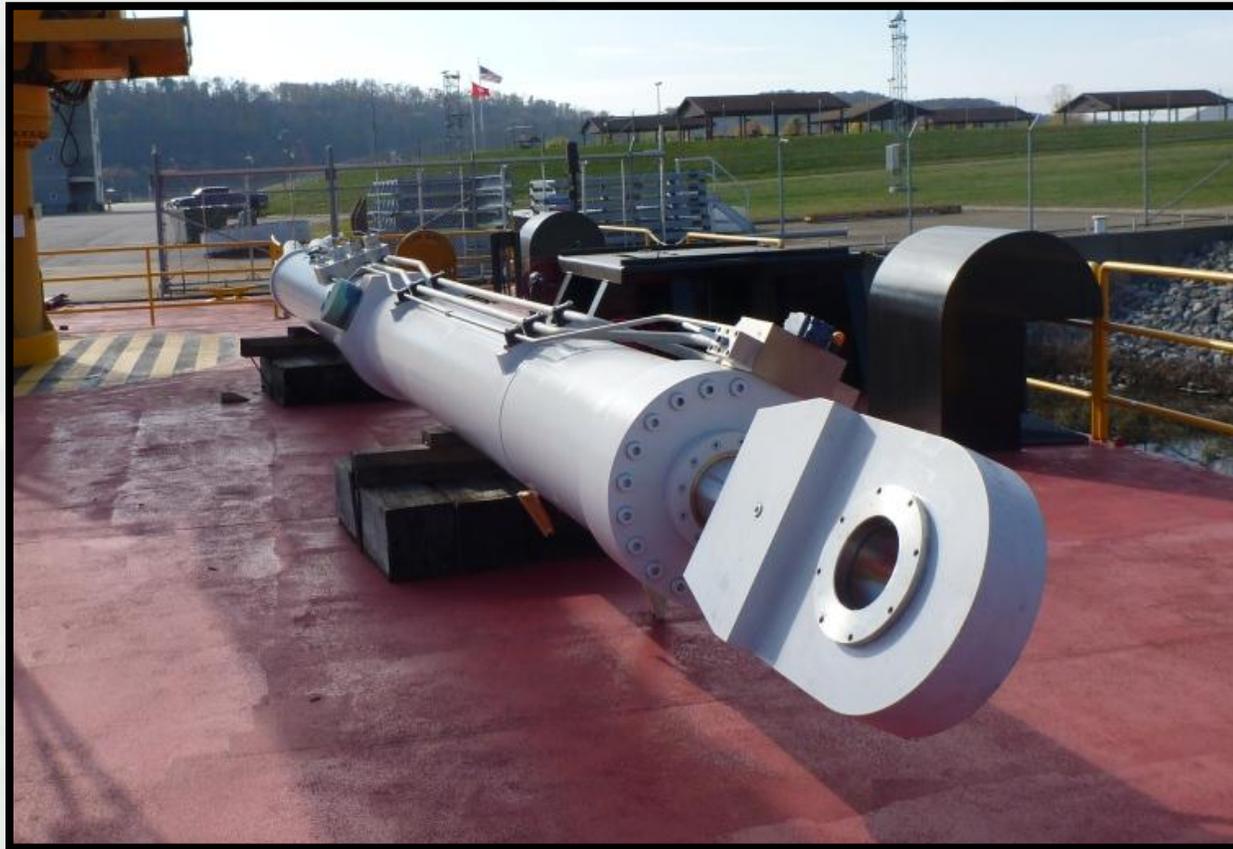
- Chrome Plated Stainless Steel Rods
- Ordered by LRH – on site at Winfield

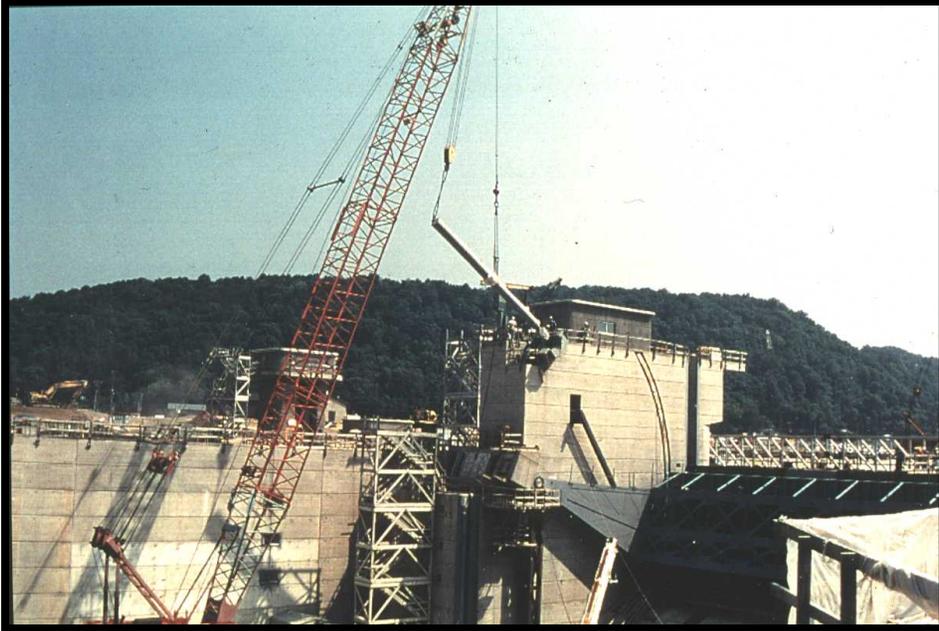
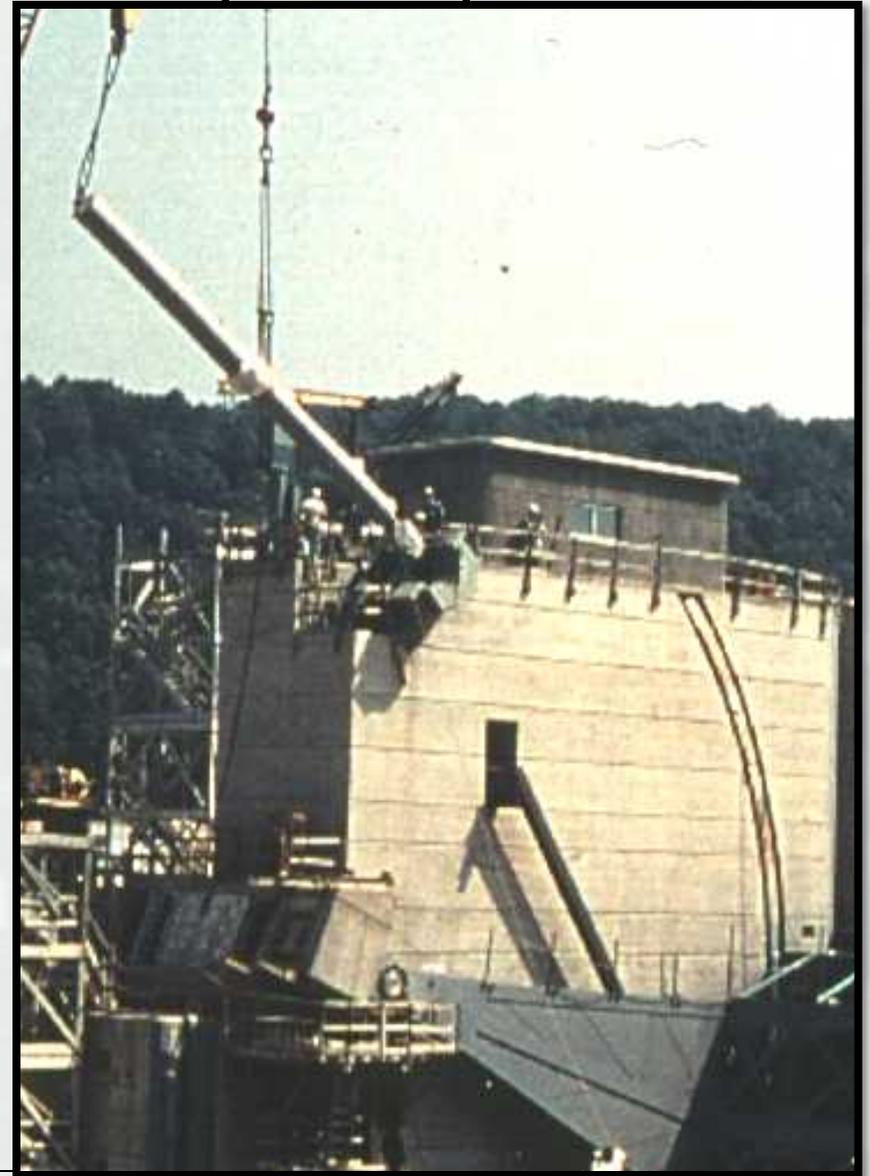
- Use of Main and Aux hoists to control angle
- Rigged around cylinder body just below trunnion
- Rod Support mounted to pier

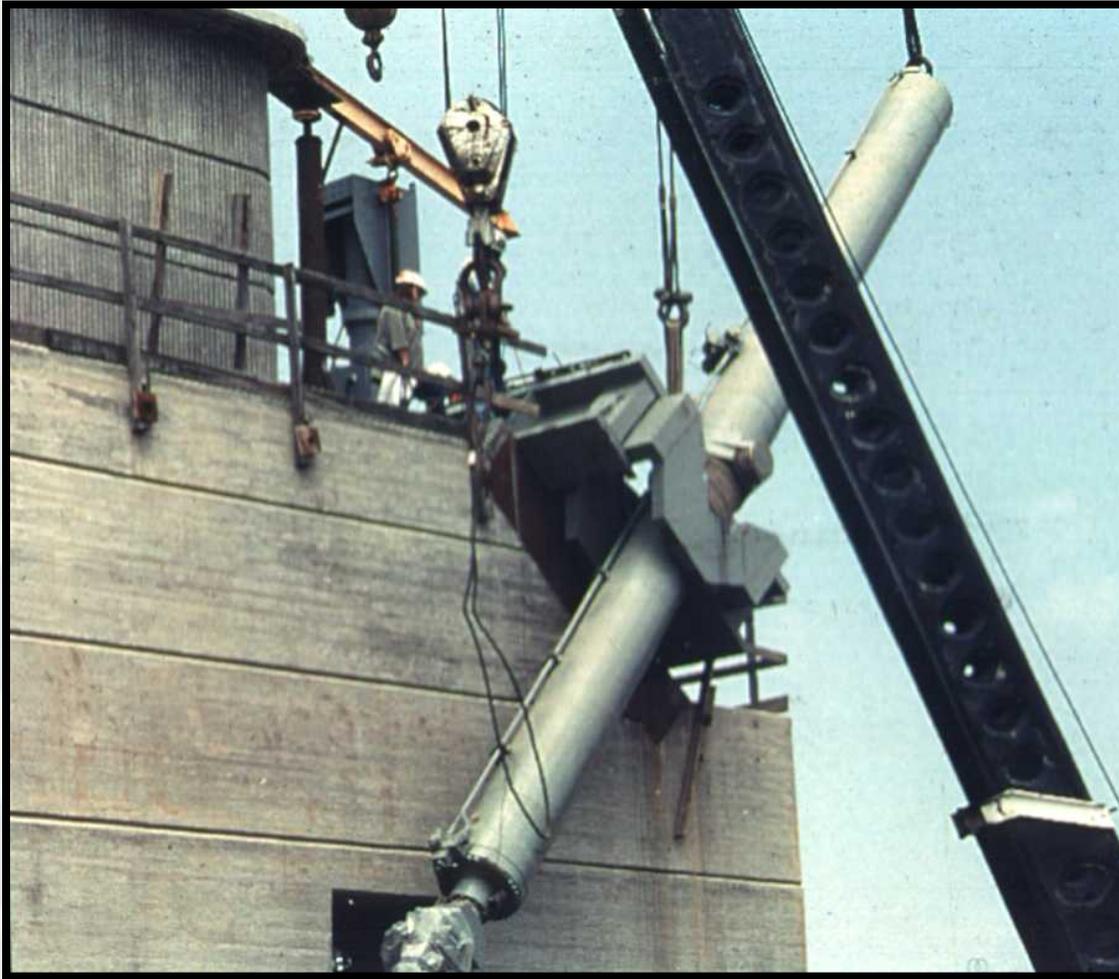
- Unable to sit pins into journals due to interference of rigging with framing
- A second crane was used to finish the lift
