Composite Materials for Steel H-Pile Bridge Repair

Lock Maintenance Workshop

10 Feb 2015

East Fork Bridge

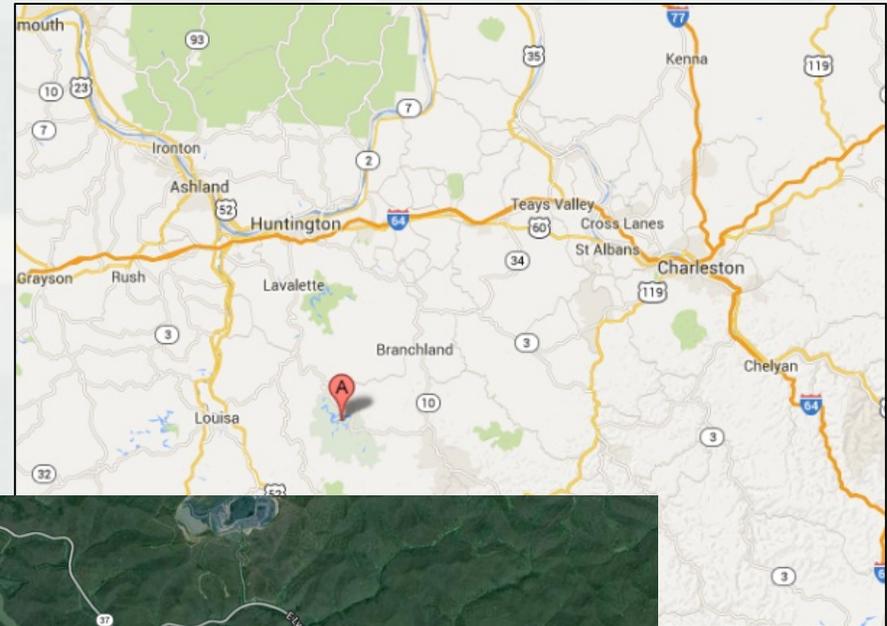
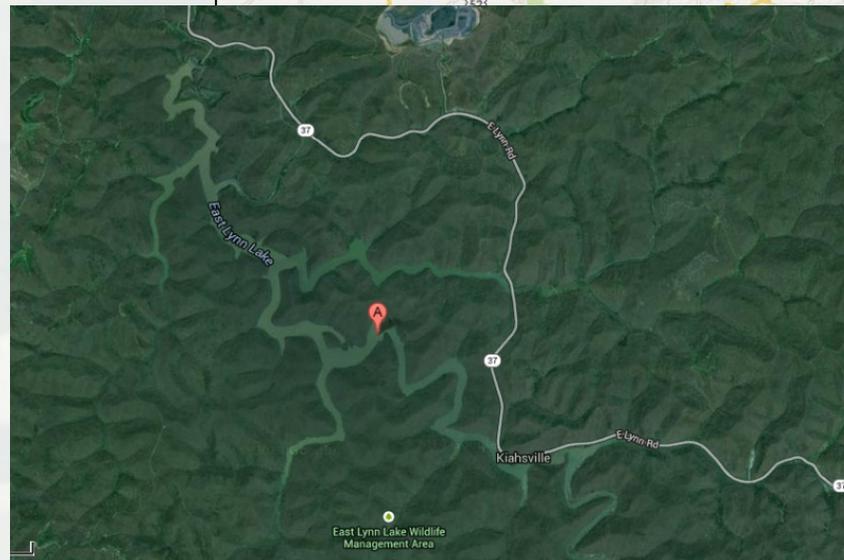
- **Built 1969**
- **Main access to Campground**
- **Length = 127 ft.**
- **Two lane, continuous reinforced concrete slab**
- **4 piers, 5 H-piles each**
- **8 ft. above seasonal pool, 14 ft. above winter pool**
- **Designed for H-15-44 Loading**

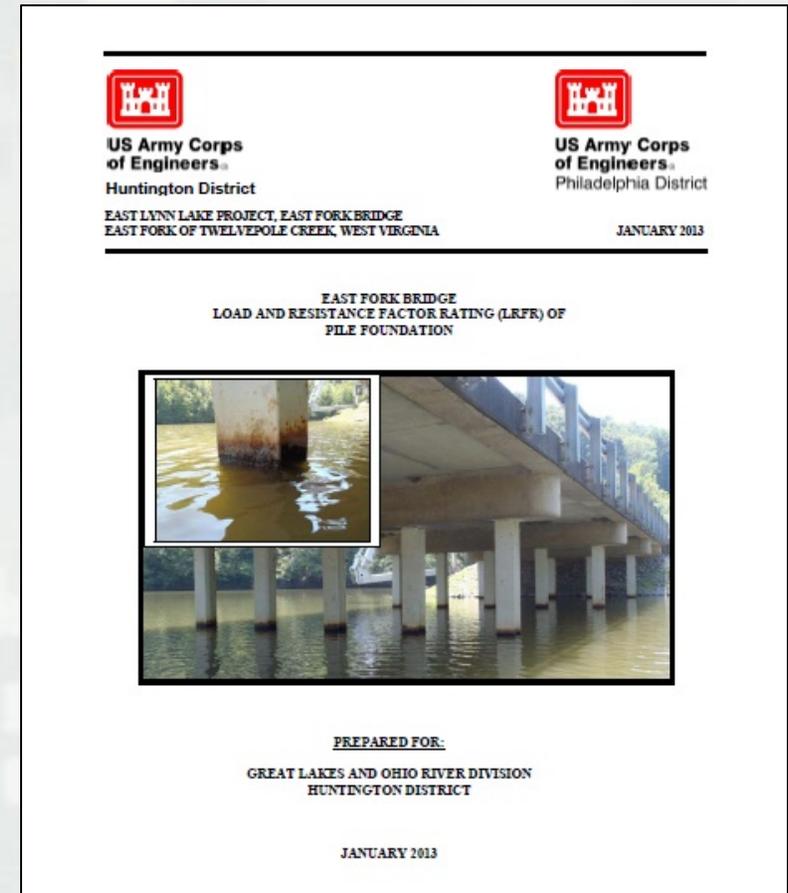
- **Extreme Corrosion Loss – 50% in areas**
- **Philadelphia District performed analysis**
 - ▶ **Used section loss measurements**
- **Result**
 - ▶ **6 ton max**
 - ▶ **Single lane use**
 - ▶ **10 mph limit**
- **Effect**
 - ▶ **Large Campers and Boats banned from use**
 - ▶ **Difficult to enforce in environment**
 - ▶ **Extremely unhappy users**
