# Mississippi Valley Division Rock Island District Illinois Waterway Project

T.J. Obrien Lock  
Dewatering 2014-15

# Project Overview

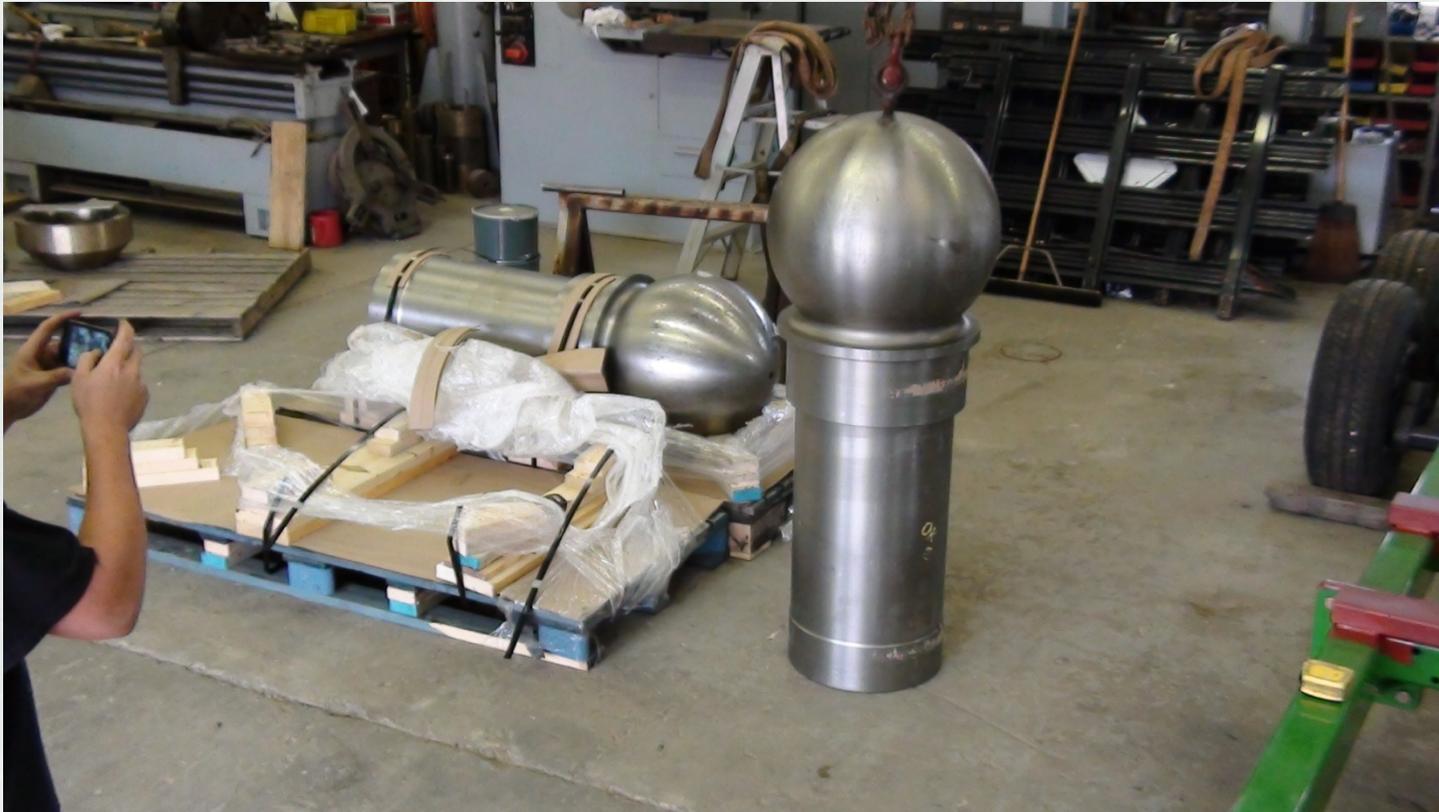
Initial Spare Parts Purchased with Maintenance Funds in 2012 to have on hand in the event of a failure.  
2 New Pintle Balls and 2 New Pintle Bushings.
