Belleville Locks & Dam Main Chamber Dewatering

Lakes and River Division

Louisville District

February 2016

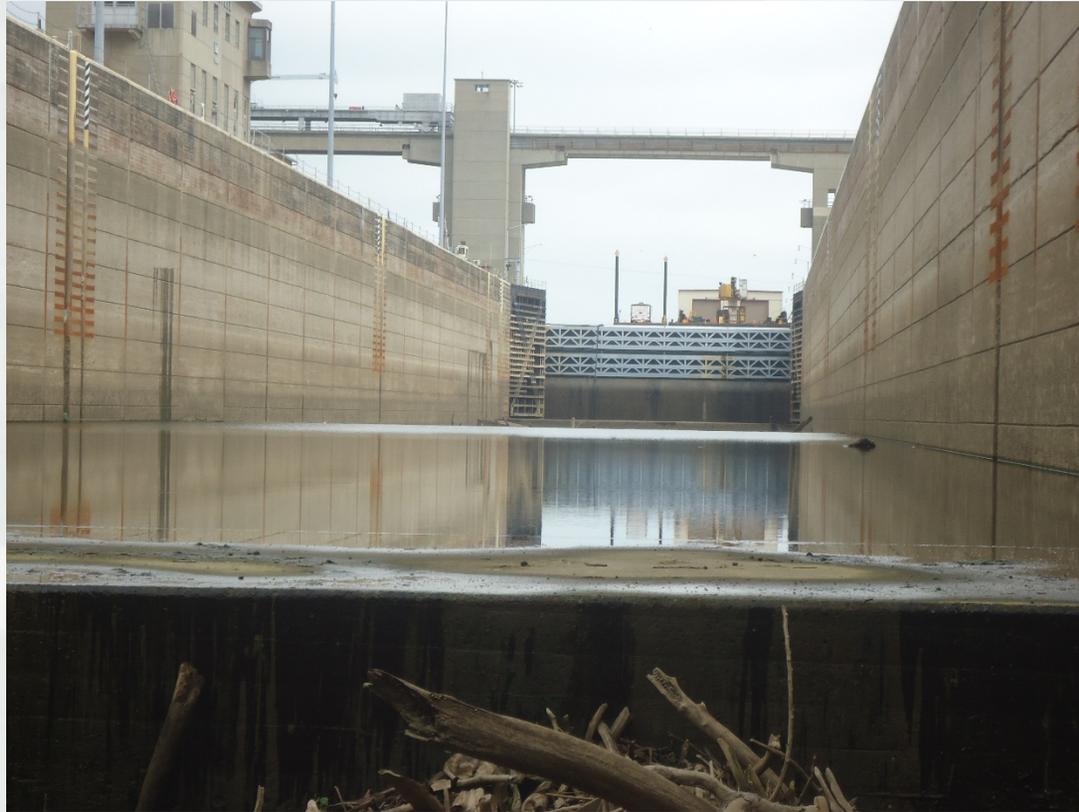
Pump Out

- The chamber took a little longer than normal to pump out because of unforeseen shore power issues causing pump malfunctions and the new bulkheads had leakage.

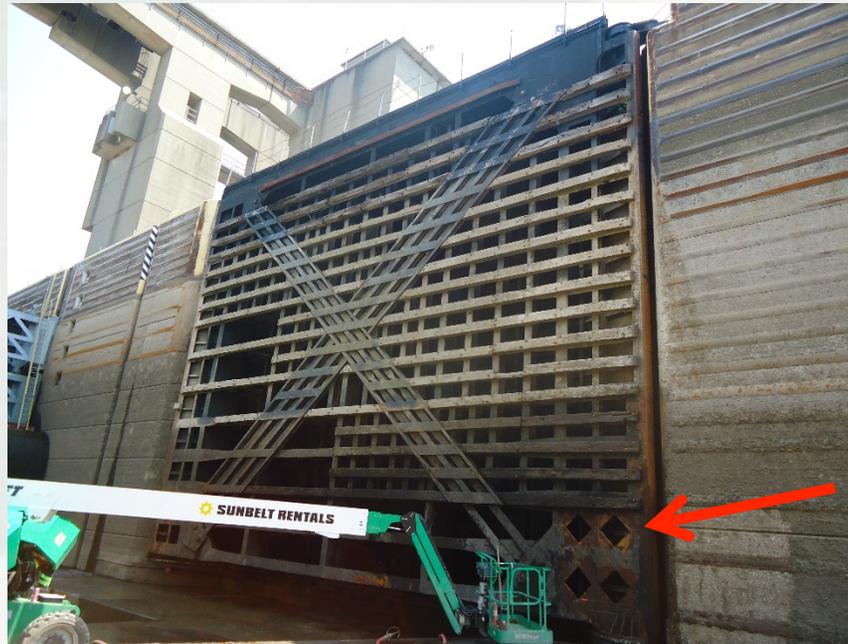
Miter Gate Window Stiffeners

- A total of 8 window stiffeners designated per gate leaf.
- 4 at the quoin on the upstream side and 4 at the quoin on the downstream side, 32 window stiffeners total.
- Stiffeners were $\frac{3}{4}$ " thick with complete joint penetration welds.

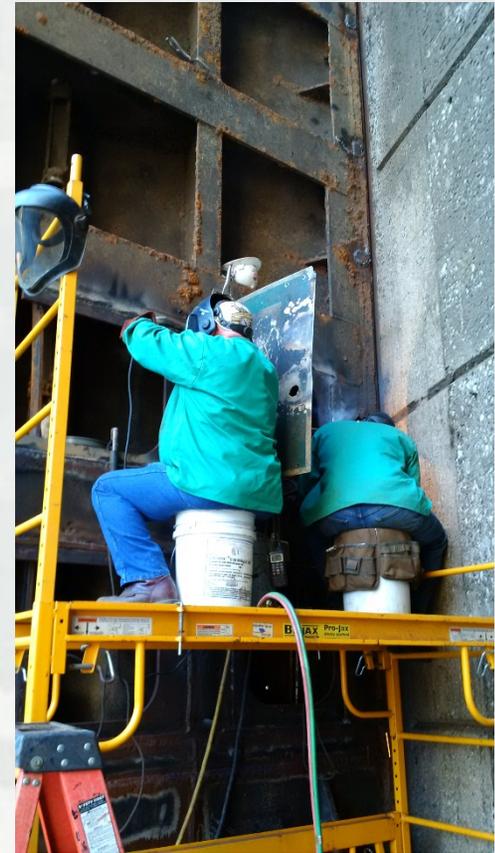
Miter Gate Window Stiffeners

- In total there was roughly 250' of $\frac{3}{4}$ " double bevel groove weld.
- This took approximately 6 men 33 days to prep the windows, repair cracks, fit the stiffener, and weld.
- With such a time consuming process, it would be beneficial to look at other options to reduce stress in the quoin areas of the gate leaves.

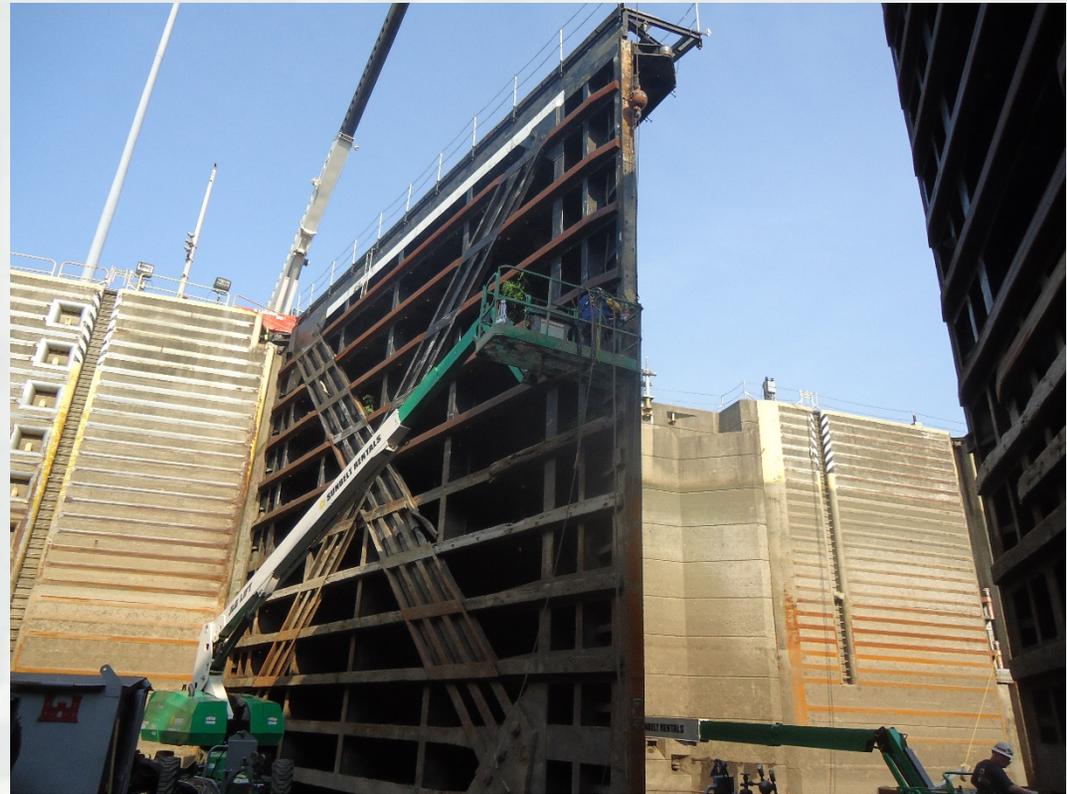
Lower End Miter/Quoin Block Replacement

- It was determined that the lower end pintle bushings were previously replaced because the gates had jacking guide cutouts and the pintle bushings had return grease lines.
